Department of Environmental Protection

HAZARDOUS WASTE INSPECTION REPORT

FACILITY NAME: Safety-Kleen Systems, Inc. **DEP/EPA ID #:** FLD 982 133 159

STREET ADDRESS: 4426 Entrepot Boulevard, Tallahassee, Florida 32310

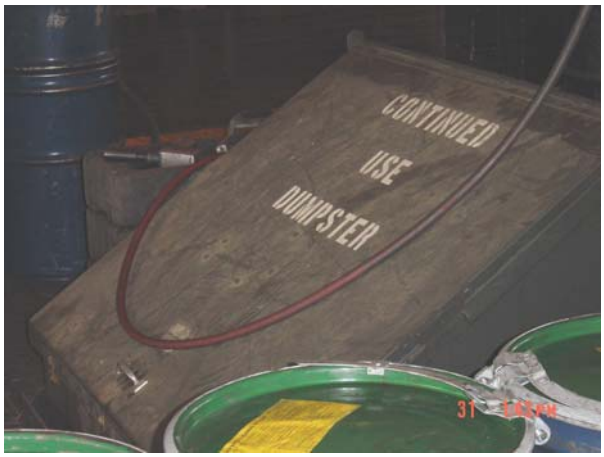
Picture A

The area was inspected mid-afternoon when no loading/unloading activity was underway. No route truck was parked in the unload area. The loading and unloading area was well maintained, with easy access to the emergency and safety equipment installed in this area. **See *Pictures A and B***.

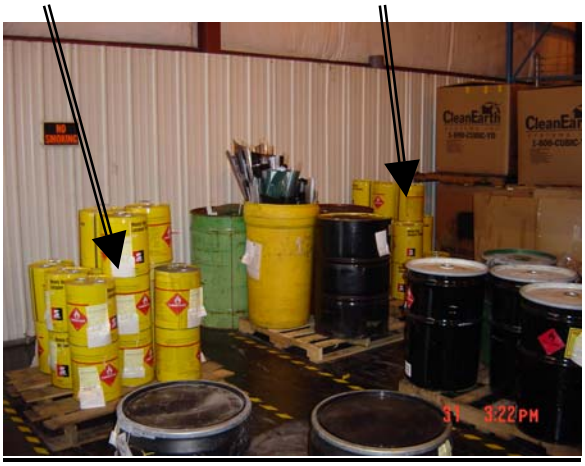
Picture F

The TSD Storage Area was organized and aisle space maintained to allow inspection of each container. All containers were in good physical condition, closed, and labeled. **See Picture F.** Two random containers were selected and a computer and hardcopy records check conducted to verify their origin, transport history and storage inventory. No discrepancies were noted. A visual inventory of drums versus computer record inventory for the TSD Storage Area was conducted by Mr. Hinsey and the Department inspector with one discrepancy identified. One yellow, 5-gallon, paint cleaning solvent container (Item #50219024509) was incorrectly placed on the pallet with the numerous empty yellow, 5-gallon, paint cleaning solvent containers. **See Picture G**. Discrepancy corrected at time of discovery.

TSD storage Empty can storage

S-K Tallahassee should review and improve its procedures for the location and handling of non-hazardous containers to ensure that no inadvertent mixed storage of hazardous and non-hazardous containers occurs.

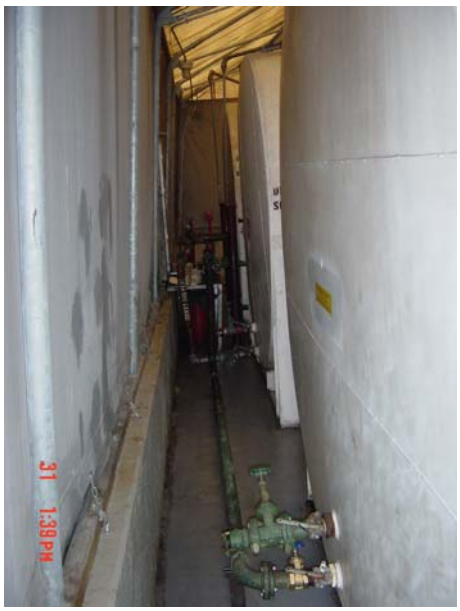
Picture H

The area was well maintained with no evidence of tank leakage noted. The load/unload pipe manifold area showed no evidence of leakage or spillage from the piping and equipage in this area. The accumulation drum located in this area was closed, labeled and in good condition. The daily inspection logs were reviewed for the previous year with no discrepancies noted. See Pictures H and J.

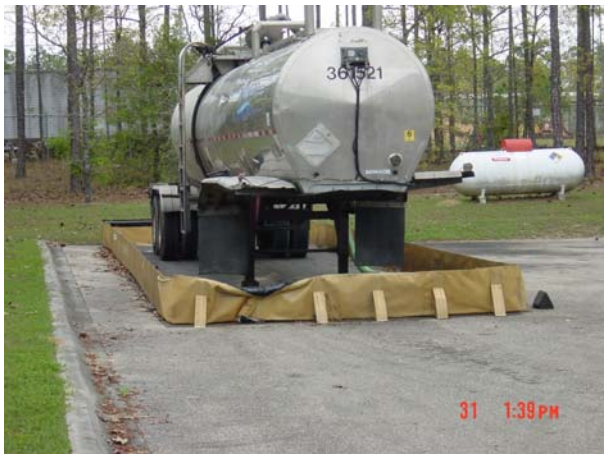
Picture K

The outside storage/laydown area, driveways, vehicle parking lot, solid waste dumpsters and the perimeter fence/lawn areas were inspected with no discrepancies noted. A tanker trailer is parked within a temporary secondary containment at the southwest corner of the rear asphalt parking area. This tanker will be used for on-site consolidation of wastes collected daily in the vacuum truck and then transferred and stored on-site in the tank trailer until a full 5000-gallon load makes it necessary for transport to the follow-on processor. All other security and safety equipment was installed in accordance with the permit and operational. (**See Pictures K and L**)
