Subject: **Five Year Submittal**
Trail Ridge Landfill (WACS ID# 33628)
Permit No. 0013493-026-SC-01
Specific Condition Section 2.A.5

Enclosed is the Report for Hydro Jet Cleaning and Inspection of the Leachate Collection Lines and Side Slope Riser Piping conducted by Integrated Environmental Technology (IET) in December 2018. Video Inspections are on file at Trail Ridge Landfill.

TRAIL RIDGE LANDFILL LEACHATE COLLECTION PIPING LAYOUT

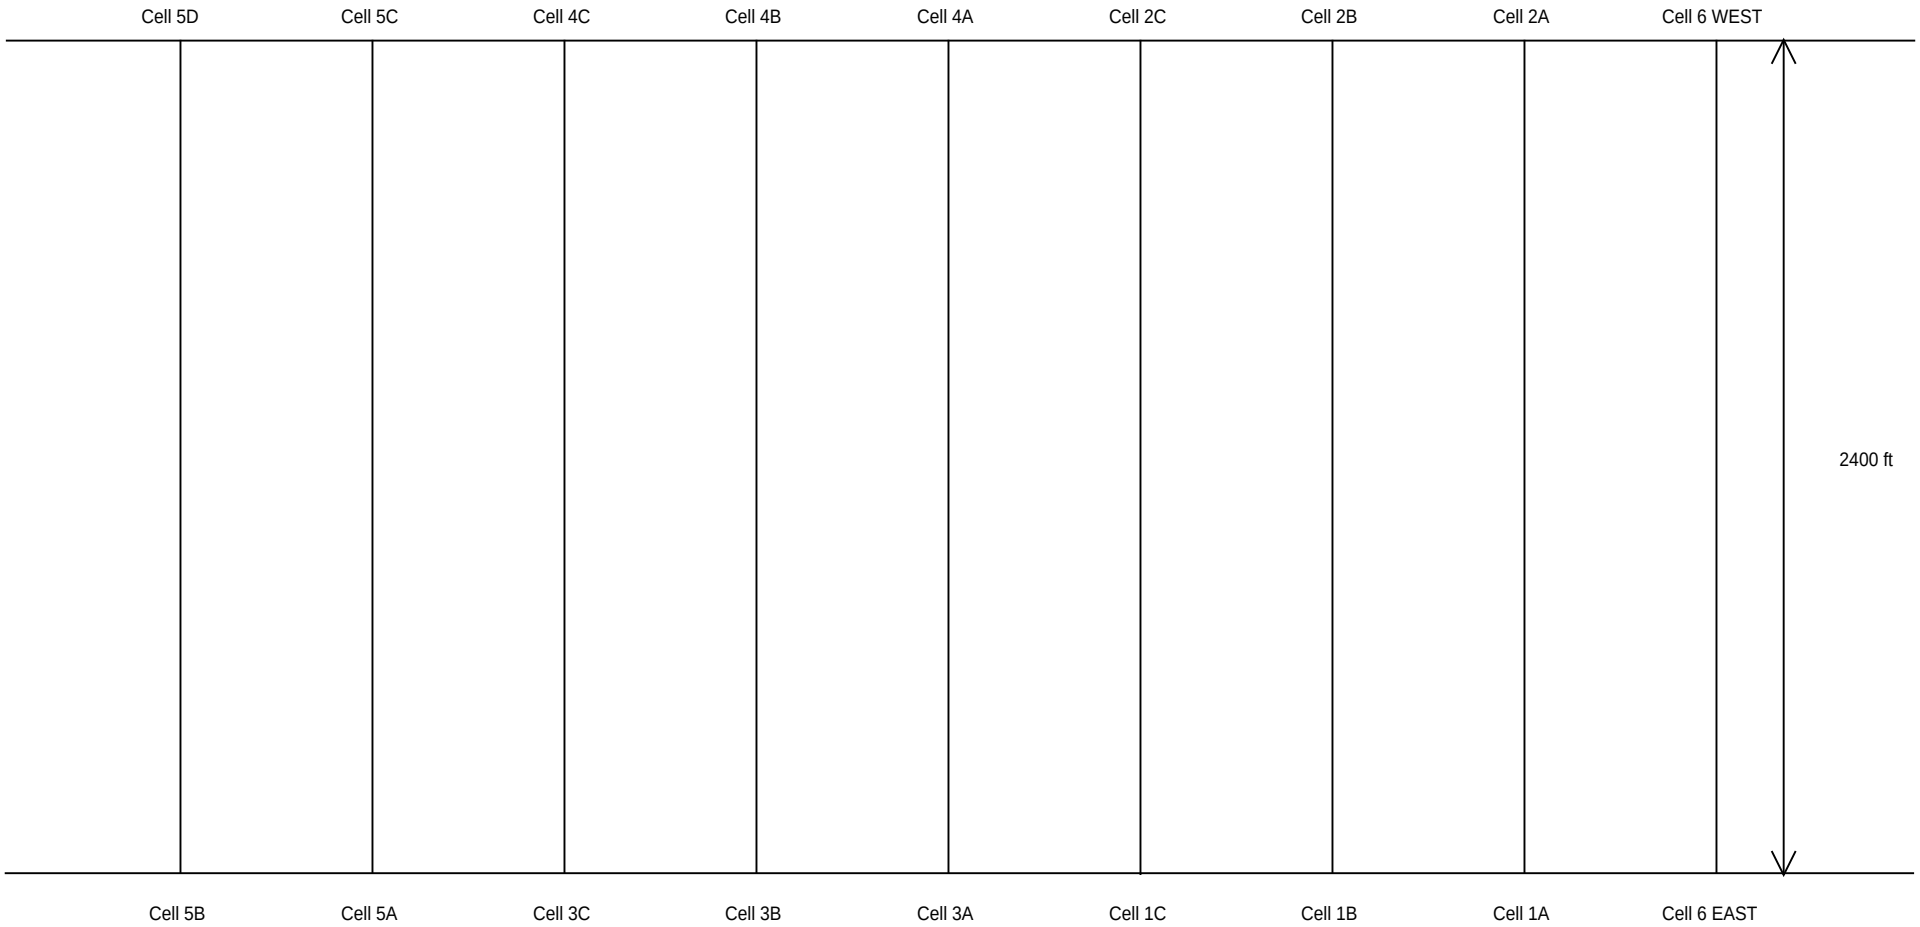
After high pressure water jetting and camera inspection of the leachate collection system, IET found no restrictions in the LCS piping that would prohibit the flow of leachate to the side slope riser stations. The leachate flow was present in the piping and moved unimpeded to each station.
