September 29, 2020
File No. 09217088.15

Subject: Landfill Gas Monitoring Report, Third Quarter 2020
Methane Perimeter Probes and Buildings Sampling
Lena Road Landfill, Manatee County, Florida
Permit # 39884-021-SO/01

ATTACHMENT 2
LANDFILL GAS MIGRATION MONITORING
3RD QUARTER 2020
LENA ROAD LANDFILL, MANATEE COUNTY, FLORIDA

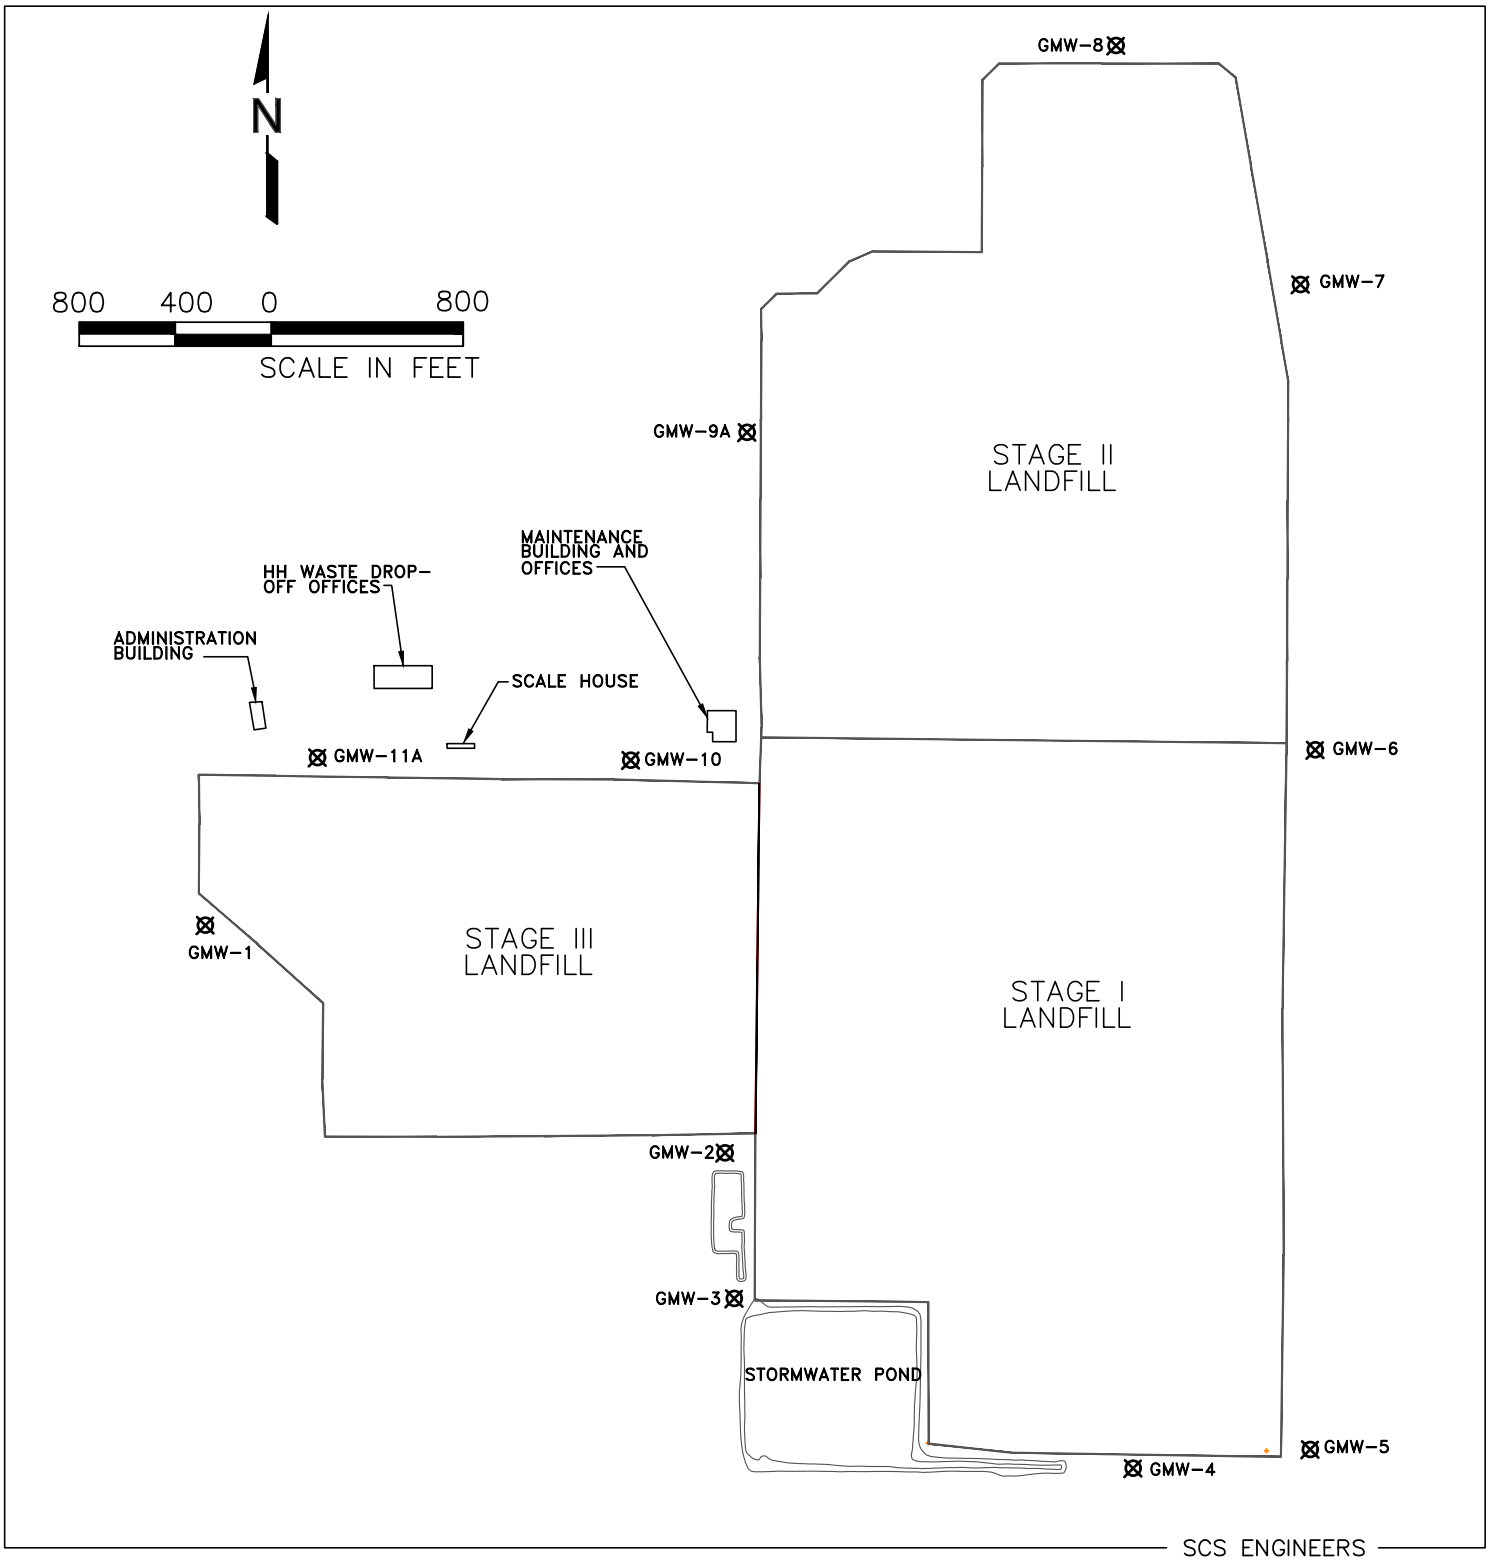
Lena Road Landfill, Manatee County, Florida
Attachment 1: Gas Monitoring Probes & Building Locations

Attachment 2 shows the readings obtained from the 11 LFG monitoring probes along the property boundary, no methane was detected in the monitoring probes aside from a 0.1% methane reading in Gas Monitoring Well 10 (GMW-10). A site plan showing the probe locations is included in Attachment 1.

No methane was detected in the any of the monitored structures on site, as shown in Attachment 2. In the buildings, SCS monitored both restrooms, the offices, and common areas. Readings were taken while walking around the buildings and interior rooms in a continuous manner. The location of the buildings monitored can be seen in Attachment 1.
