HAZARDOUS WASTE INSPECTION REPORT

FACILITY NAME: Terminal Service Company **DEP/EPA ID #:** FLD980848758

ADDRESS: 2778 West Tharpe Street, Tallahassee, Florida, 32303

COUNTY: Leon **PHONE:** (850) 576-1221 **DATE:** 2/28/07 **TIME:** 12:15 P.M.

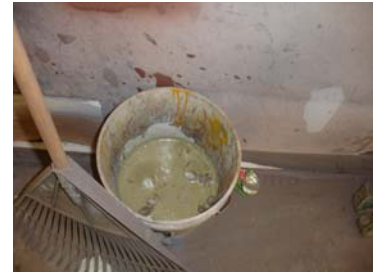
We inspected the paint booth and found a small bucket with paint waste located inside. This bucket was not labeled nor closed. We asked Mr. Wier how the paint waste and paint waste filters were being managed/disposed. Mr. Wier stated that he did not know what was in the bucket or how the paint waste or waste filters were being managed.

TSC failed to make a hazardous waste determination on numerous containers that did not have labels during this inspection. These containers include: four 55-gallon drums that were labeled "Non Hazardous Waste" at the Interior/Exterior Washing Facility; two 55-gallon drums of unknown wastes located behind the Interior/Exterior Washing Facility; approximately 70 containers of various sizes (55-gallon, 30-gallon and 5-gallon drums/buckets) at the Adjacent Areas near the Interior/Exterior Washing Facility; the numerous 55-gallon drums located north of the Diesel Tank Fueling Station; and one 5-gallon bucket of waste paint related material in the Paint Booth.
