SUBJECT: Short Form Consent Order
Proposed Settlement of Veolia ES Technical Solutions, L.L.C.
OGC File No.: 11-0801-37-HW

**Florida Department of
Environmental Protection
Hazardous Waste Inspection Report**

Facility Name: Veolia ES Technical Solutions LLC
On-Site Inspection Start Date: 12/07/2010 **On-Site Inspection End Date:** 12/07/2010
ME ID#: 6716 **EPA ID#:** FL0000207449
Facility Street Address: 342 Marpan Ln, Tallahassee, Florida 32305-0904
Contact Mailing Address: 342 Marpan Ln, Tallahassee, Florida 32305-0904
County Name: Leon **Contact Phone:** (850) 877-8299

Inspection Date: 12/07/2010

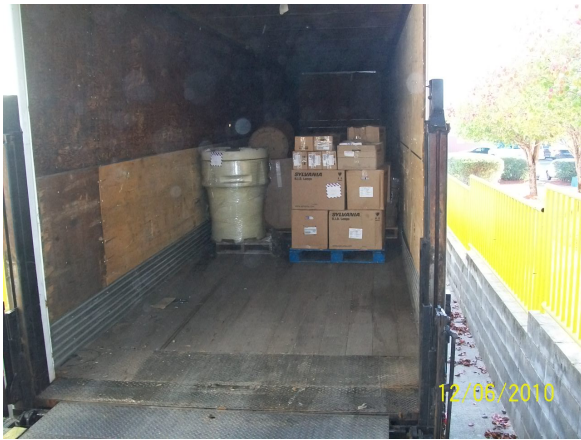
Loading Dock

During the inspection of the facility, Department and Agency staff observed approximately 20 drums total of post-retort phosphor powder, hazardous waste (pre-retort powder from long and compact fluorescent lamps) and PCB-ballasts being stored in this area. Ms. Dunwoody explained that the hazardous waste drums are normally stored in the designated area, but that they had been moved to this area temporarily due to the HWS Area being cleaned.
