**From:** Lucas Barroso-Giachetti <lucas@gleassociates.com>  
**Sent:** Thursday, March 10, 2016 4:43 PM  
**To:** Choi, Juchan  
**Cc:** hjasph  
**Subject:** RE: Notification of failure to follow up on compliance requests - H&J Asphalt Inc. FLD984205765  
**Attachments:** Comment No. 3 - Hose Leak Area with New Concrete Pad.jpg; Comment No. 7 - Oil Pans - New Disposal Drums in Garage Area.jpg; Comment No. 8 - Maintenance Area - Spill Removed.jpg; Comment No. 9 - Pipe Leak Area.jpg; Comment No. 10 - Pit Pumped Out.jpg; Comment. No. 11 - Oily Rags Removed.jpg

**From:** Choi, Juchan [mailto:[Juchan.Choi@dep.state.fl.us](mailto:Juchan.Choi@dep.state.fl.us)]  
**Sent:** Thursday, March 03, 2016 3:05 PM  
**To:** Lucas Barroso-Giachetti  
**Cc:** hjasph  
**Subject:** RE: Notification of failure to follow up on compliance requests - H&J Asphalt Inc. FLD984205765  
**Importance:** High

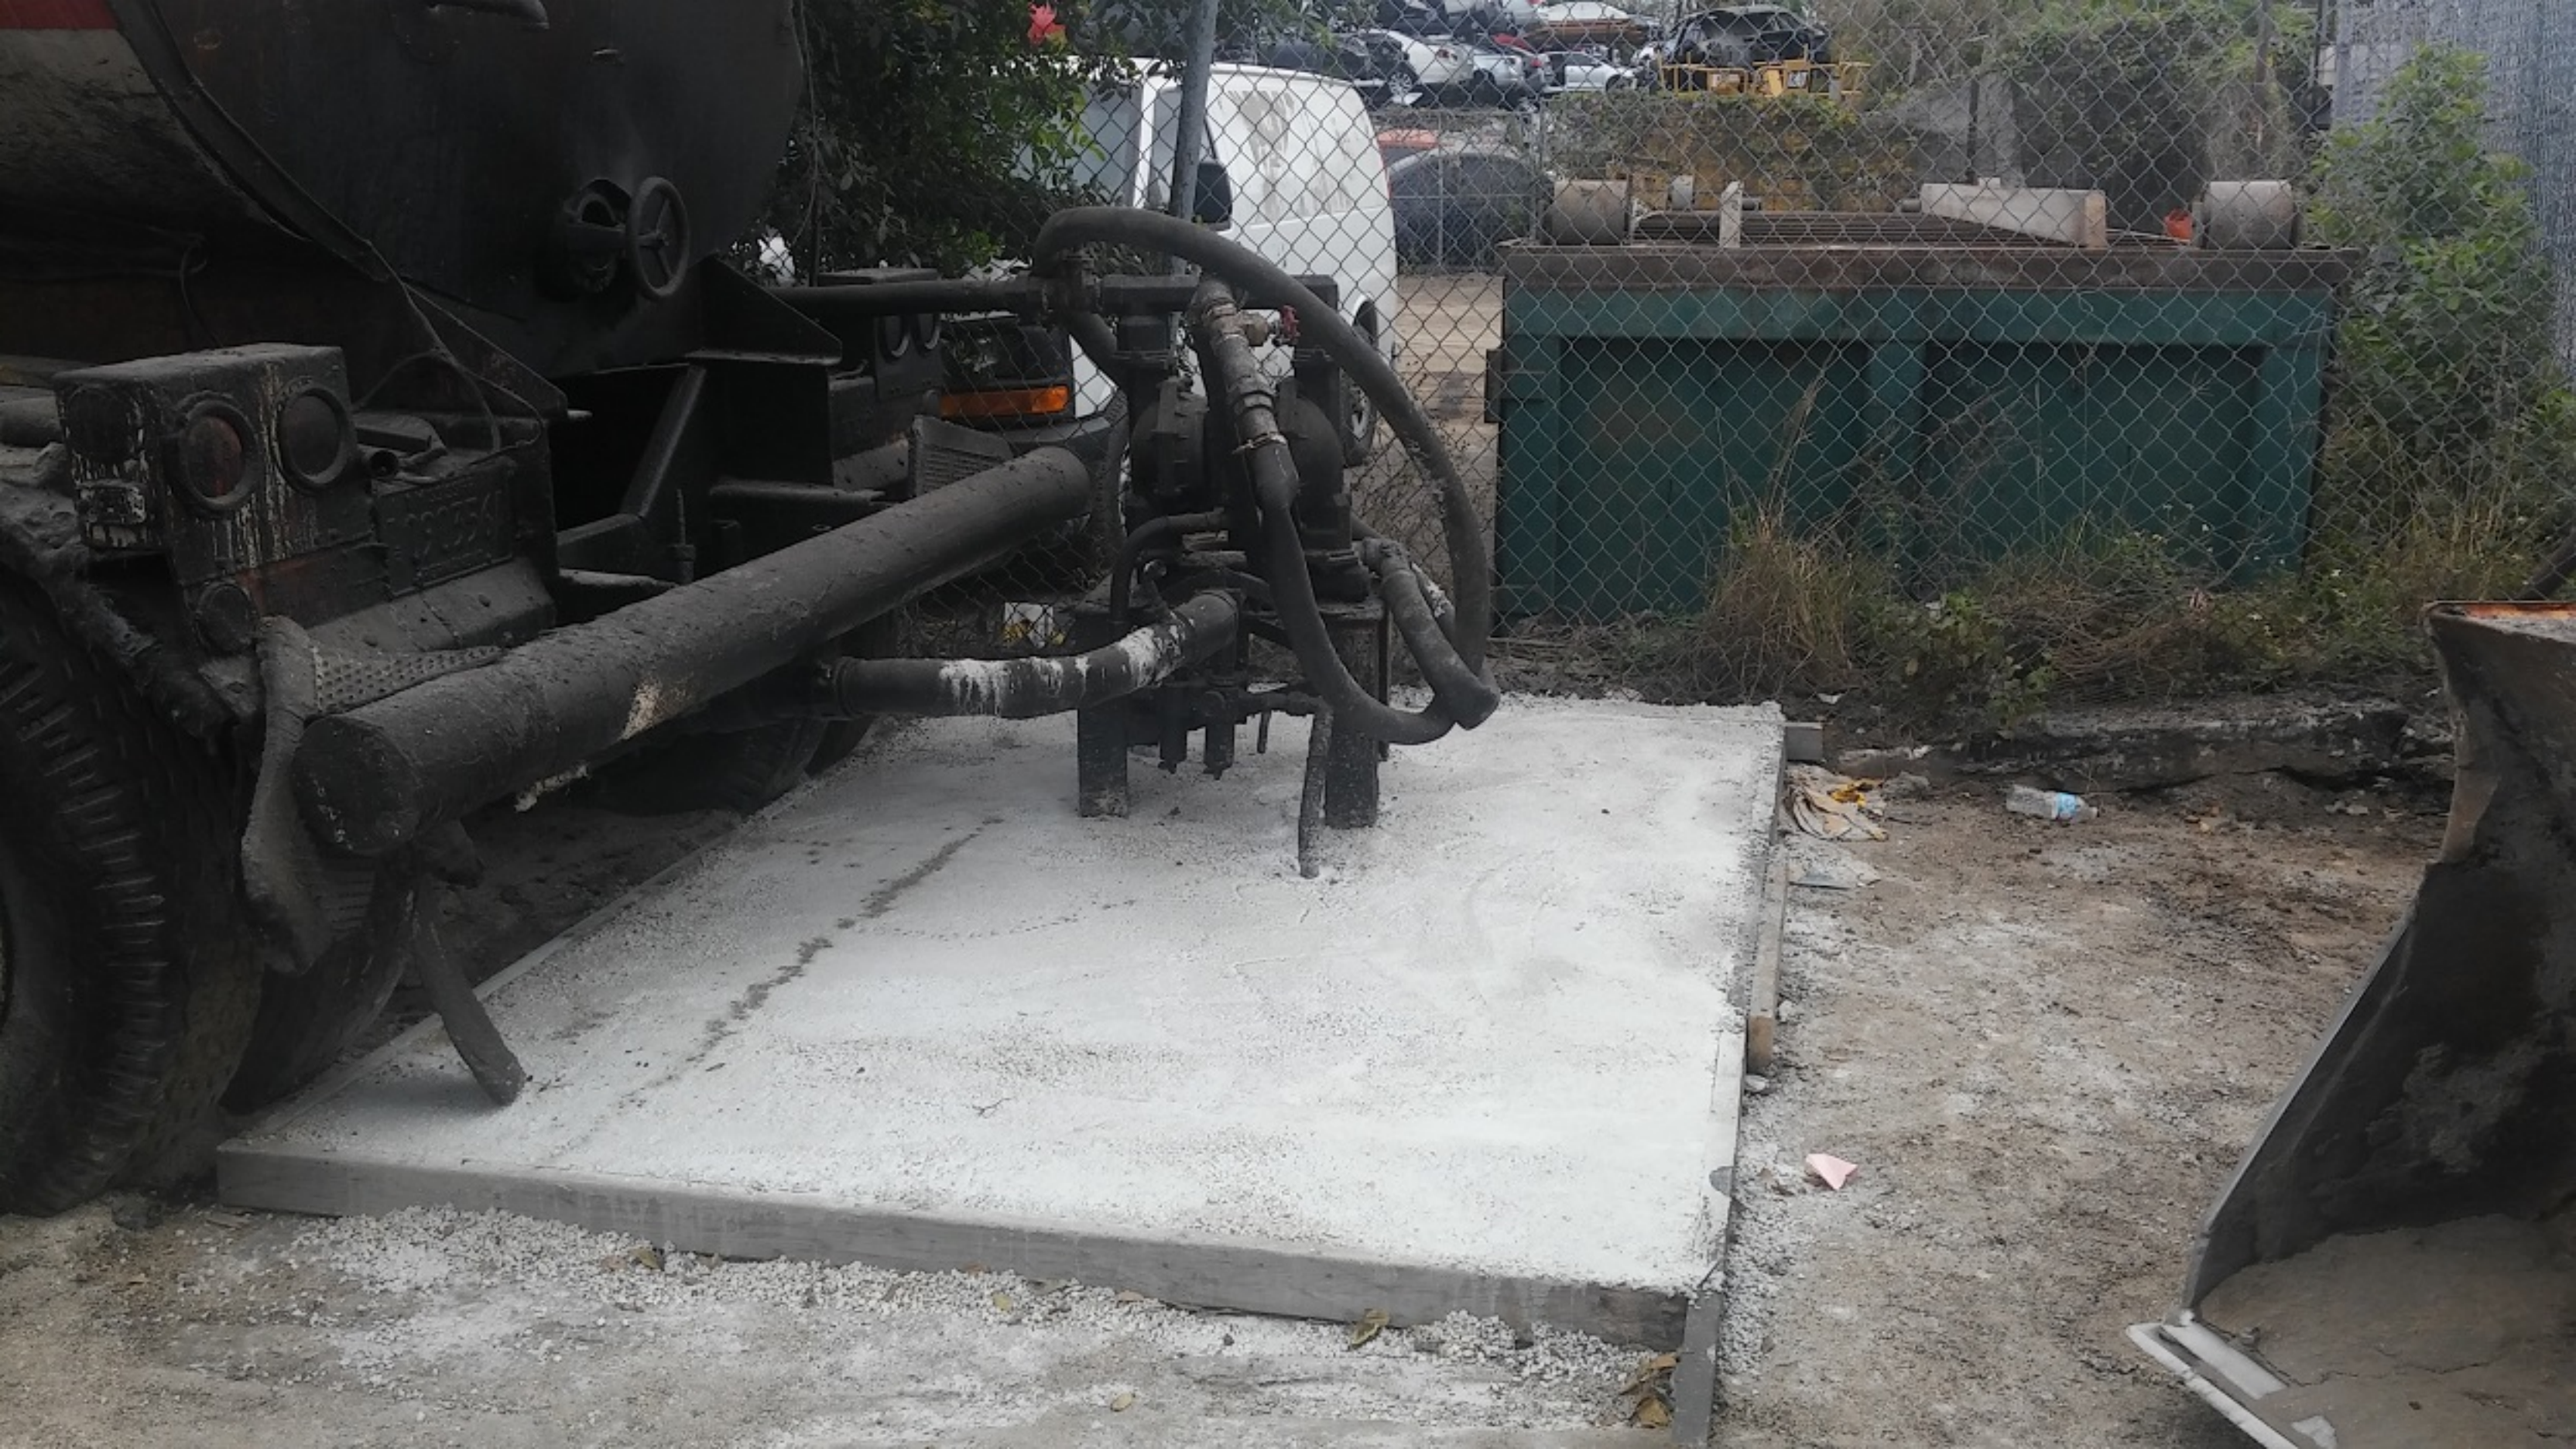
- Comment No. 6 – The area with dirty oil dry has been cleaned and the sand placed in the newly implemented 55-gallon disposal drums.
- Comment No. 7 – As requested, the pans and buckets have been removed and the used oil properly containerized. A photo showing the area with the newly installed disposal drums is attached. In addition, oils/liquids in the parts washer have been removed. Please note that the facility does not generate a large volume of waste oil and typically conducts disposal pickups approximately every 6 months.
