# FLORIDA DEPARTMENT OF Environmental Protection

**RE: Warning Letter No. WL19-103 (Significant Non-Complier)**  
**EPA/DEP ID: FLD 984 209 346**  
**Duval County – Hazardous Waste**

**Florida Department of  
Environmental Protection  
Hazardous Waste Inspection Report**

**Facility Name:** Ring Power Corp

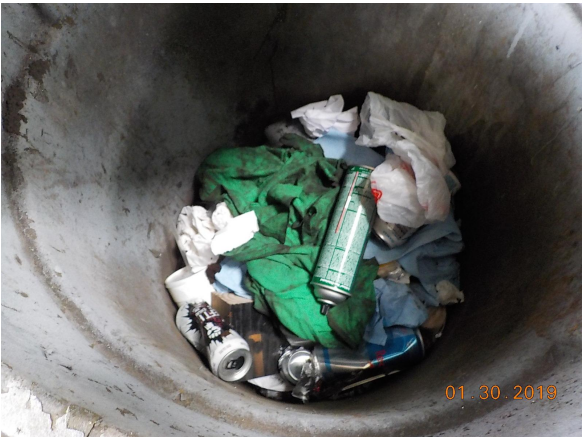
Photo 9

The facility's process indicates that aerosol cans should be punctured and drained into the 55-gallon drum with a drum-top aerosol can puncturing device that is located in the Wash Rack area and managed as described below. However, several empty cans were observed in various trash cans and dumpsters that appeared to have been punctured in some other manner and had not been properly drained (Photo 8). One non-empty aerosol can of Brakleen Brake Parts Cleaner-Non-Chlorinated was observed in the trash can located in the Utility Truck Division area (Photo 9) [40 CFR 262.14(a)(5)]. Liquid from the can leaked out when it was removed from the trash can.
