**CITRUS COUNTY CENTRAL LANDFILL  
PHASE 1/1A LEACHATE COLLECTION SYSTEM  
ISSUES**

**230 W. GULF TO LAKE HIGHWAY  
LECANTO, FLORIDA**

**DEPARTMENT OF PUBLIC WORKS  
DIVISION OF SOLID WASTE MANAGEMENT**

# **CITRUS COUNTY LANDFILL PHASE 1/1A LEACHATE COLLECTION SYSTEM ISSUES**

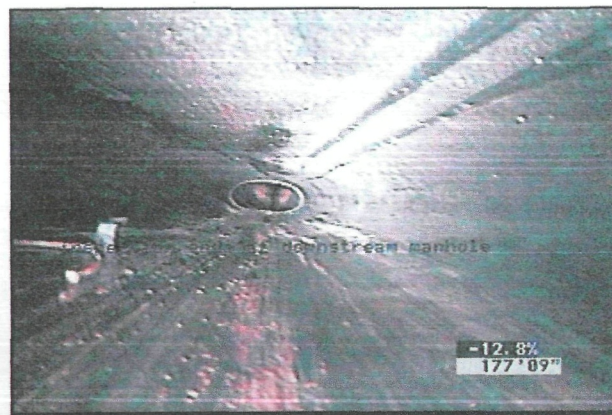
Photo: S\_StartNode\_S\_EndNode\_091108\_094618\_A.JPG,  
VCR #: 1  
177.75FT, inspection ends

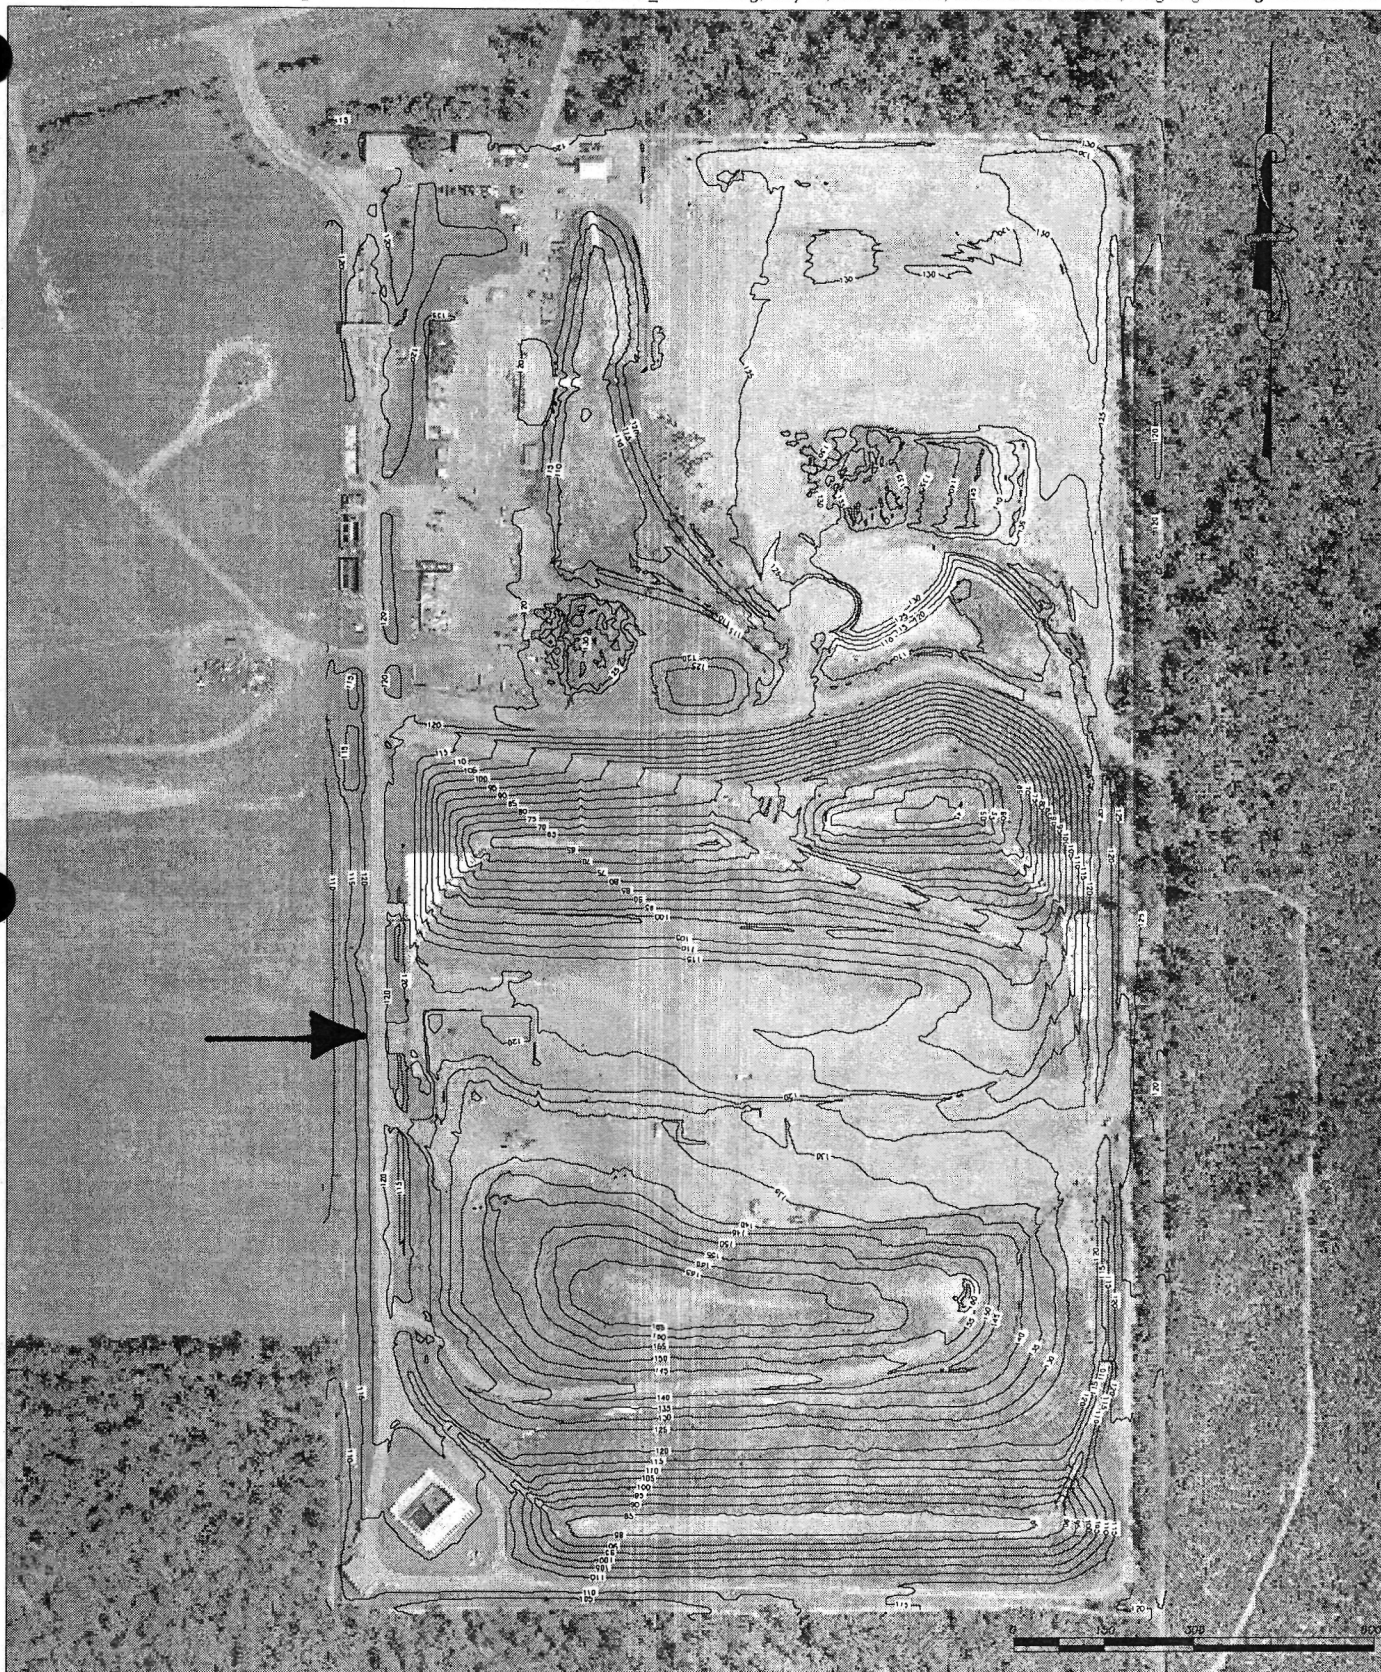
FIGURE 1. LOCATION OF PHASE 1/1A LEACHATE PIPES

On the west side of the active Citrus County Central Landfill, there are seven pipes that lay on the side slope of Phase 1/1A. They are located in a notch in the 2:1 side slope and are bedded in polyurethane foam. The location of those pipes is shown on Figure 1. Details of the arrangement are shown in Figure 2, a reduced size excerpt from the as-built drawings prepared by CH2M Hill, the engineer for the project.

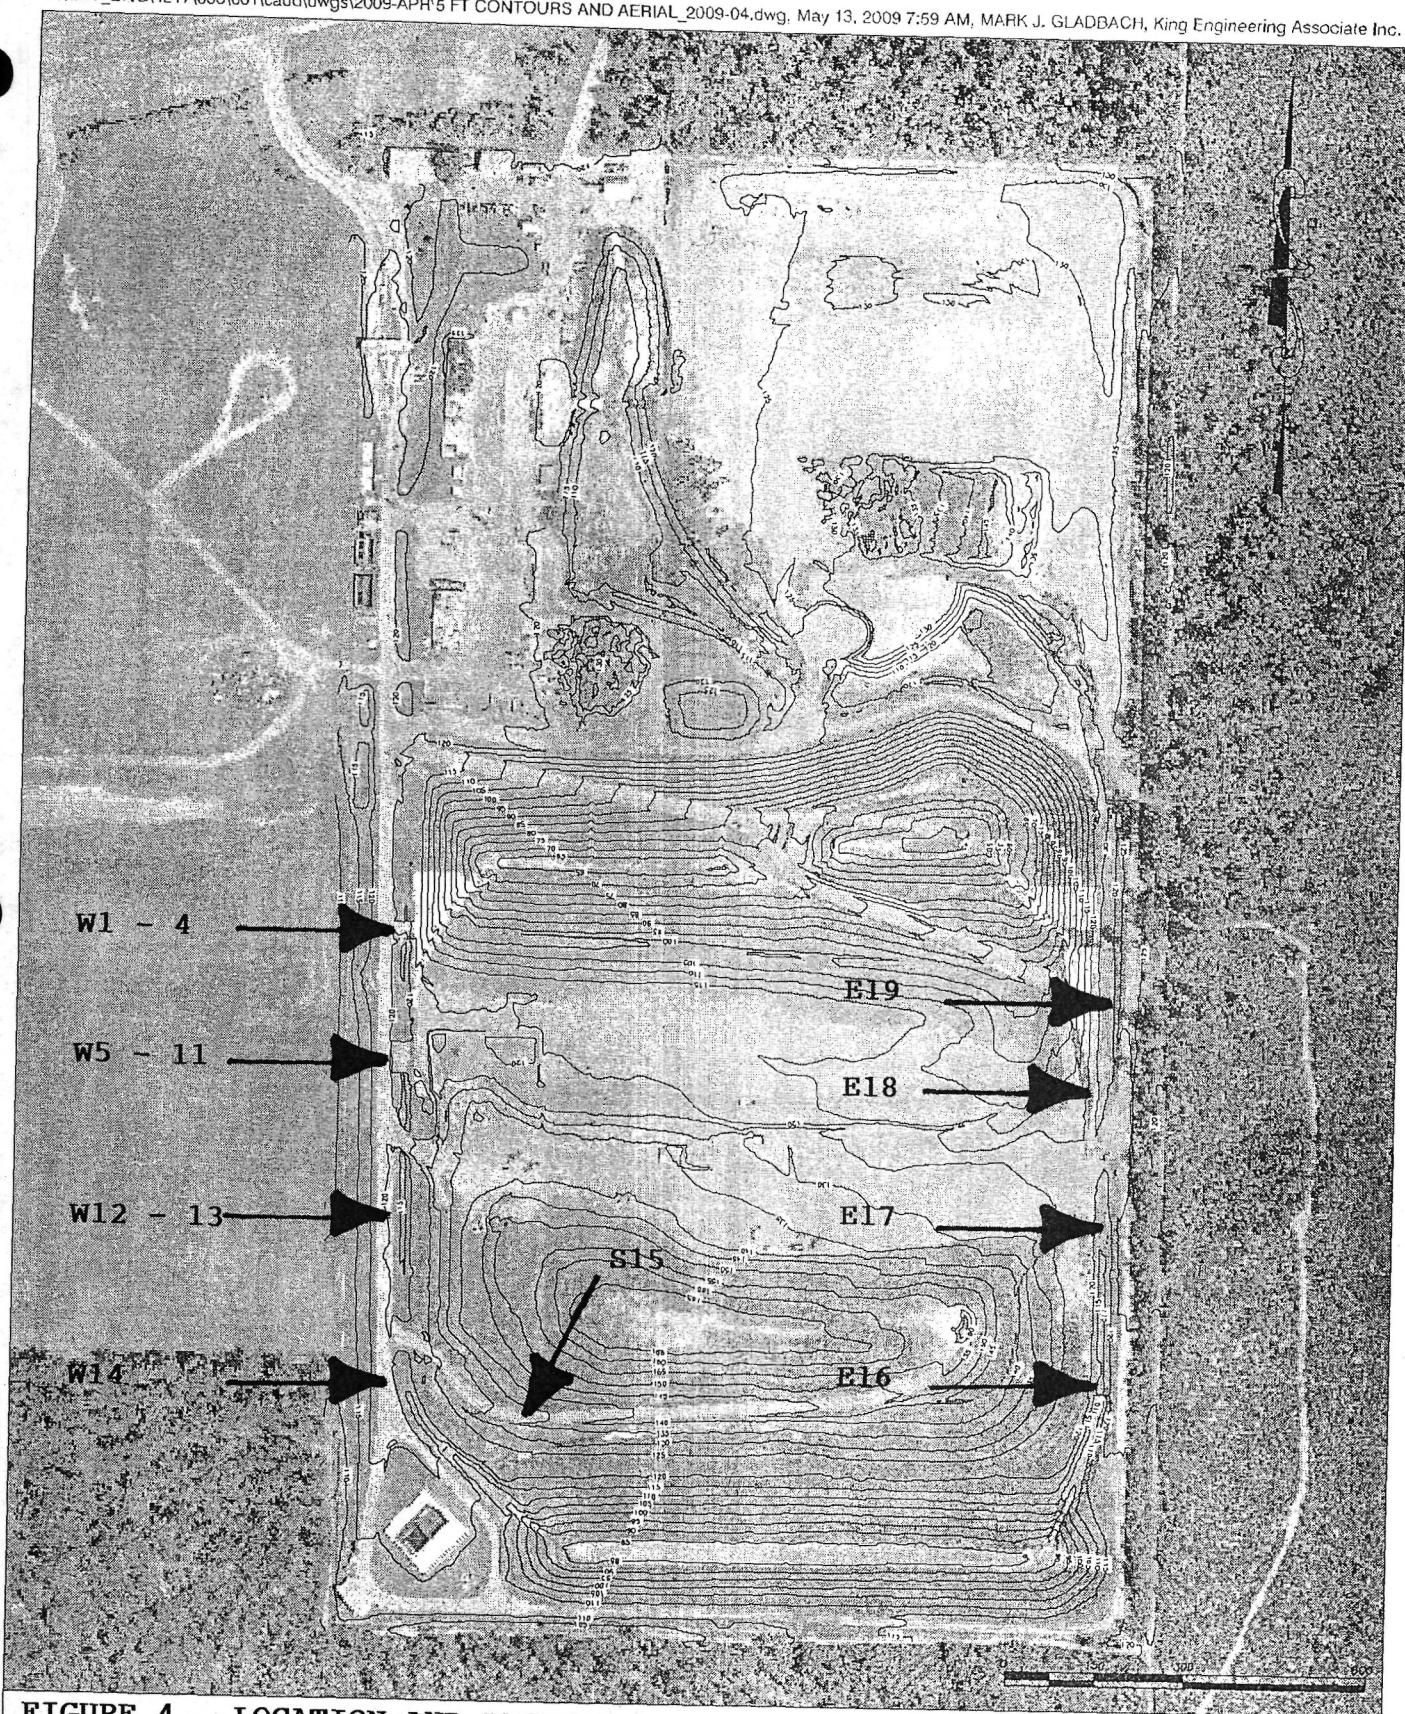
FIGURE 4. LOCATION AND DESIGNATION OF LEACHATE PIPES VIDEO INSPECTION IN MAY 2009, CITRUS COUNTY CENTRAL LANDFILL

Later in May 2009, video inspections of all of the leachate pipes in the active landfill were conducted. DVDs of the video are attached (Attachment I) with a summary of observations shown in Table 2. The location of the top end of these pipes is shown on Figure 4 with the designations matching those in Table 2.

Some condition has occurred that caused all the leachate pipes on the side slope associated with Phase 1A to deform in the section between about 90 feet and 190 feet below the top of the slope. The assumed vertical dimension has been reduced to the point that removal and replacement of one and possibly more leachate pumps is impossible. The deformation of the pipes may be increasing. The leachate collection pumps continue to function, except for Primary Pump #2. The cleanouts for the Phase 1 sump which are located at the south end of the same side-slope section appear to be full diameter to the bottom. None of the other leachate collection pipes at the site show any diameter changes from previous inspections.

Slip-lining the carrier pipes with smaller pipes and grouting between the inner and outer pipes is one possible solution. Pumps that would fit inside the smaller pipes would be used to replace the existing pumps. Sufficient pump capacity should be achievable in the smaller size, running longer at lower pumping rates to keep the level of leachate in the sump at compliant elevations.

Another possibility would be to create a new vertical pump carrier shaft into the primary sump. The next possibility is removing all waste over the side-slope leachate pipes in order to replace them.
