**Re: Southeast County Landfill
Phases I-VI Leachate Collection System
Water Jet Cleaning and Video Inspection Report
FDEP Permit No.: 35435-014-SO/01
WACS Facility ID No.: SWD/29/41193**

Hillsborough County Solid Waste Southeast County Landfill High-pressure Water-jetting & Explosion-proof Video-inspection

DATE : 3/24/2011
TO : Walter Gray, Larry Ruiz – Hillsborough County Solid Waste
FROM : Ralph Calistri (floridajetclean@yahoo.com)
SUBJECT : Hillsborough County Southeast Landfill – LCS Maintenance

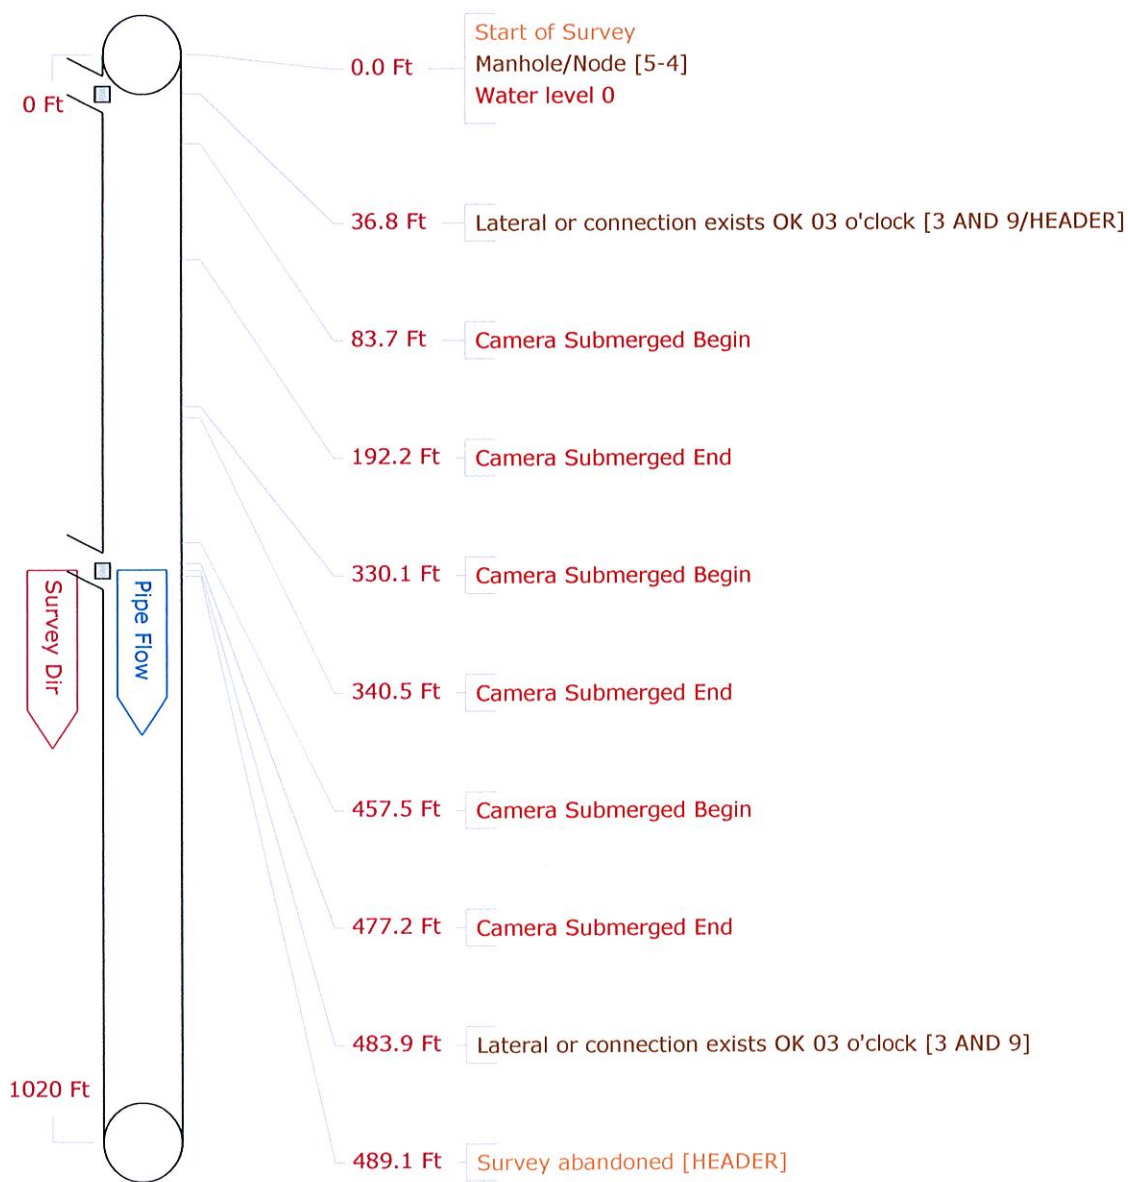
Pipe Graphic Report of PLR 5-4 A for SWA

Work Order		Contract		Video	1	Setup		1
Facility		Operator		BMN	Van Ref	2	Surveyed On	03/15/2011
Street Name		HILLSBOROUGH SCLF		City		SCLF		
Location type		Berm						
Surface								
Survey purpose				Other (state in comments)				
				Weather Dry				
Pipe Use		Other (state in comments)		Schedule length		1020.0 Ft		
Shape		Circular		Size 8		by ins		
Material		Other (state in comments)		Joint spacing		Ft		
Lining				Year laid				
General note				HDPE LEACHATE COLLECTION		Structural		Service
Location note				JETTING=1020		Miscellaneous		Constructional
						Hydraulic

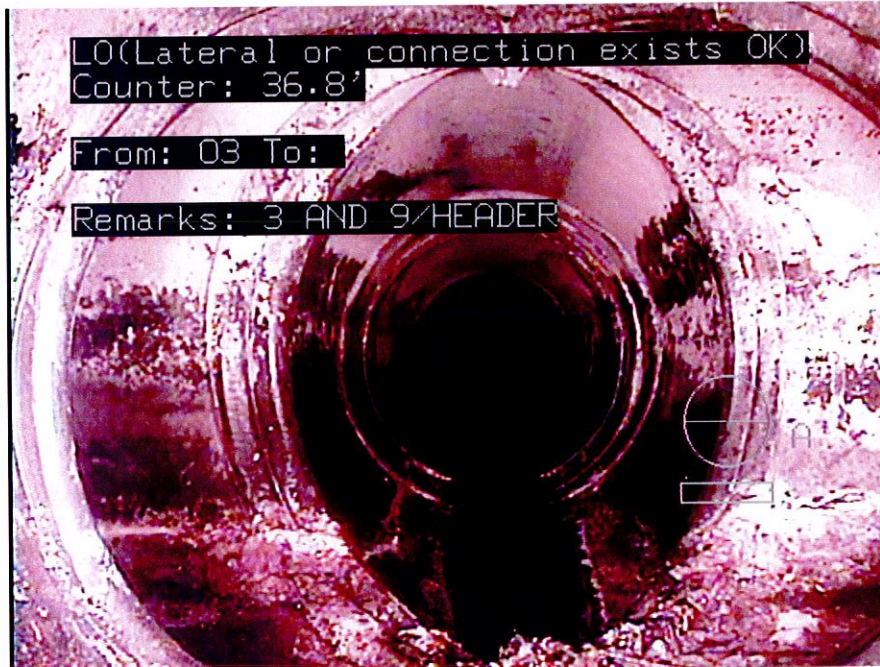
Distance: 36.8 Ft

Obs: Lateral or connection exists OK

Comments: 3 AND 9/HEADER

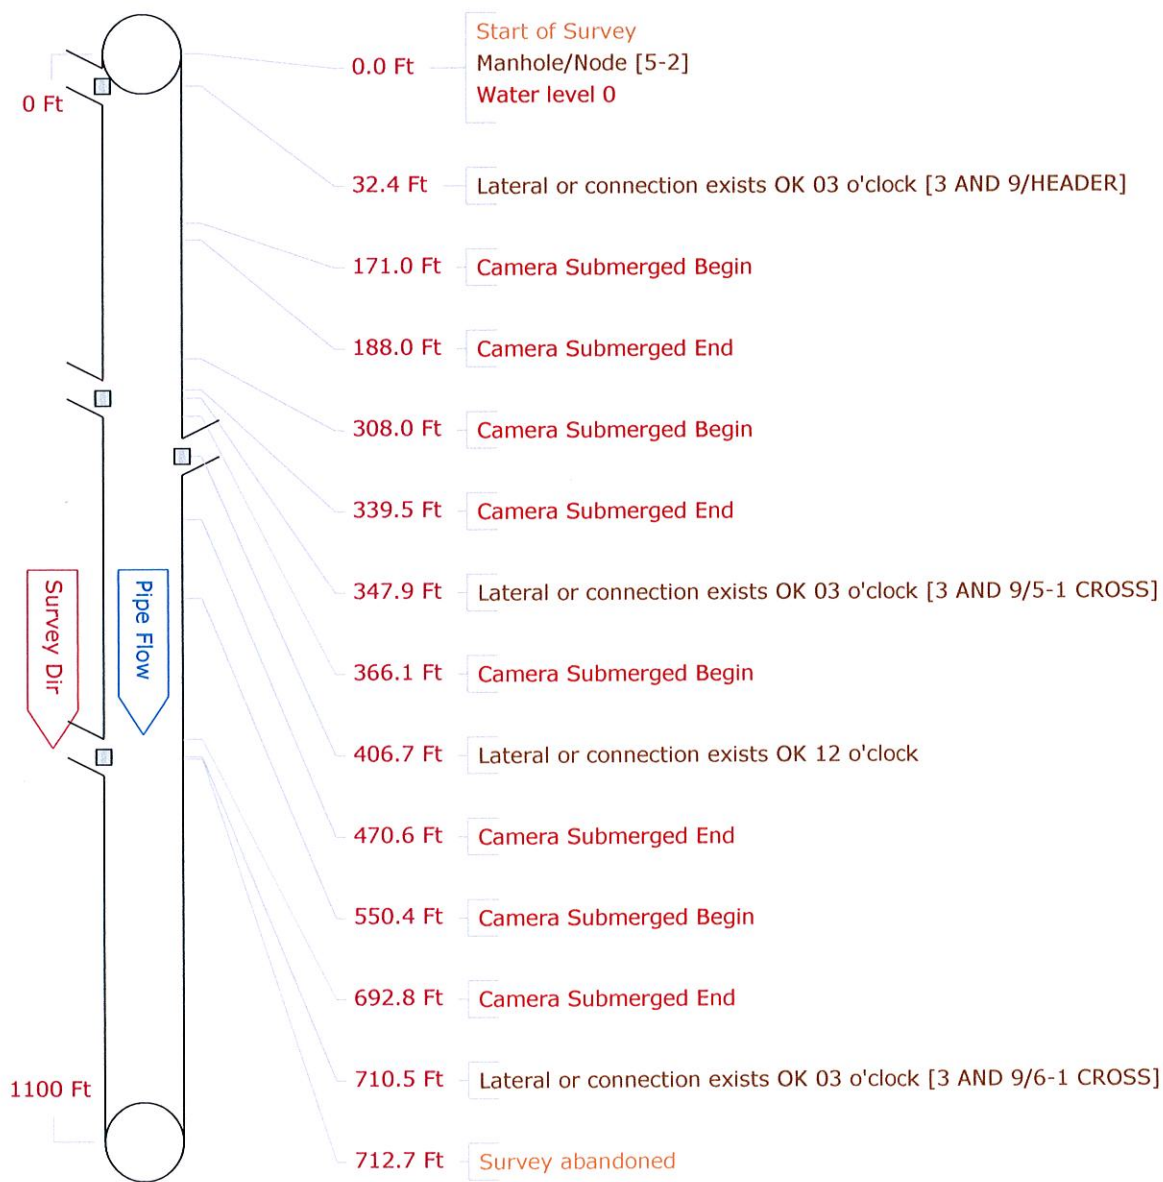
Pipe Graphic Report of PLR 5-2

Work Order	Contract	Video	1	Setup	3
Facility	Operator BMN	Van Ref	2	Surveyed On	03/15/2011
Street Name	HILLSBOROUGH SCLF	City	SCLF		
Location type	Berm				
Surface					
Survey purpose	Other (state in comments)	Weather	Dry		
Pipe Use	Other (state in comments)	Schedule length	1100.0 Ft	From	5-2
Shape	Circular	Size	8 by ins	To	B SUMP
Material	Other (state in comments)	Joint spacing	Ft	Direction	Downstream
Lining		Year laid		Pre-clean	Y
				Last cleaned	3/14/2011
General note	HDPE LEACHATE COLLECTION	Structural		Service	Constructional
Location note	JETTING=1100	Miscellaneous		Hydraulic

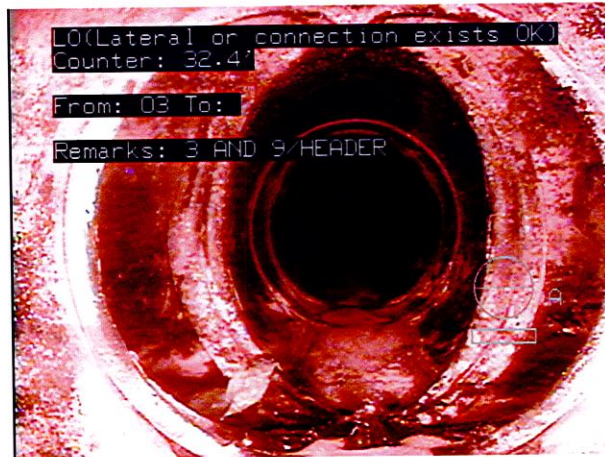
Distance: 32.4 Ft

Obs: Lateral or connection exists OK

3 AND 9/HEADER

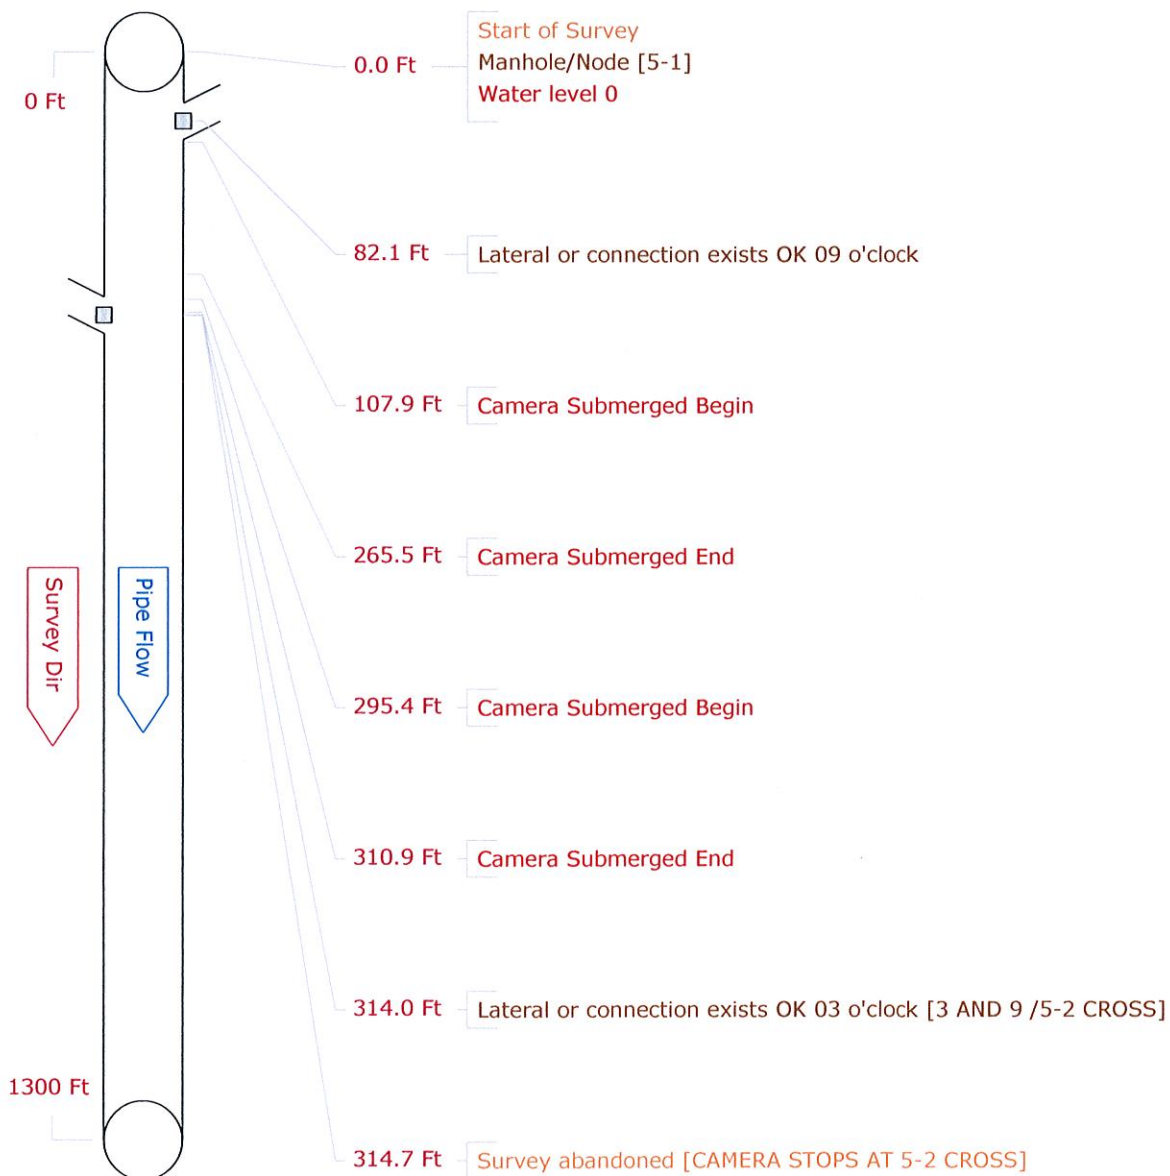
Pipe Graphic Report of PLR 5-1

Work Order		Contract		Video 2		Setup 4	
Facility		Operator BMN		Van Ref 2		Surveyed On 03/15/2011	
Street Name		HILLSBOROUGH SCLF		City		SCLF	
Location type		Berm					
Surface							
Survey purpose		Other (state in comments)			Weather Dry		
Pipe Use		Other (state in comments)		Schedule length 1300.0 Ft		From 5-1 Depth Ft	
Shape		Circular		Size 8 by ins		To B SUMP Depth Ft	
Material		Other (state in comments)		Joint spacing Ft		Direction Downstream	
Lining				Year laid		Pre-clean Y Last cleaned 3/14/2011	
General note		HDPE LEACHATE COLLECTION			Structural Service Constructional		
Location note		JETTING=1300			Miscellaneous Hydraulic

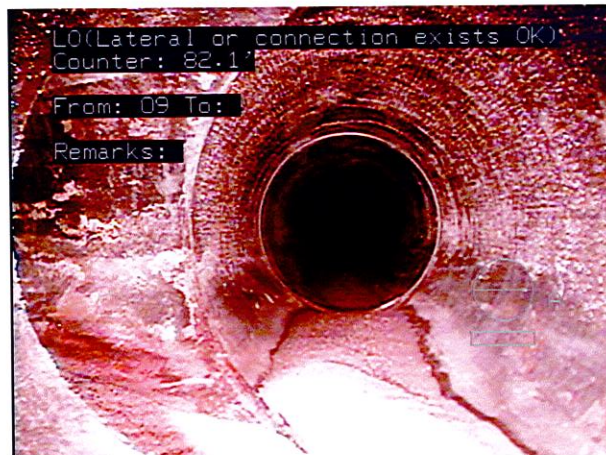
Distance: 82.1 Ft

Obs: Lateral or connection
exists OK

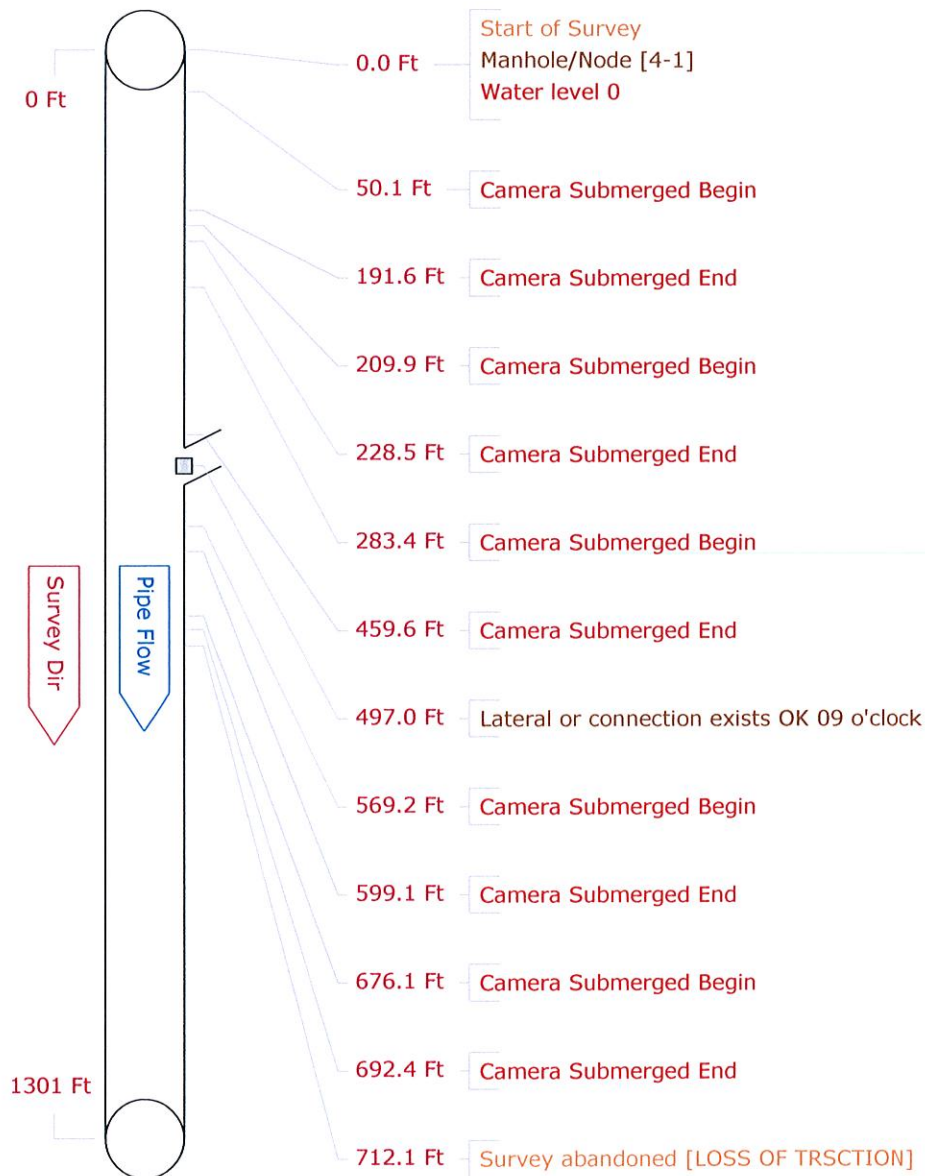
Pipe Graphic Report of PLR 4-1 F for SWA

Work Order	Contract	Video	2	Setup	6
Facility	Operator BMN	Van Ref	2	Surveyed On	03/15/2011
Street Name	HILLSBOROUGH SCLF	City	SCLF		
Location type	Berm				
Surface					
Survey purpose	Other (state in comments)	Weather	Dry		
Pipe Use	Other (state in comments)	Schedule length	1301.0 Ft	From	4-1
Shape	Circular	Size 8 by ins		To	B SUMP
Material	Other (state in comments)	Joint spacing	Ft	Direction	Downstream
Lining		Year laid		Pre-clean	Y
				Last cleaned	3/14/2011
General note	HDPE LEACHATE COLLECTION	Structural		Service	Constructional
Location note	JETTING=1301	Miscellaneous		Hydraulic

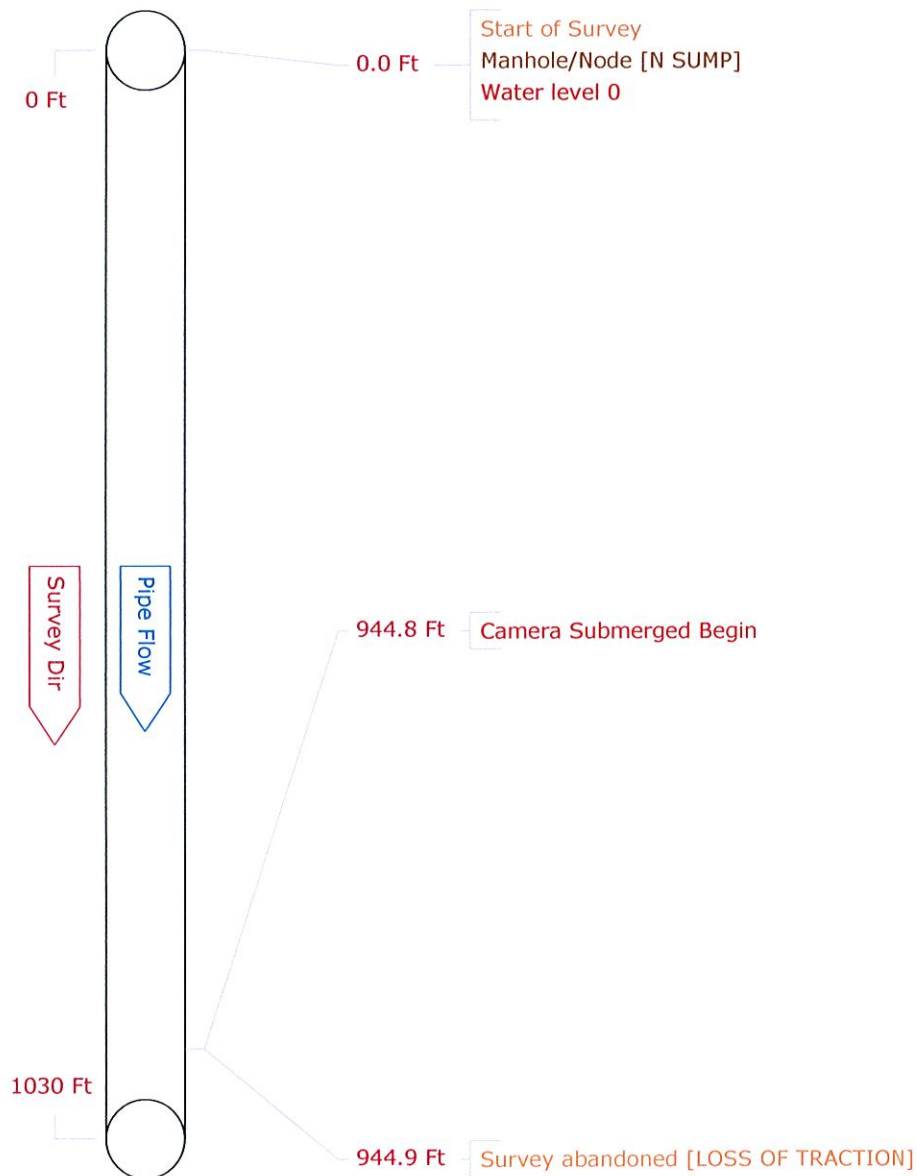
Pipe Graphic Report of PLR N SUMP G for SWA

Work Order	Contract	Video	Setup
Facility	Operator BMN	Van Ref 2	Surveyed On 03/16/2011
Street Name	HILLSBOROUGH SCLF	City	SCLF
Location type	Berm		
Surface			
Survey purpose	Other (state in comments)	Weather	Dry
Pipe Use	Other (state in comments)	Schedule length	1030.0 Ft
Shape	Circular	Size 18 by ins	
Material	Other (state in comments)	Joint spacing	Ft
Lining		Year laid	
From	N SUMP	Depth	Ft
To	B SUMP	Depth	Ft
Direction	Downstream		
Pre-clean	Y	Last cleaned	3/16/2011
General note	HDPE LEACHATE COLLECTION	Structural	Service Constructional
Location note	JETTING=1030	Miscellaneous	Hydraulic

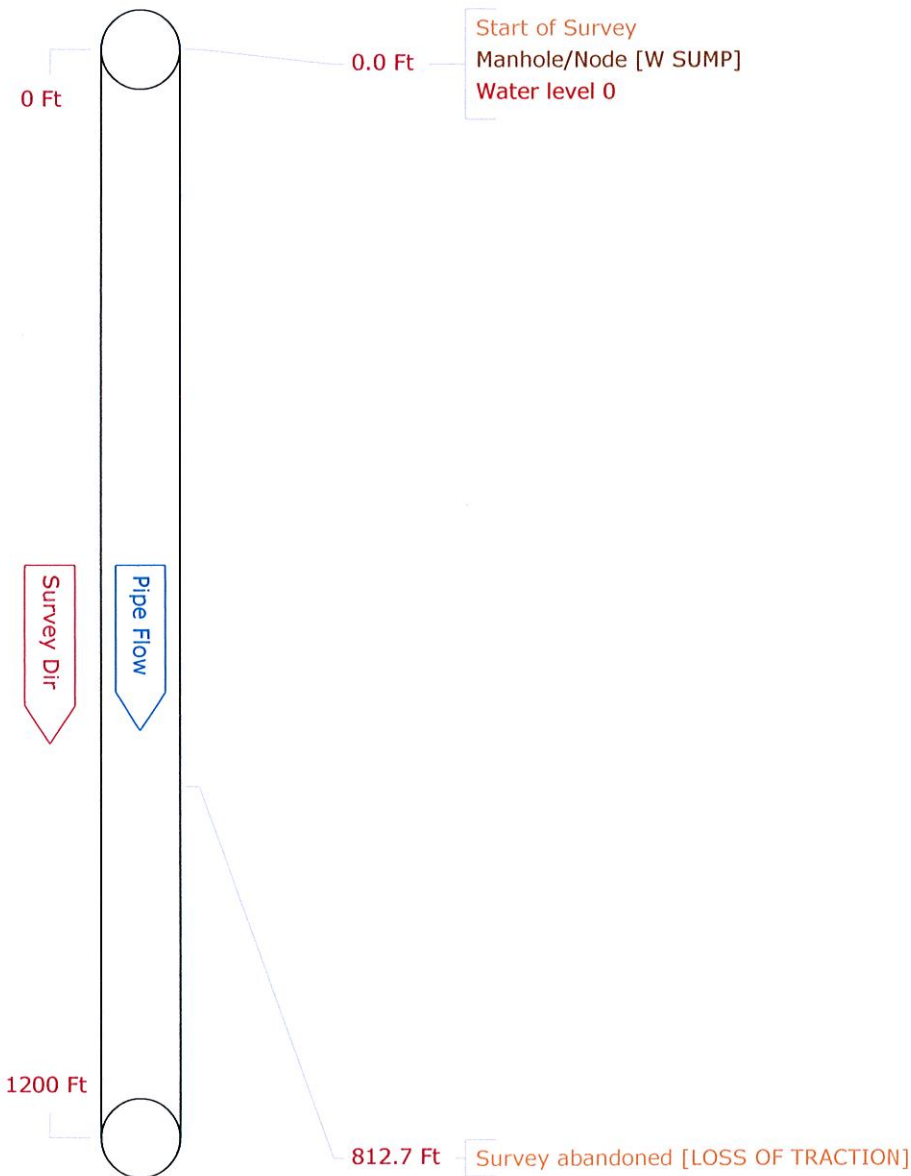
Pipe Graphic Report of PLR W SUMP G for SWA

Work Order		Contract		Video		3		Setup		8							
Facility		Operator		BMN		Van Ref		2		Surveyed On		03/16/2011					
Street Name		HILLSBOROUGH SCLF				City		SCLF									
Location type		Berm															
Surface																	
Survey purpose		Other (state in comments)					Weather		Dry								
Pipe Use		Other (state in comments)		Schedule length		1200.0 Ft		From		W SUMP		Depth		Ft			
Shape		Circular		Size		18 by		ins		To		B SUMP		Depth		Ft	
Material		Other (state in comments)		Joint spacing		Ft		Direction		Downstream							
Lining				Year laid				Pre-clean		Y		Last cleaned		3/16/2011			
General note		HDPE LEACHATE COLLECTION						Structural		Service		Constructional					
Location note		JETTING=1200						Miscellaneous		Hydraulic
