## SCS ENGINEERS

August 12, 2011  
File No. 09207049.04

Subject: Response to RAI No. 2  
Citrus County Central Class I Landfill  
7-Acre Re-Closure Construction Certification  
Permit No. 21375-014-SF/01, Citrus County  
WACS No.: SWD/09/39859

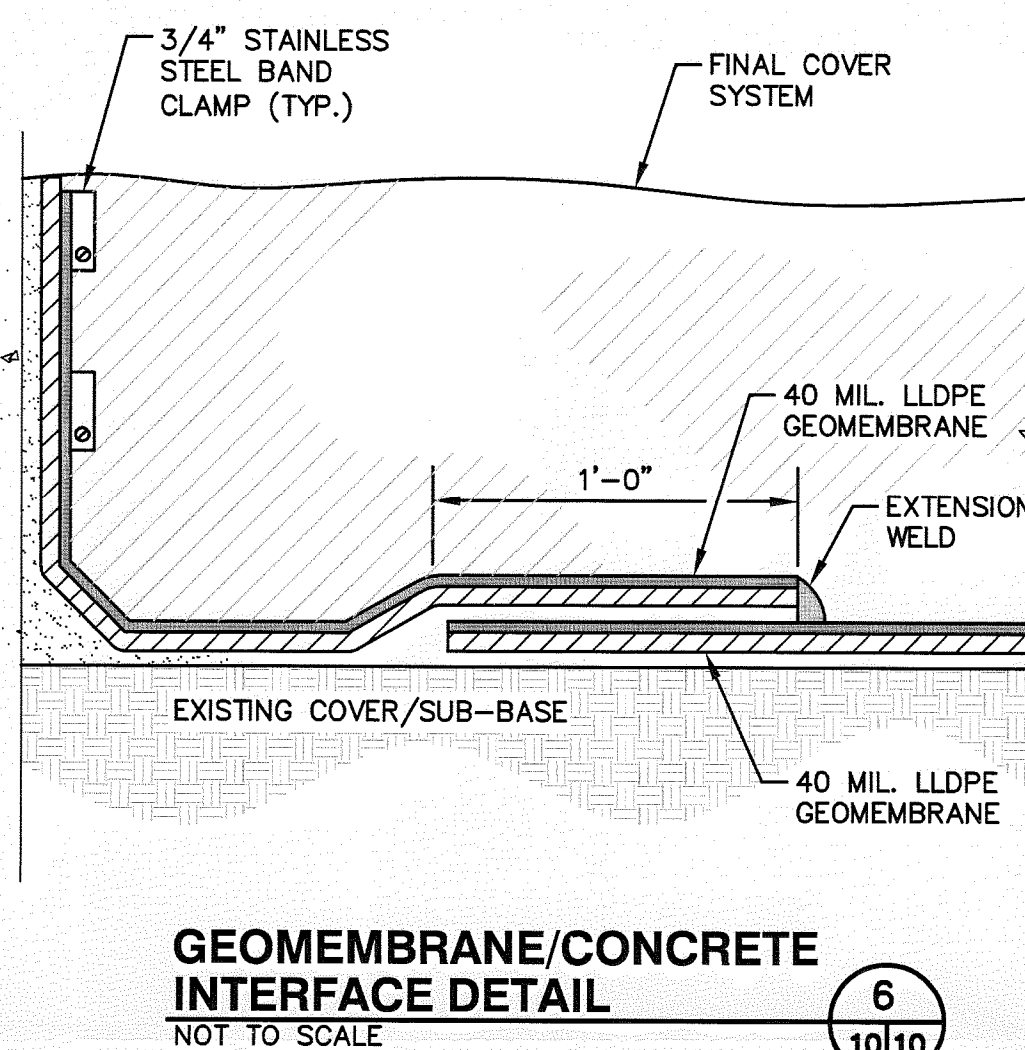
REVISED RECORD DRAWINGS SHEET 10 OF 27

36" BOREHOLE

EXTRUSION WELD TO EXISTING LINER

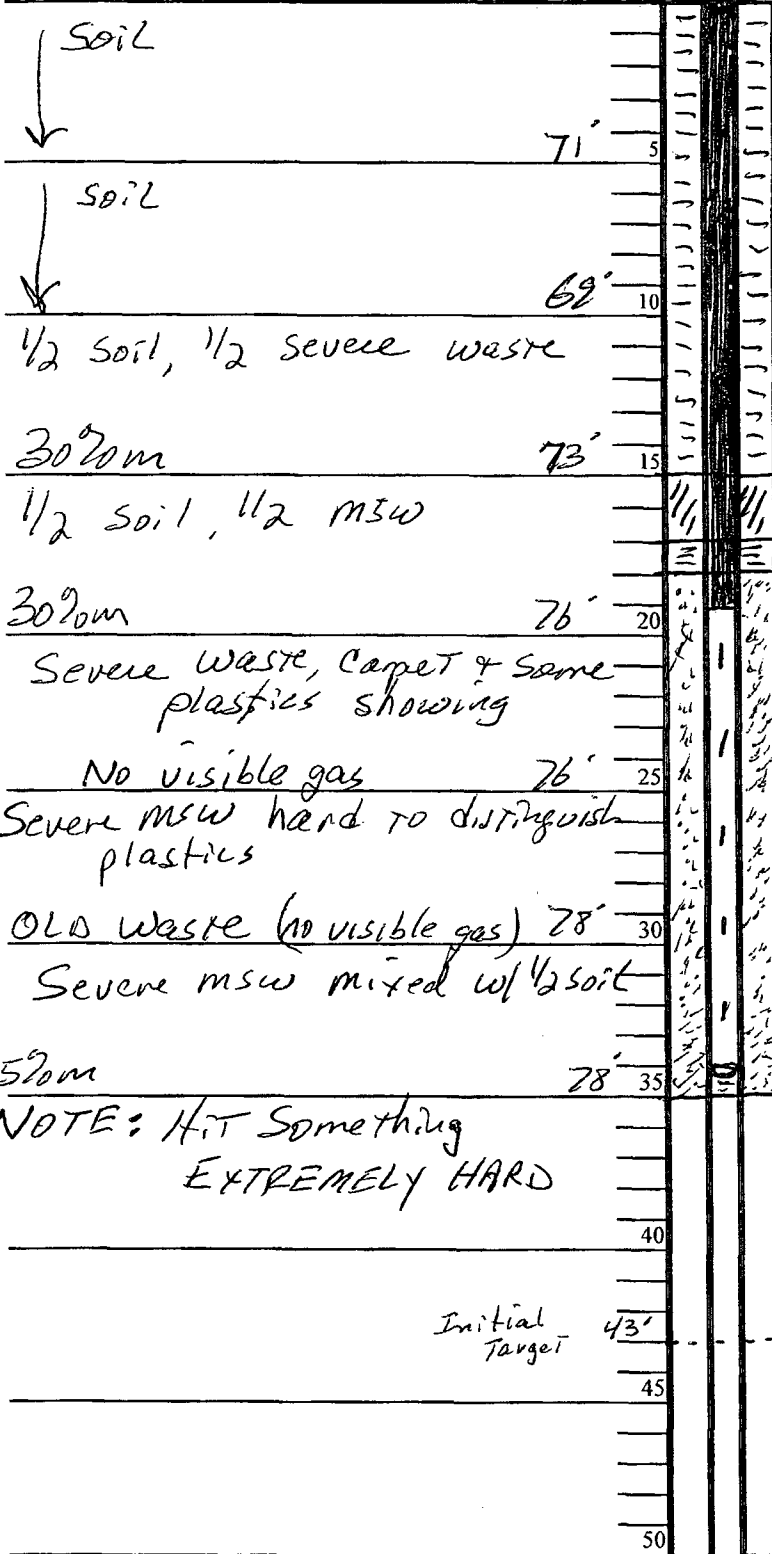
Site Name: \_\_\_\_\_ Well Number: **GV-06**  
 Project #: \_\_\_\_\_ Coordinates: \_\_\_\_\_  
 Start Date: \_\_\_\_\_ Surface Elevation: **126.00**  
 Completed: \_\_\_\_\_ Top of Casing Elevation: **133.00**

Contractor: Belair Boring Diameter: 36"  
 Inspector: Jim Burzenski Pipe Material Diameter 6" Sch. 80 PVC  
 Driller: Shaw Drilling Total Depth Drilled: **35**  
 Completion: **35**

COMPLETION LOG	
RISER STICK UP	7'
RISER BELOW	19'
SLOTTED PIPE	15'
BACKFILL	15'
HYDRATE	✓
BENTONITE #1	2'
BACKFILL	1'
DONUT	✓
GRAVEL PACK	13'
MATERIALS LIST	
Stone	
Structural fill	
Bentonite fill	
TOP CAP	✓
SOLID PIPE	7' + 19'
SLOTTED PIPE	15'
BOTTOM CAP	✓
BENTONITE	12 BAGS
BACKFILL	1' + 15'
STONE	13'
