Re: Notification of Completion of Repairs – Cell 1 Leachate Sump Manholes
Oak Hammock Disposal Facility (JED Solid Waste Management Facility)
Osceola County, Florida
Permit Nos. SC49-0199726-004 and SO49-0199726-005

Please find enclosed two copies of the CQA Report for Cell 1 Sump Repairs prepared by Globex Engineering and Development. Documented in the report are repairs made to the Cell 1 leachate sump manholes damaged by a lightning strike in July, 2007. The Cell 1 leachate system has been fully repaired and is operating as designed.

Subject: CQA Report for Cell 1 Sump Repairs
The J.E.D. Solid Waste Management Facility
Osceola County, Florida

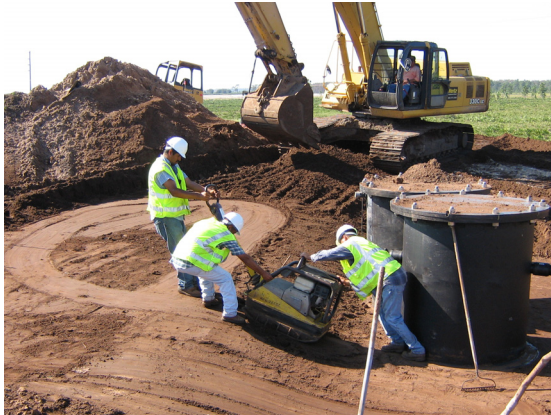
While G4 was cleaning the area around the sump found a repair, a hole was made in the liner going thru the 6 layer in the east corner of the sump.

G4 clean the area to Comanco could repair it to morrow.
