LOBEX

7 February 2008

Subject: CQA Report for Cell 1 Sump Repairs
The J.E.D. Solid Waste Management Facility
Osceola County, Florida

Globex Engineering & Development, Inc. (Globex) is pleased to submit this letter report for the construction quality assurance (CQA) services provided by Globex during repairs to the vertical risers at the Cell 1 sump at the J.E.D. Solid Waste Management Facility located in Osceola County, Florida. The remainder of this letter report includes a background, parties involved, description of repair activities monitored by Globex, and certification of the completed work.

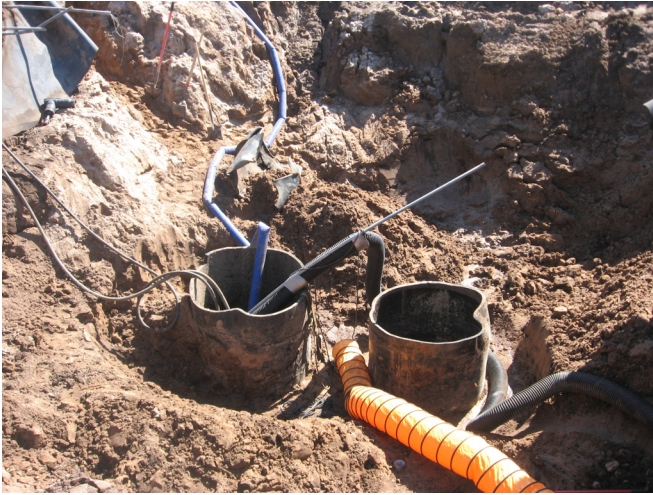
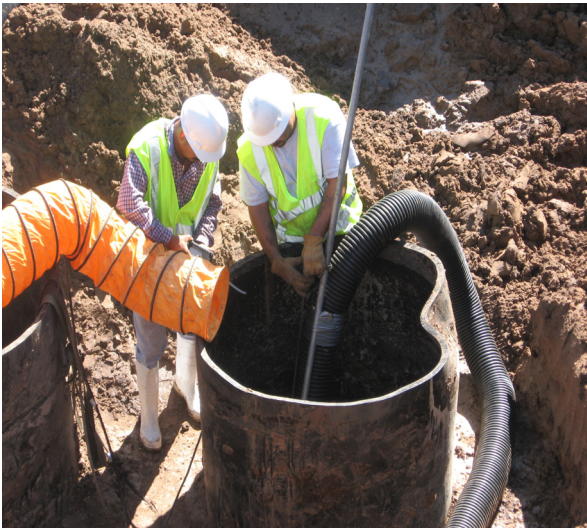
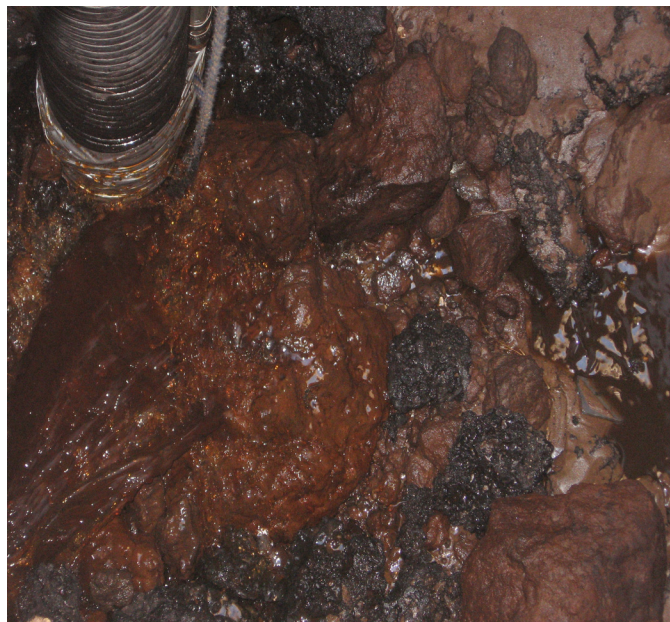
At 12:00pm gas concentration went to high CO-39, H2S-27AND LEL-19. We evacuate the area and G4 superintendent and vacuum truck operator in charge re evaluate work conditions at the excavated area and conclude that it was to dangerous to continued operations and more safety equipment will be needed.
