SOUTHEAST LANDFILL - SOIL TESTING

HILLSBOROUGH COUNTY, FLORIDA

LAW ENGINEERING PROJECT NO. TM-1103A

SUBJECT: Southeast Landfill - Soil Testing  
Hillsborough County, Florida  
Law Engineering Project No. TM-1103A

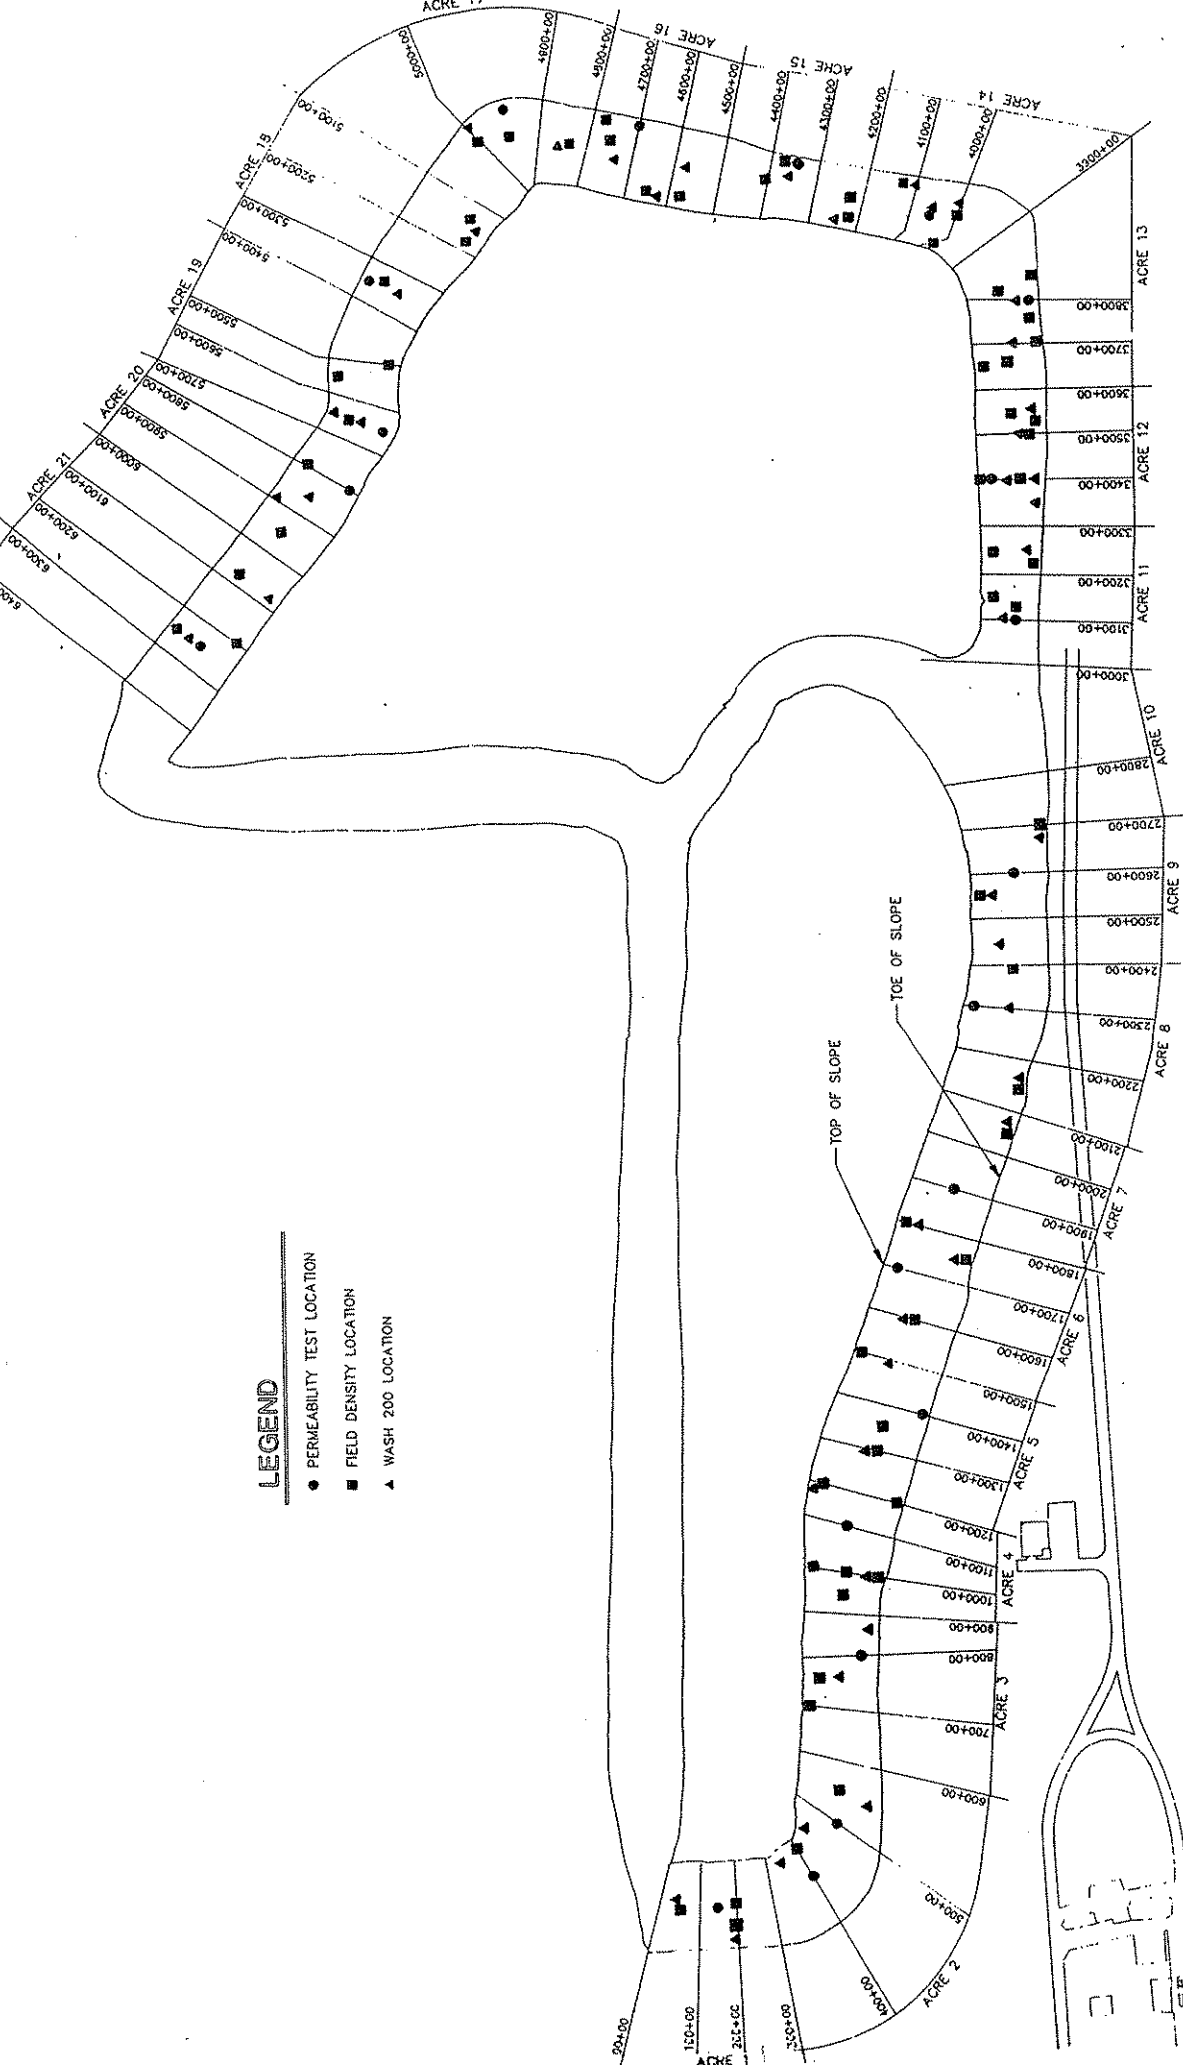
Due to samples for permeabilities having cracks and sand layers two perms were picked up on acres 16, 17, 18, 19 one perm sample was picked up on acre 20.

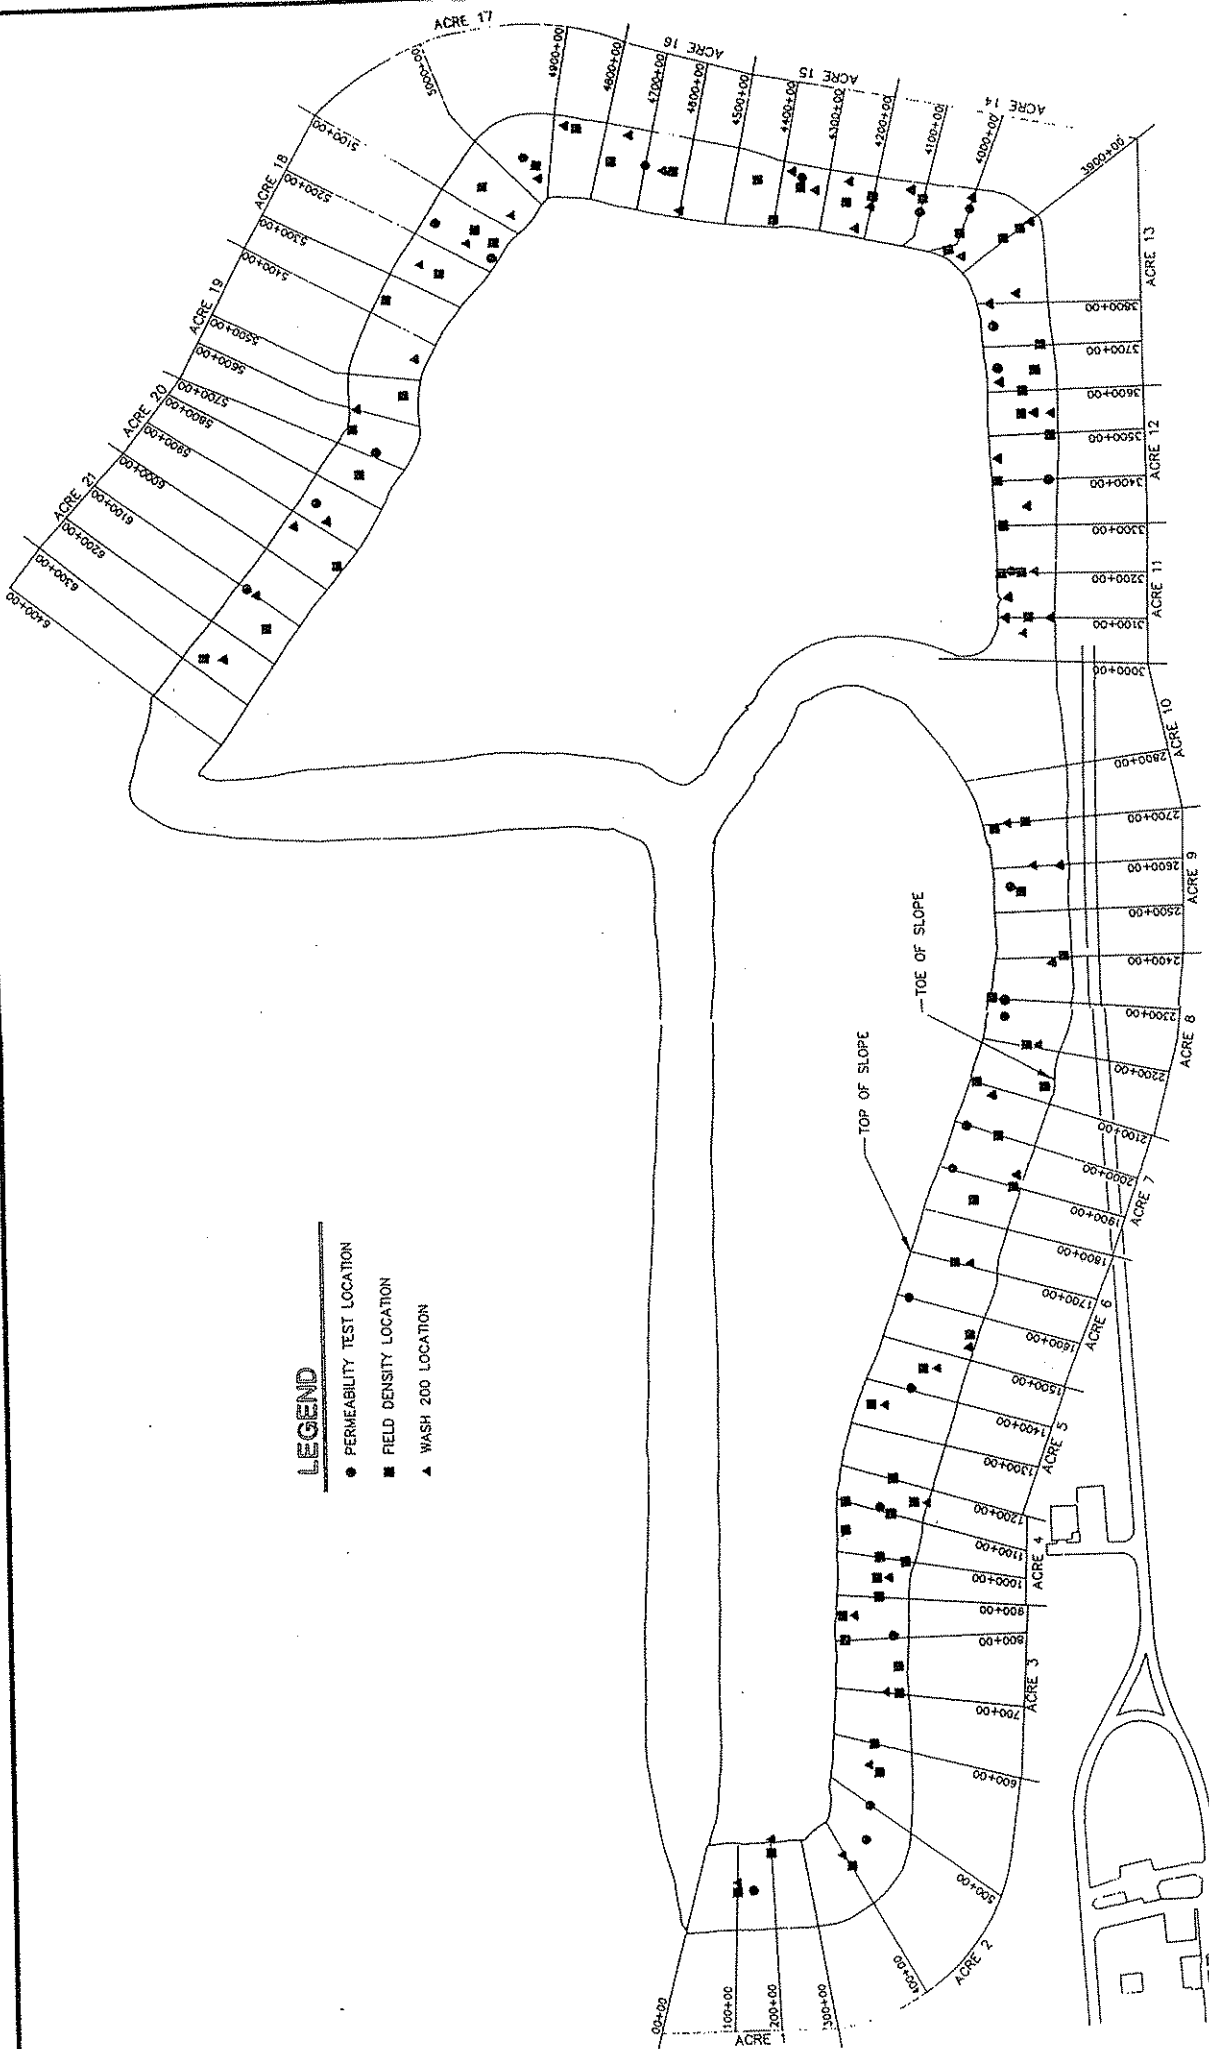
2 OF

Arrived on site at 7:30 am as requested by Greg Walk of waste management and picked up 2 perms on acre 12 and one perm on acre 21. Densities (2) were performed on acre 12 and were found to be satisfactory. Also (2) wash 200's were picked up on acre 12. This completes phase II second lift unless failures occur on perms or wash 200
