SITE INSPECTION REPORT

INSPECTION DATE: 5/31/2011

LOCATION: Tomoka Farms Landfill, 1990 Tomoka Farms Road, Port Orange FL

5 31 2011 JURISDICTIONAL SITE VISIT
P. AMMON, D. BAGGETT
TOMOKA FARMS LANDFILL SPRAYFIELD

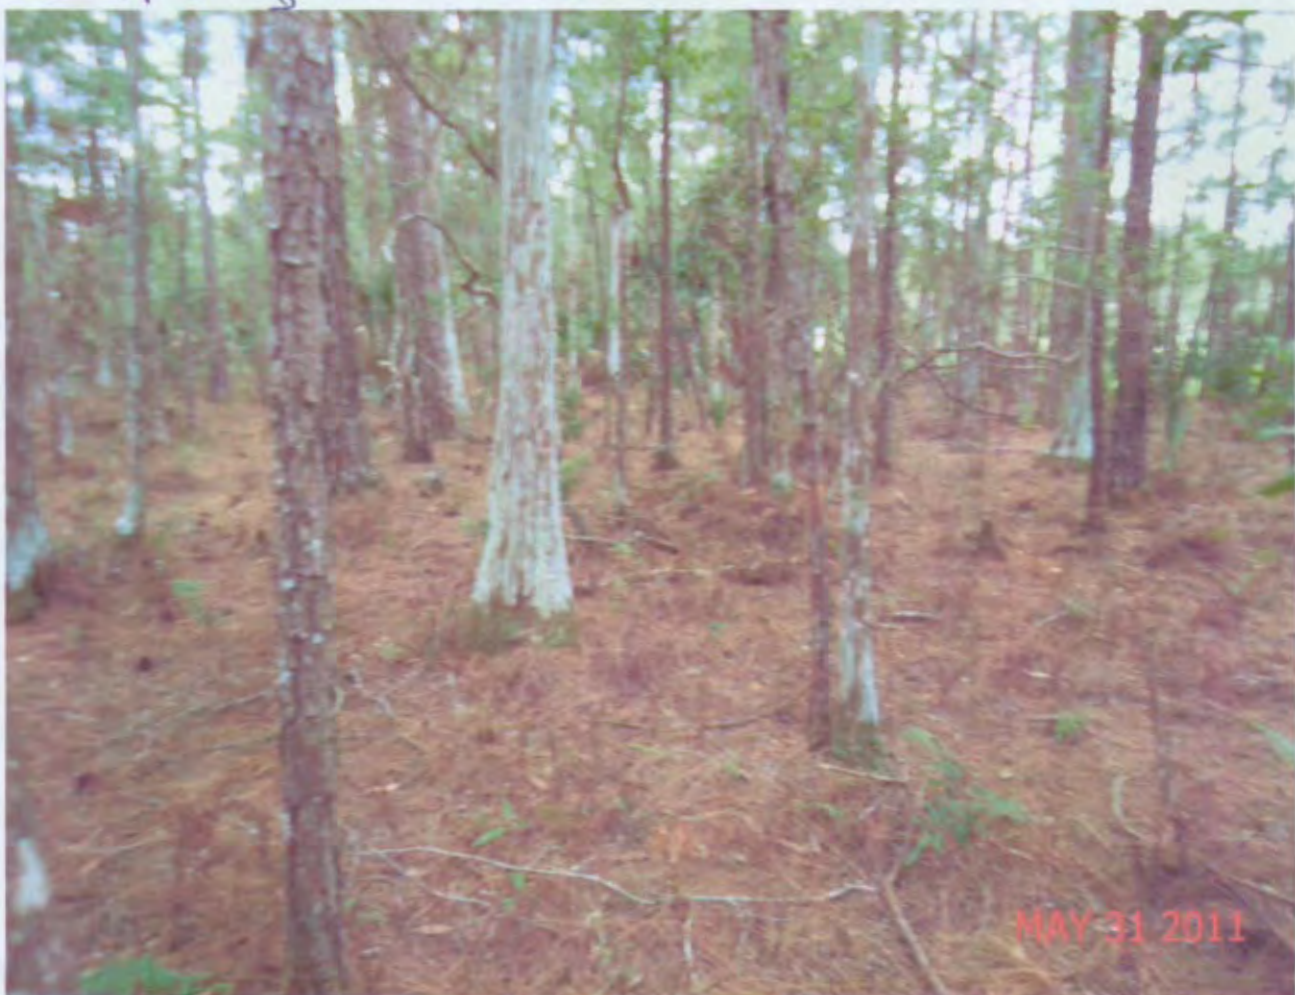
Staff walked the berm and eventually into the forested system to a point labeled on the attached aerial as "Insp 1". This pine / cypress system appears to have been intact and not replanted or previously altered. Staff did not find typical rows & furrows which one would see in a replanted system. Staff also noted the persistence of larger, older growth, pines. Staff identified the vegetation (native and exotic), hydric soils and hydrological indicators.

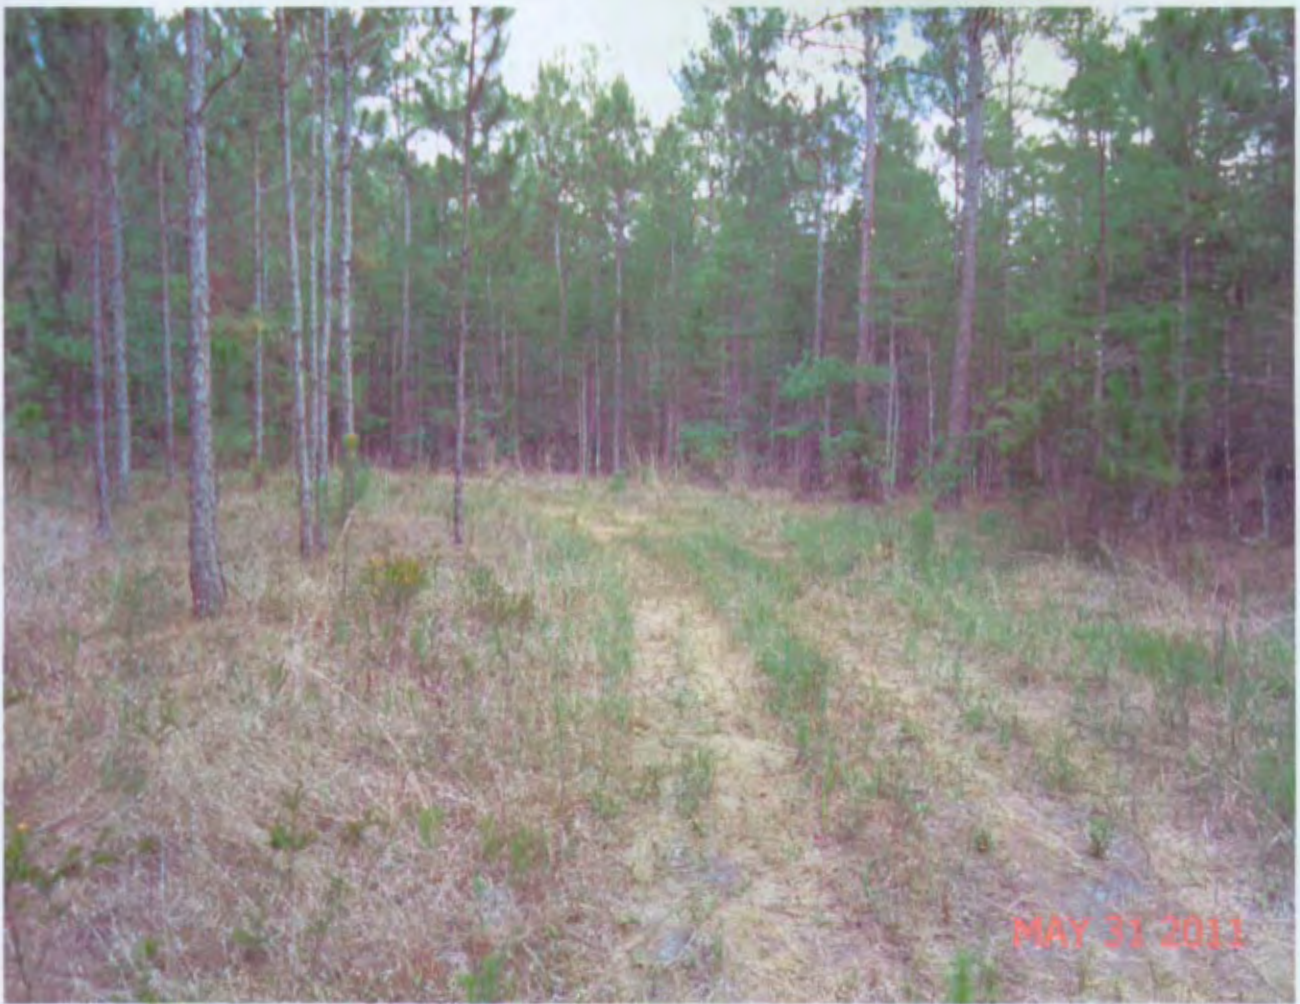
"road" into
wetlands

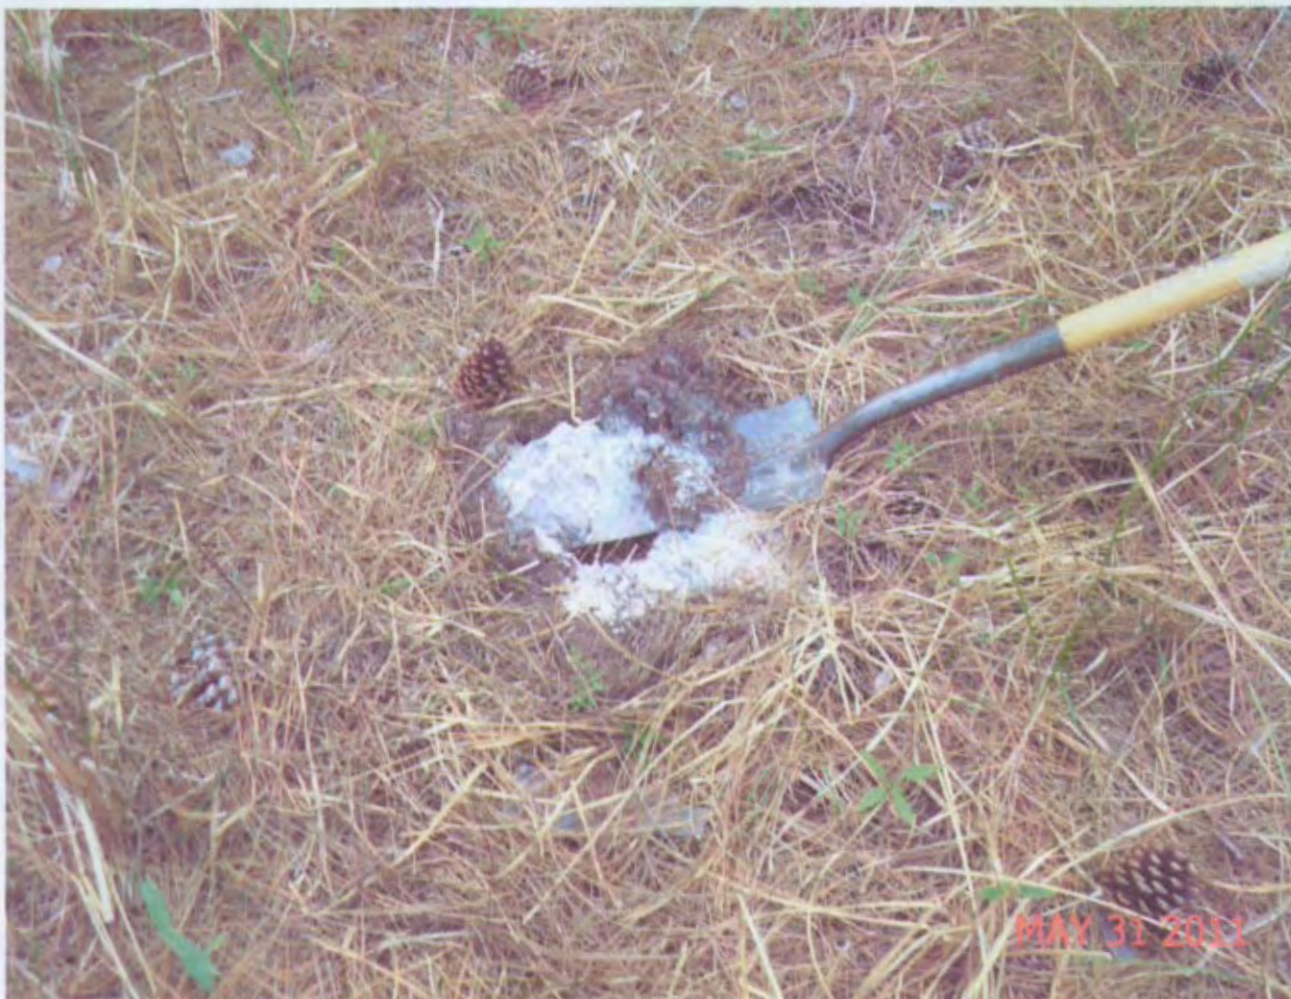
Inspect 4
Monitoring well
Road

Staff left this area and went to "Insp 3." While at this location it was noted that areas south of this location had been cleared, replanted, rowed, and furrowed, while the north area had not. Rows of slash pines were easily identifiable with sparse scattered ground cover. Staff identified plants within this area, but prior to identifying hydrological indicators and investigating the soils, it was suggested all parties drive east into the property (wetlands) to inspect the ground monitoring wells.

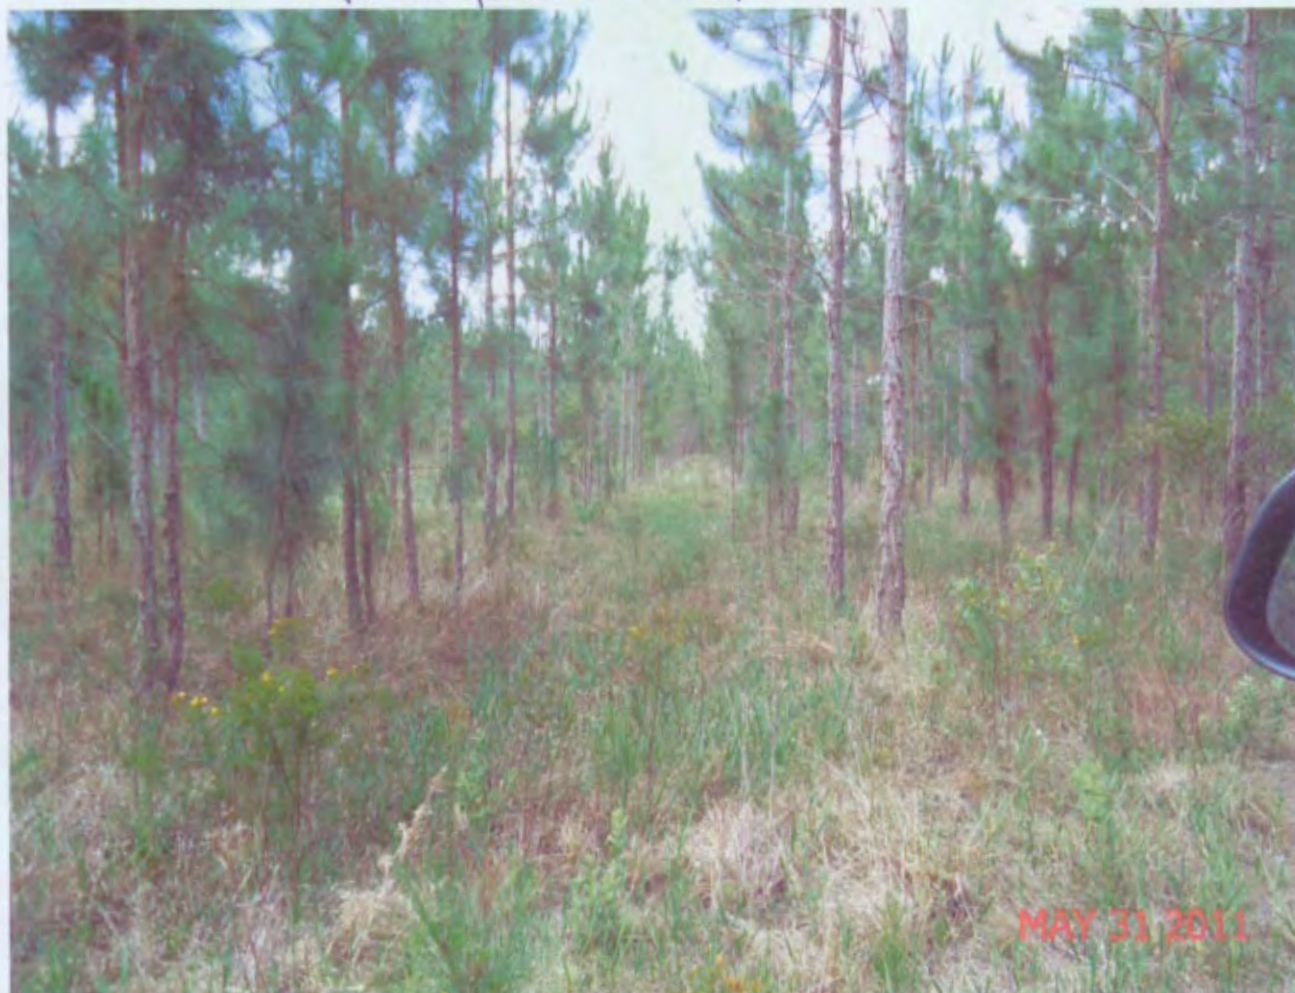
planted pines near transpec 3 from "road", S side

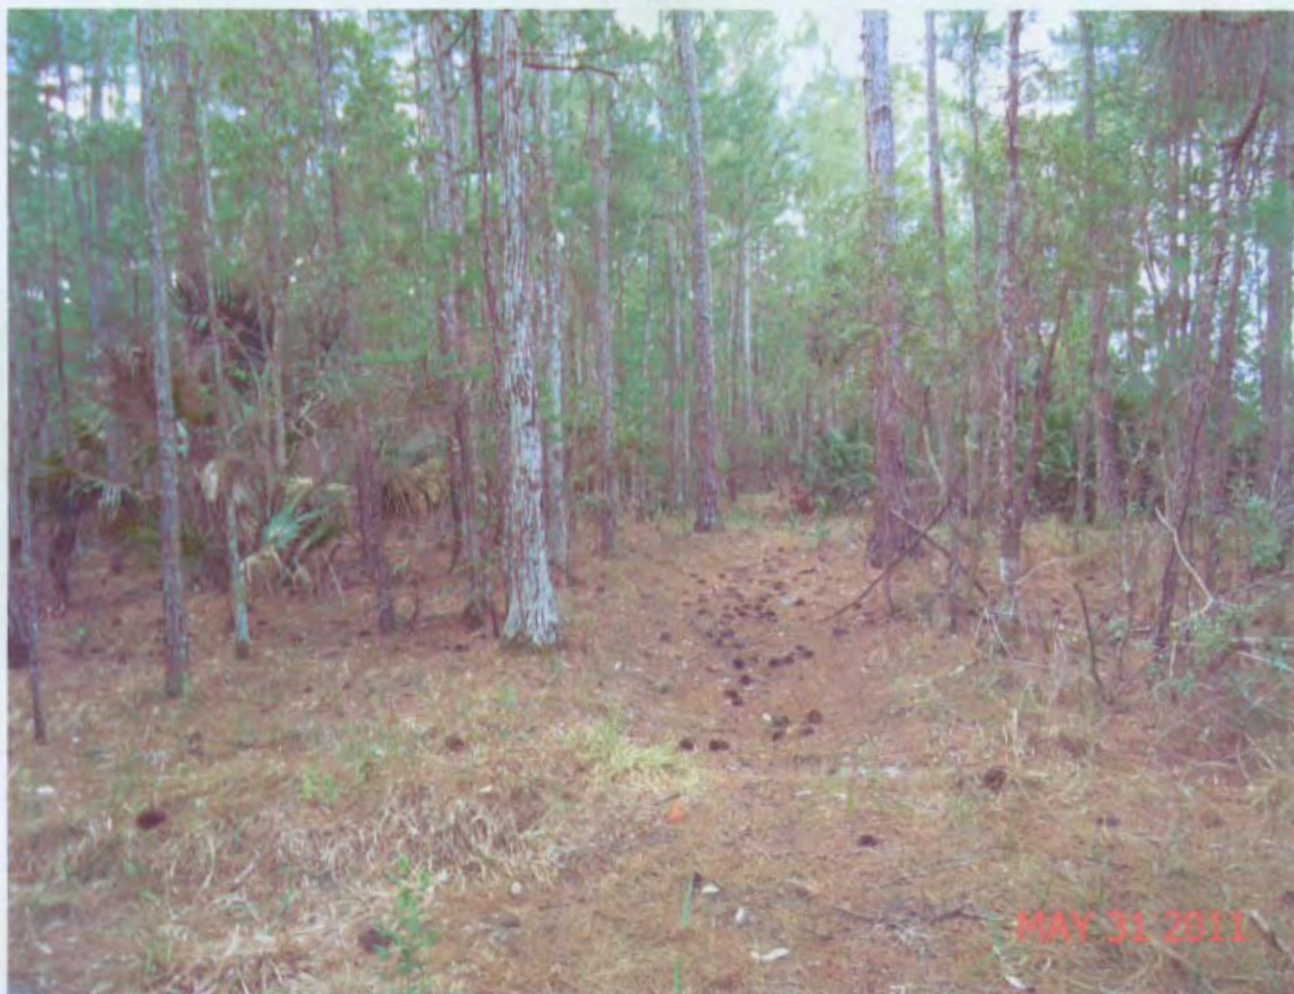
ATV & ditch going toward Insp 5

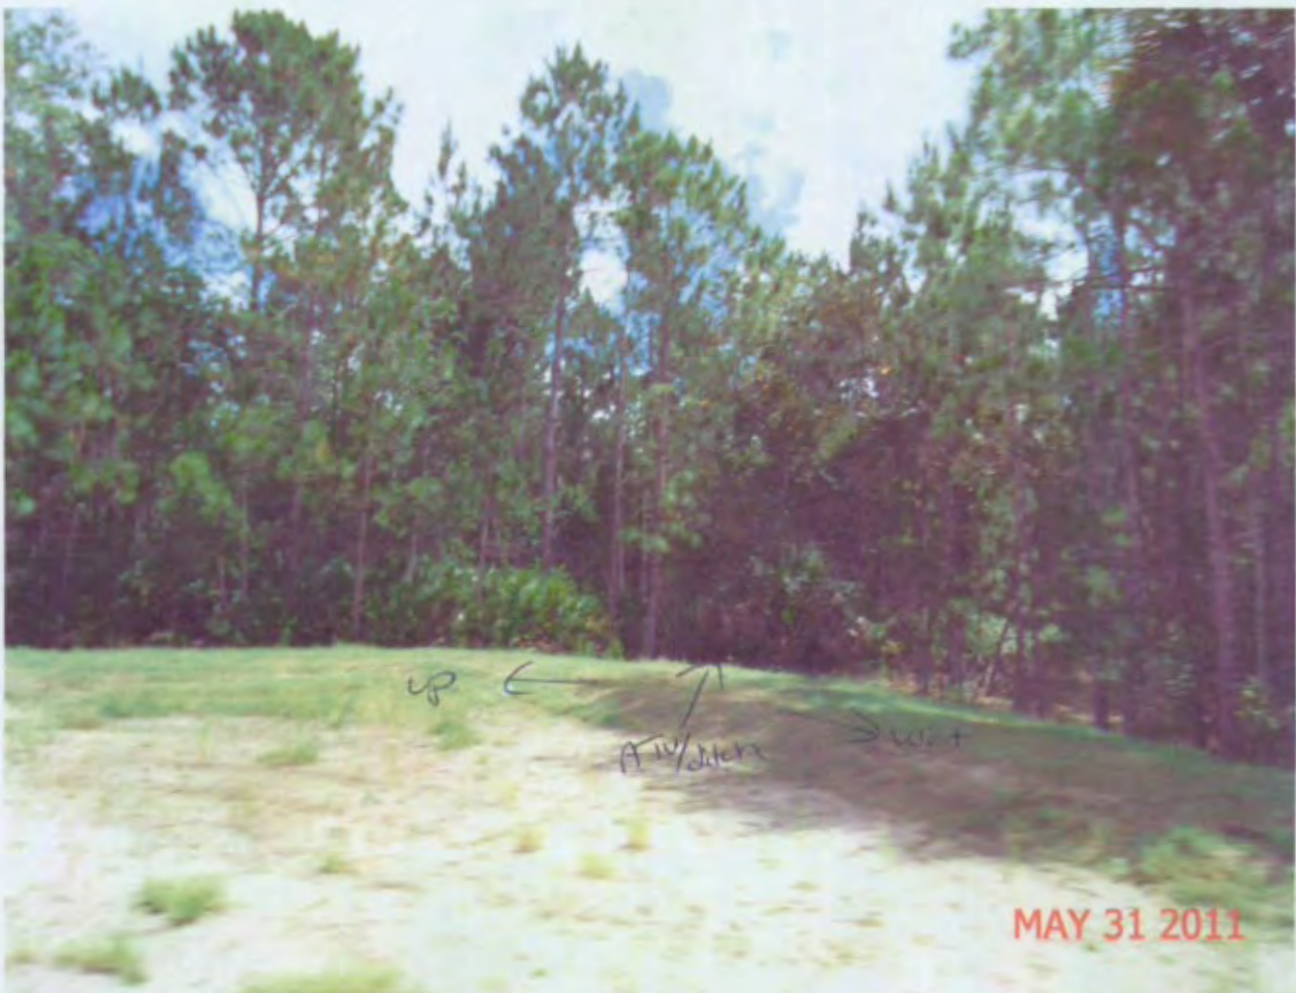
Staff proceeded to “Insp 6” and noted that it appeared to be uplands as previously identified in 1993. This area lacked signs of alteration (rows, furrows) and had significant diversity within all levels of vegetation (canopy, sub canopy, & ground cover).

uplands
Insp 6
