**HILLSBOROUGH COUNTY
SOUTHEAST COUNTY LANDFILL
CAPACITY EXPANSION, SECTION 8
CERTIFICATION OF CONSTRUCTION
COMPLETION REPORT
RESPONSE TO DEP REQUEST FOR
ADDITIONAL INFORMATION**

Permit #35453-009-SC

Subject: Response to Request for Additional Information
Southeast County Landfill, Hillsborough County
Capacity Expansion Section 8
Certification of Construction Completion
Permit No. 35453-009-SC
Jones Edmunds Project No. 08449-020-01

**CERTIFICATION OF CONSTRUCTION
COMPLETION REPORT**

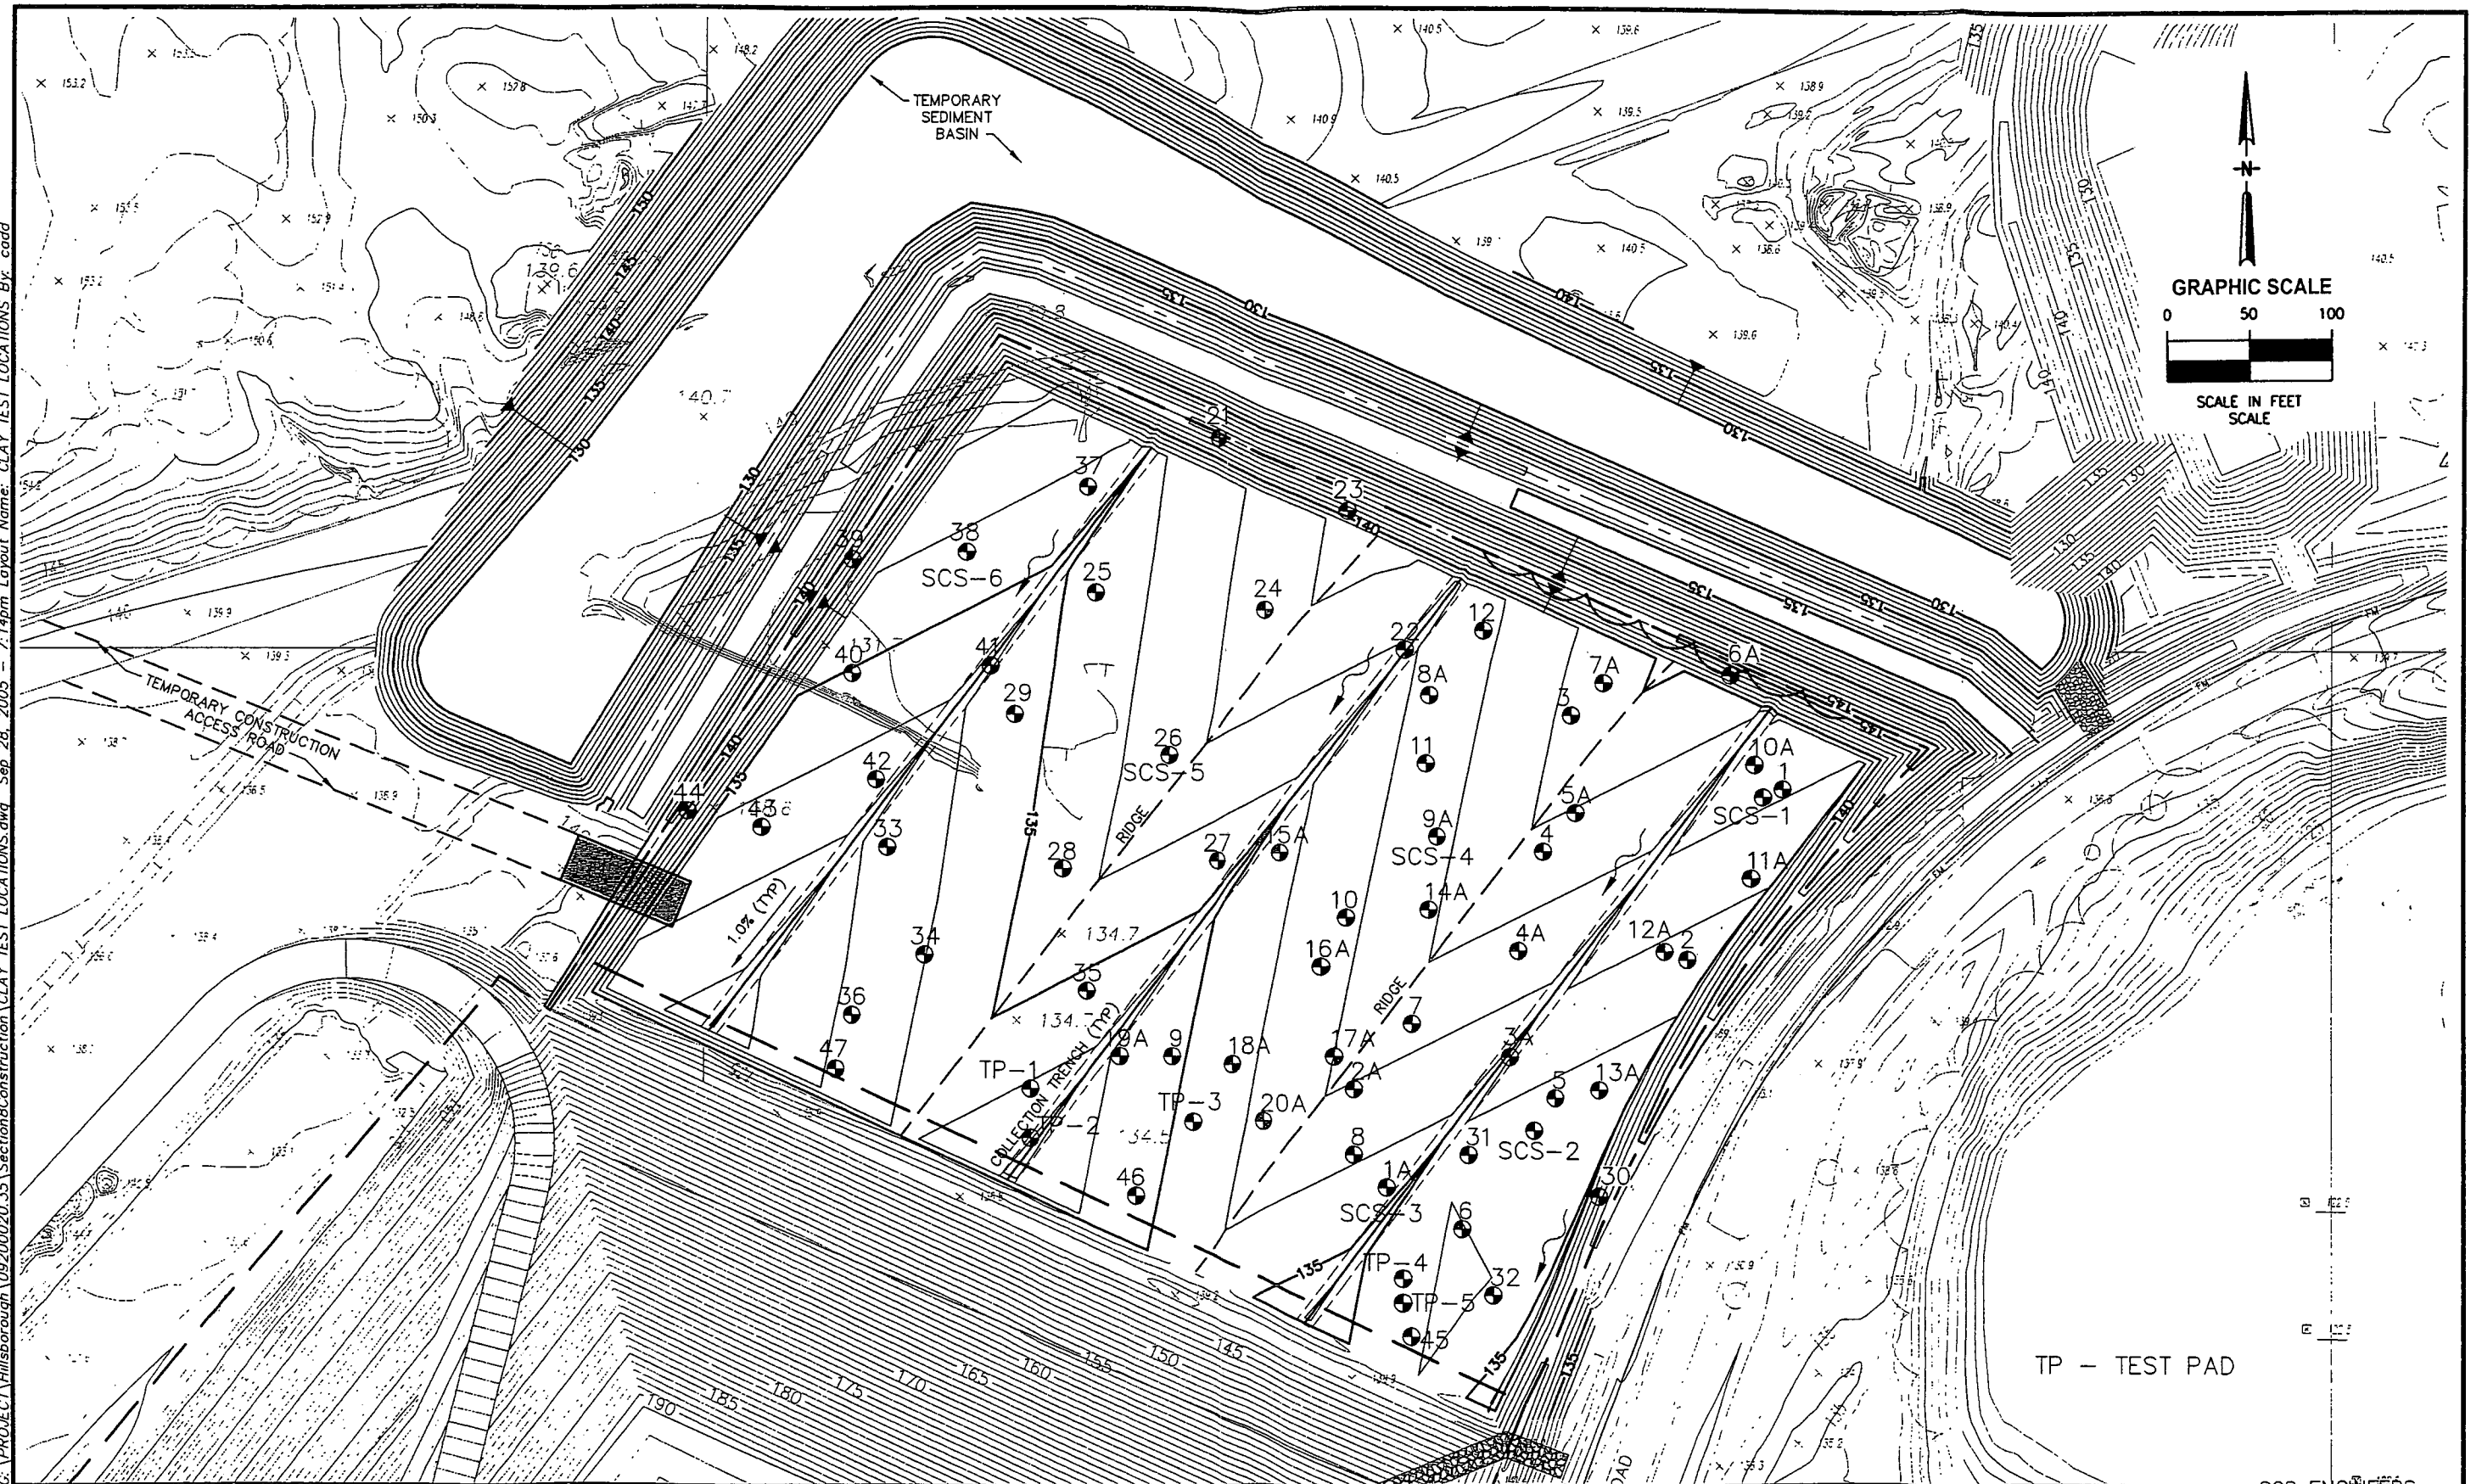
Figure 1. CLAY TEST LOCATIONS, SOUTHEAST COUNTY LANDFILL, HILLSBOROUGH COUNTY, FLORIDA

Response 18.c.1): In the CQA test results performed by PSI and as shown in Attachment 5-3, PSI sample Test #1 correlates to SCS -1 as shown on Figure 1, Test #2 correlates to SCS-2 on Figure 1, etc. Therefore, a table is not warranted. Figure 1 has been revised to include a north arrow and scale (Attachment R18.c.1).

Response 18.d.1): The locations of samples P1, P2, and P3 are shown in Figure 1 as TP-1, TP-2, and TP-3 (TP = Test Pad). The location of the 200-foot-by-50-foot test pad was located in the southeast corner of the Section 8 cell (see sample locations TP-1 through TP-6). Burcaw used Qore as a subcontractor for the permeability tests. Burcaw did not have the resources to perform the flexible wall permeability tests.
