LEACHATE TREATMENT
and
RECLAMATION
FACILITY TANK ASSESSMENT

HILLSBOROUGH COUNTY
SOUTHEAST COUNTY LANDFILL

**TANK ASSESSMENT INSPECTION REPORT
LEACHATE TREATMENT AND RECLAMATION FACILITY
SOUTHEAST COUNTY LANDFILL
HILLSBOROUGH COUNTY, FLORIDA**

TANK ASSESSMENT INSPECTION REPORT

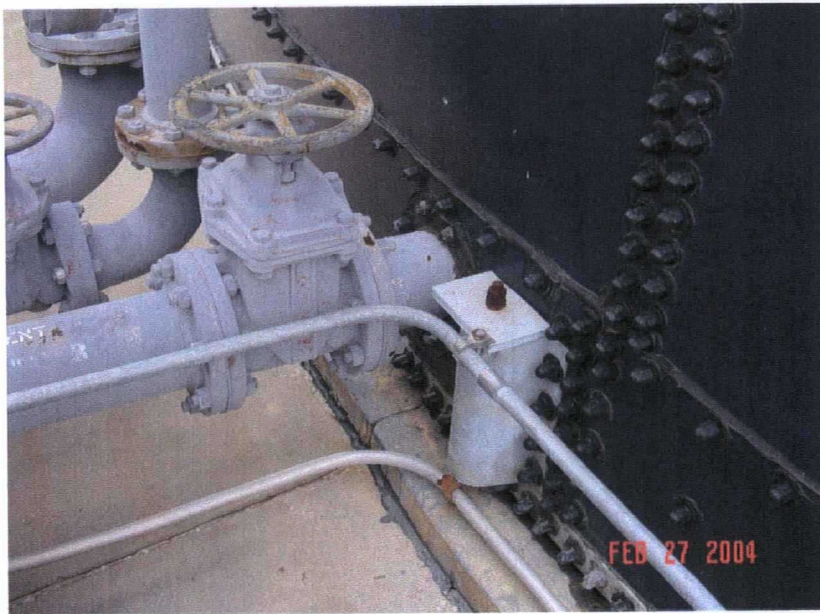
11. Lower nozzle exterior.

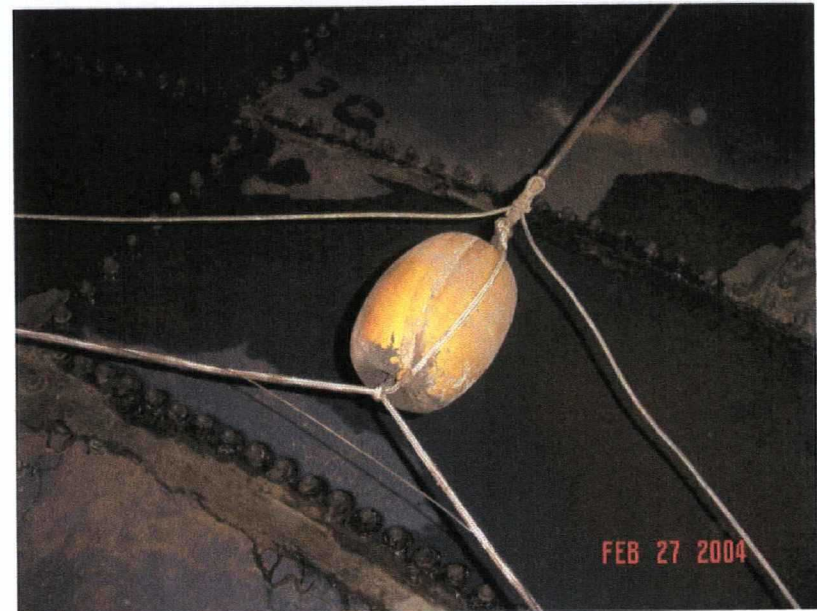
16. Cathodic protection float

1. Replace corroded bolts on interior ladder brackets.
2. Replace missing bolt caps on the interior of the tank and re-seal.
3. Replace guide arm on level indicator float.
4. Maintain proper settings and operation of the cathodic protection system.
