Re: Sarasota County
Central County Solid Waste Disposal Complex
Permit No. 0130542-028-SO-IM)
WACS No. 51614
Above-Ground Leachate Storage Tank Inspection

In-Depth Inspection Report for

Sarasota County

Lechate Storage Tank

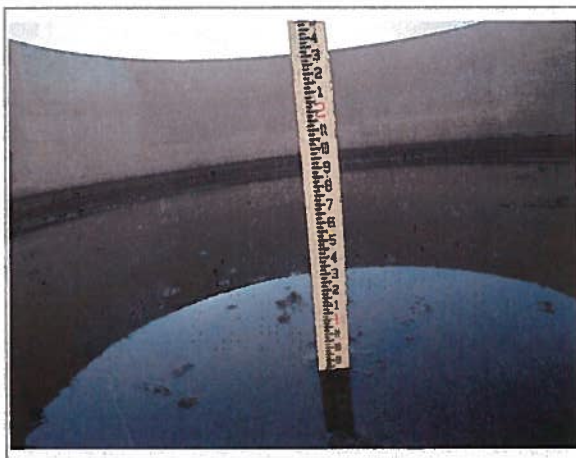
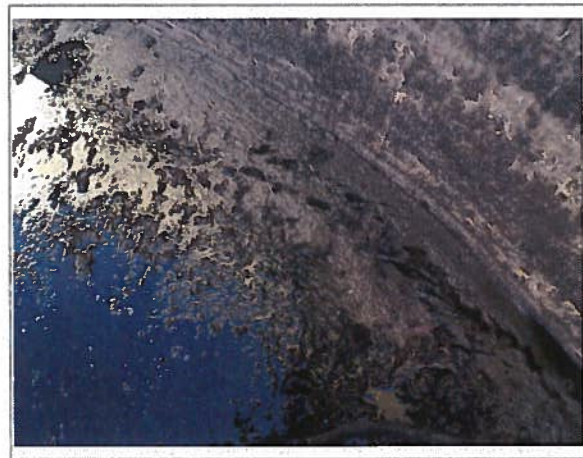
Additional Pictures

Wall Condition

Signs of Leaking? Y ☐ N ☒
 Dents / Holes? Y ☐ N ☒ Type: None
☐ De-lamination: N/A
☐ Deterioration: N/A
☒ Pop-outs: Minor
☐ Voids: N/A
☐ Unevenness: N/A
☒ Cracking: Moderate Type: Hairline / Shrinkage
☐ Growth: N/A Type: None
☒ Staining: Minor Type: Mildew / Moisture
☐ Exposed Aggregate: N/A
☐ Exposed Reinforcement: N/A
☒ Spalling: Minor

- Prestressed concrete walls (no coating)
- Minor spalling noted on upper walls near opening
- Mildew staining localized on upper walls
- Consistent ratings noted throughout

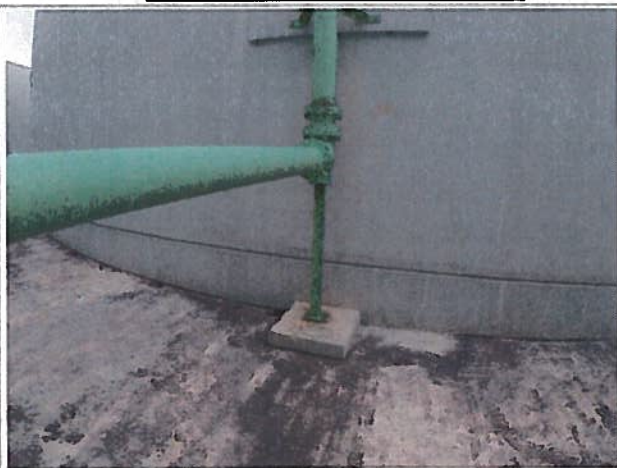
Primary Inlet Crossover Plumbing

1. Crossover plumbing components in good to excellent condition
2. Heavy - moderate staining noted throughout floor
3. Heavy signs of shrinkage / hairline cracking noted throughout inner & outer walls
4. Minor corrosive staining noted on walls in areas of exposed reinforcements

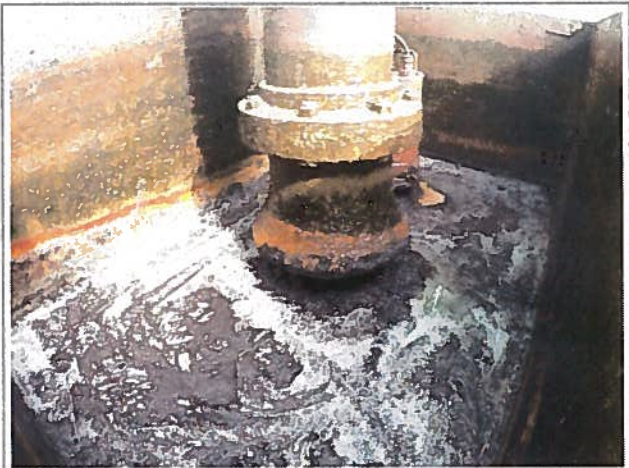
Drain / Outlet / Sump

1. 6 to 10 inches of sediment found throughout tank (Removed during clean)
2. Severe corrosion noted throughout all internal plumbing components below waterline
3. Heavy blistering noted on floor to wall seen (elastomeric urethane floor-wall boot)
4. Moderate checking, cracking, & pop outs noted throughout upper / lower walls
5. Heavy - moderate staining noted throughout all extremities of tank
6. Minor unevenness noted throughout tank floor (coating: good - excellent condition)

1. Routine Clean & Inspect every 3 years per sludge accumulation / report findings
2. Replace severely corroded / de-alloying plumbing components (internal: inlet & outlet)
3. Pressure wash & re-coat containment tank (grout / repair areas as needed)
4. Consider replacement of elastomeric urethane floor-wall boot due to heavy blistering
