## **Citrus County Central Landfill Leachate Collection System Cleaning and Video Inspection**

**SUBJECT:** Summary of Leachate Collection System Cleaning and Inspection  
Jones Edmunds Project No. 03860-077-01

# **Jones Edmunds Citrus County Landfill Phases 1-3 Leachate Collection Pipe Maintenance**

# **SCS Engineers Citrus County Landfill 2015 Leachate Pipe Maintenance**

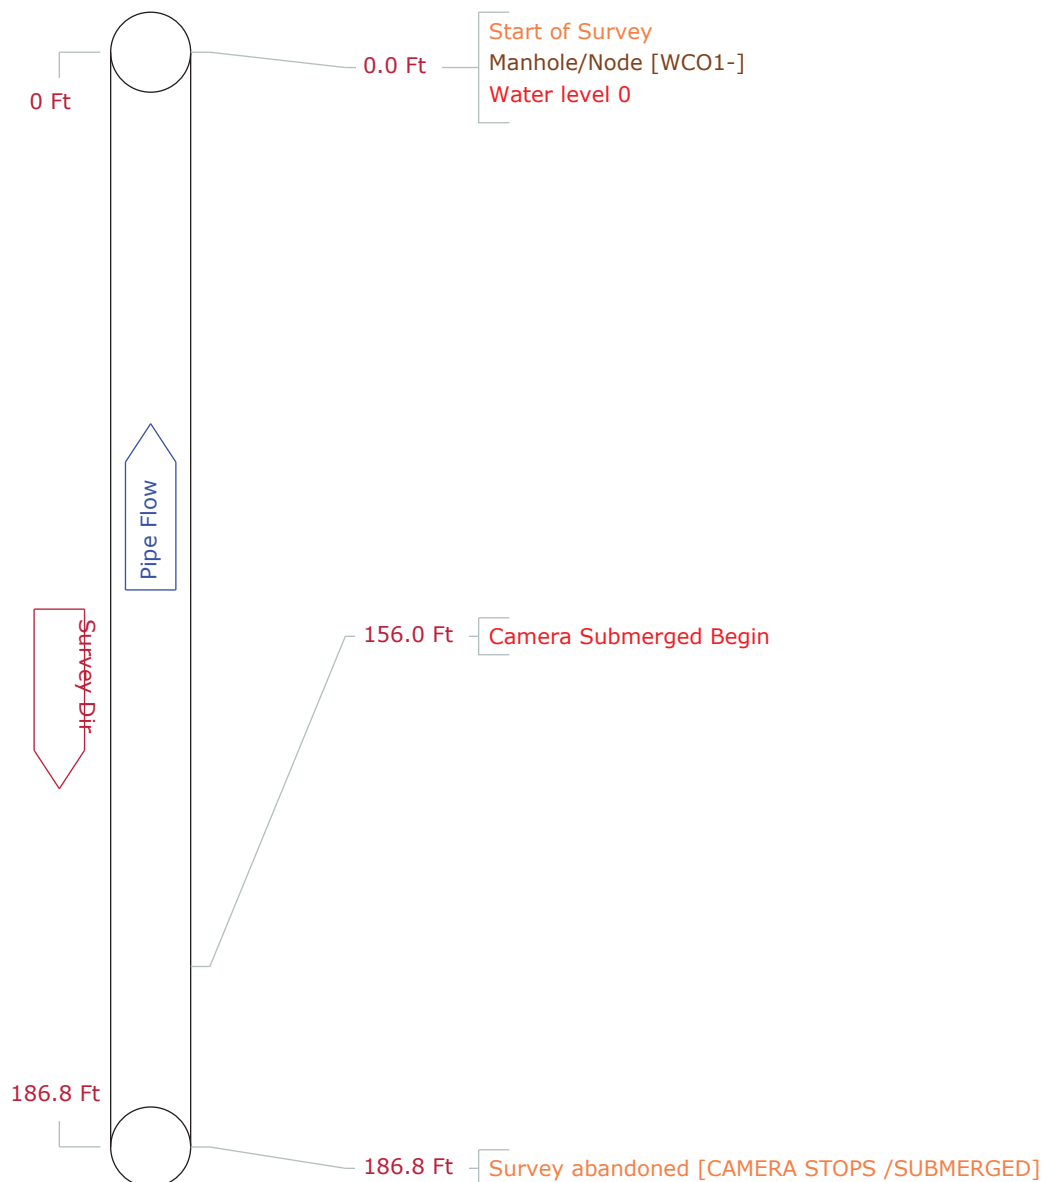
# Pipe Graphic Report of PLR ECO2 A for JEA

1. Phase 3: Setup 1 (WCO1 to ECO02)<sup>1</sup>: Video #1 shows the camera submerged at approximately 153.4 feet (4:40 minutes) and goes dark at approximately 165.9 feet (5:35 minutes). Based on the report and video, the camera stops at 186.8 feet for unknown reasons, but based on the presence of sand noted in Setup #3, sand is the likely cause. Although the water jet was able to proceed past this point, the accumulation of sand is a possible concern and may hinder future inspection events.

Video Index Count 186.8 Ft  
Code Survey abandoned  
Remarks CAMERA STOPS /SUBMERGED  
File Name 4.jpg

Sand has accumulated in the leachate pipes in Phases 2 and 3 since the 2015 Jetclean Report. Although the high-pressure jet was able to proceed through these pipes, this finding indicates that sand may continue to accumulate in the future. This sand prevents these pipes from being fully inspected, and if an issue were to arise behind a sand blockage, access would be more difficult. We will evaluate the possible cause of the sand intrusion. One option could be more intensive cleaning efforts to remove or reduce the accumulation of sand in these leachate pipes.

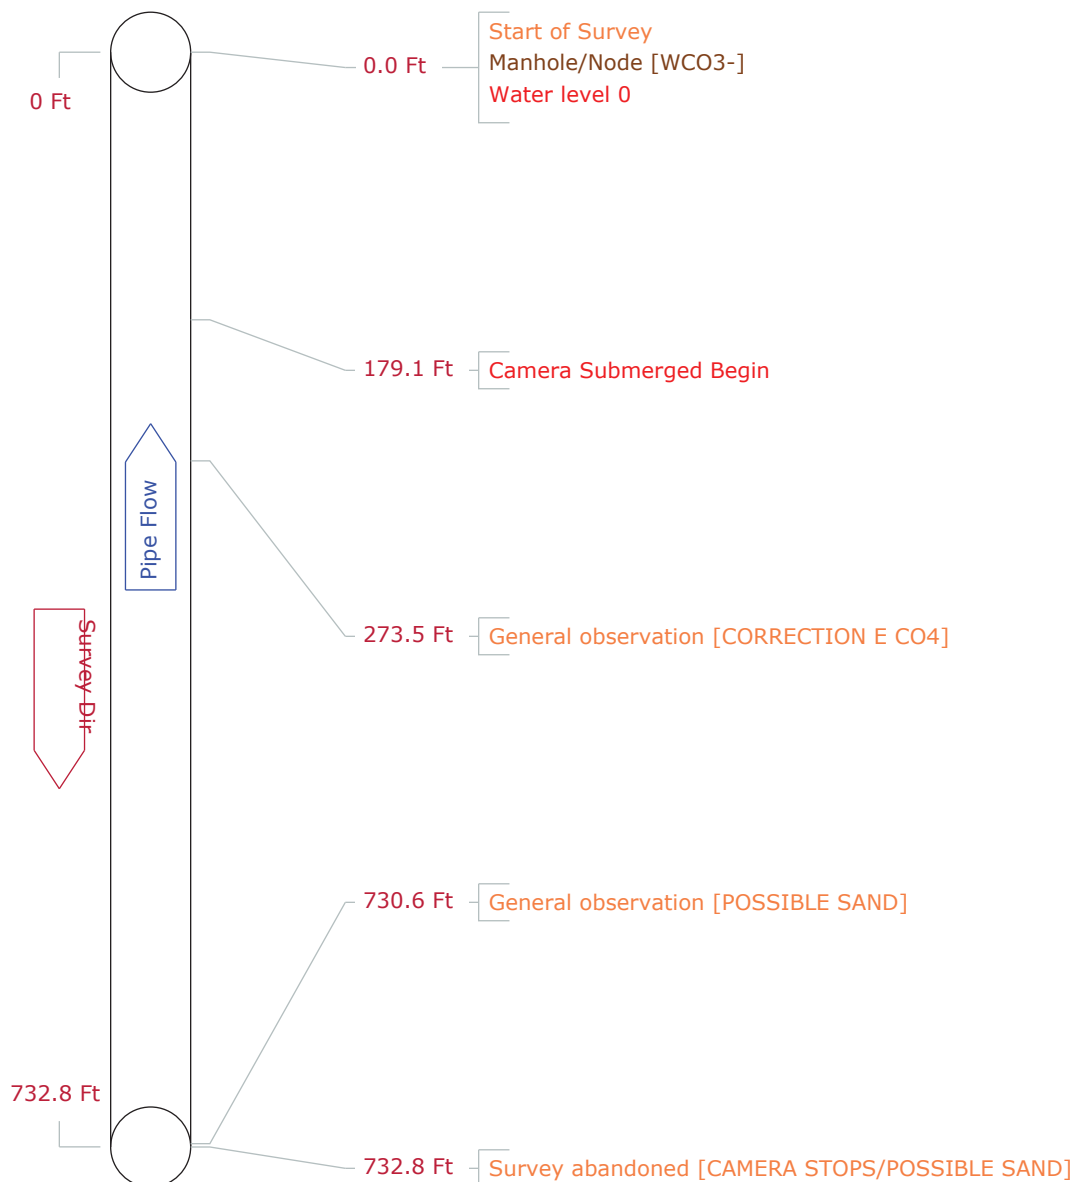
# Pipe Graphic Report of PLR ECO4 B for JEA

Remarks CAMERA STOPS/POSSIBLE SAND

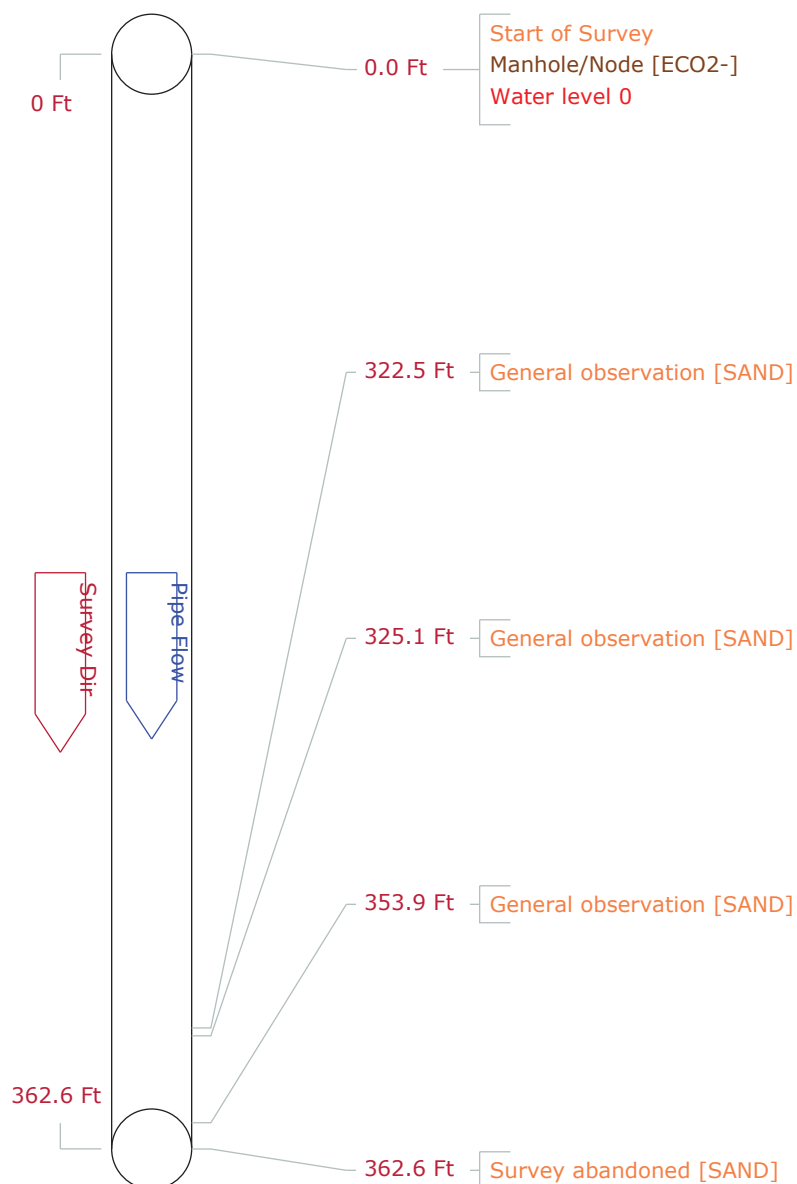
CCTV Picture List of ECO2- C for JEA

Video Index Count 322.5 Ft  
 Code General observation  
 Remarks SAND  
 File Name 8.jpg

Video Index Count 325.1 Ft  
 Code General observation  
 Remarks SAND  
 File Name 9.jpg

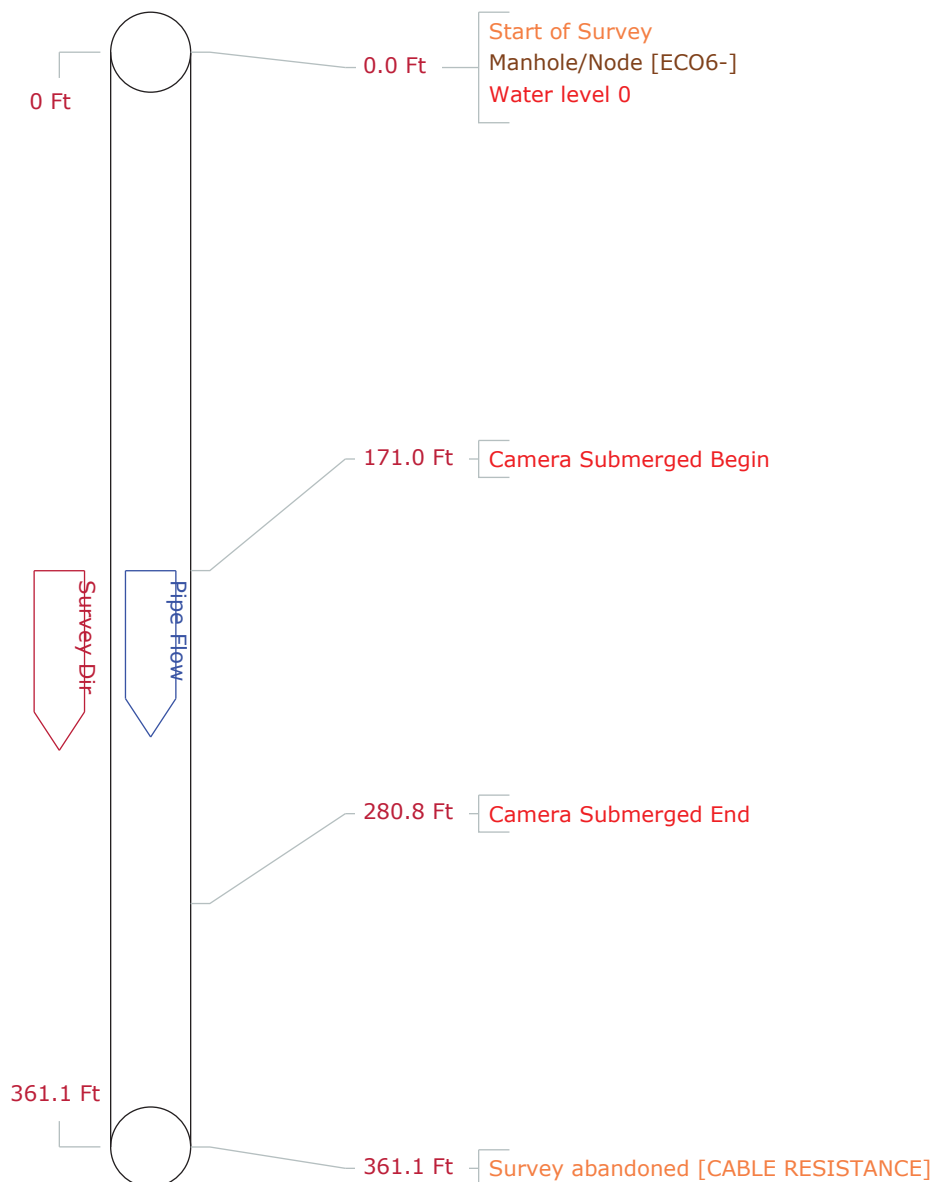
# Pipe Graphic Report of PLR ECO6- C for JEA

Video Index Count 361.1 Ft  
 Code Survey abandoned  
 Remarks CABLE RESISTANCE  
 File Name 13.jpg

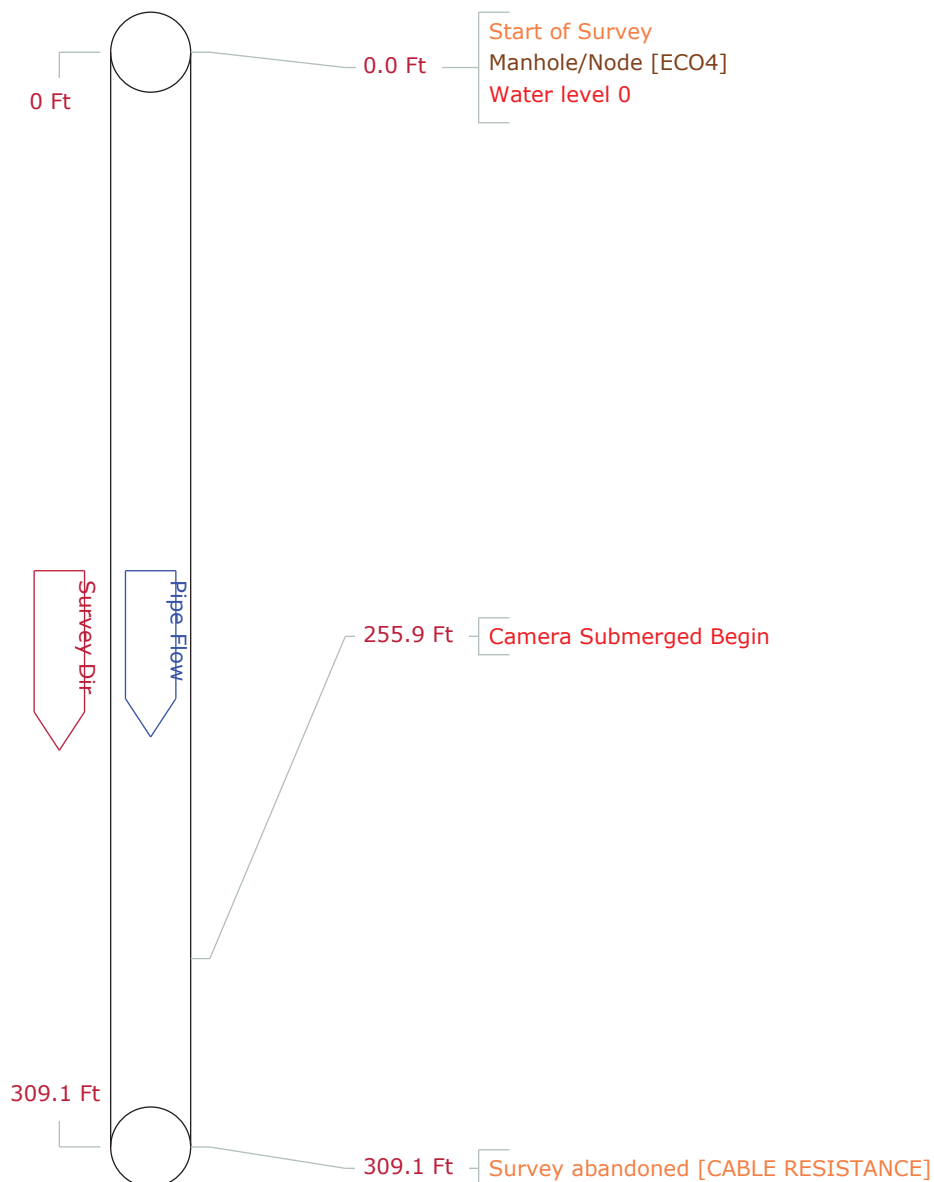
# Pipe Graphic Report of PLR ECO4 D for JEA

Video Index Count 309.1 Ft  
 Code Survey abandoned  
 Remarks CABLE RESISTANCE  
 File Name 16.jpg

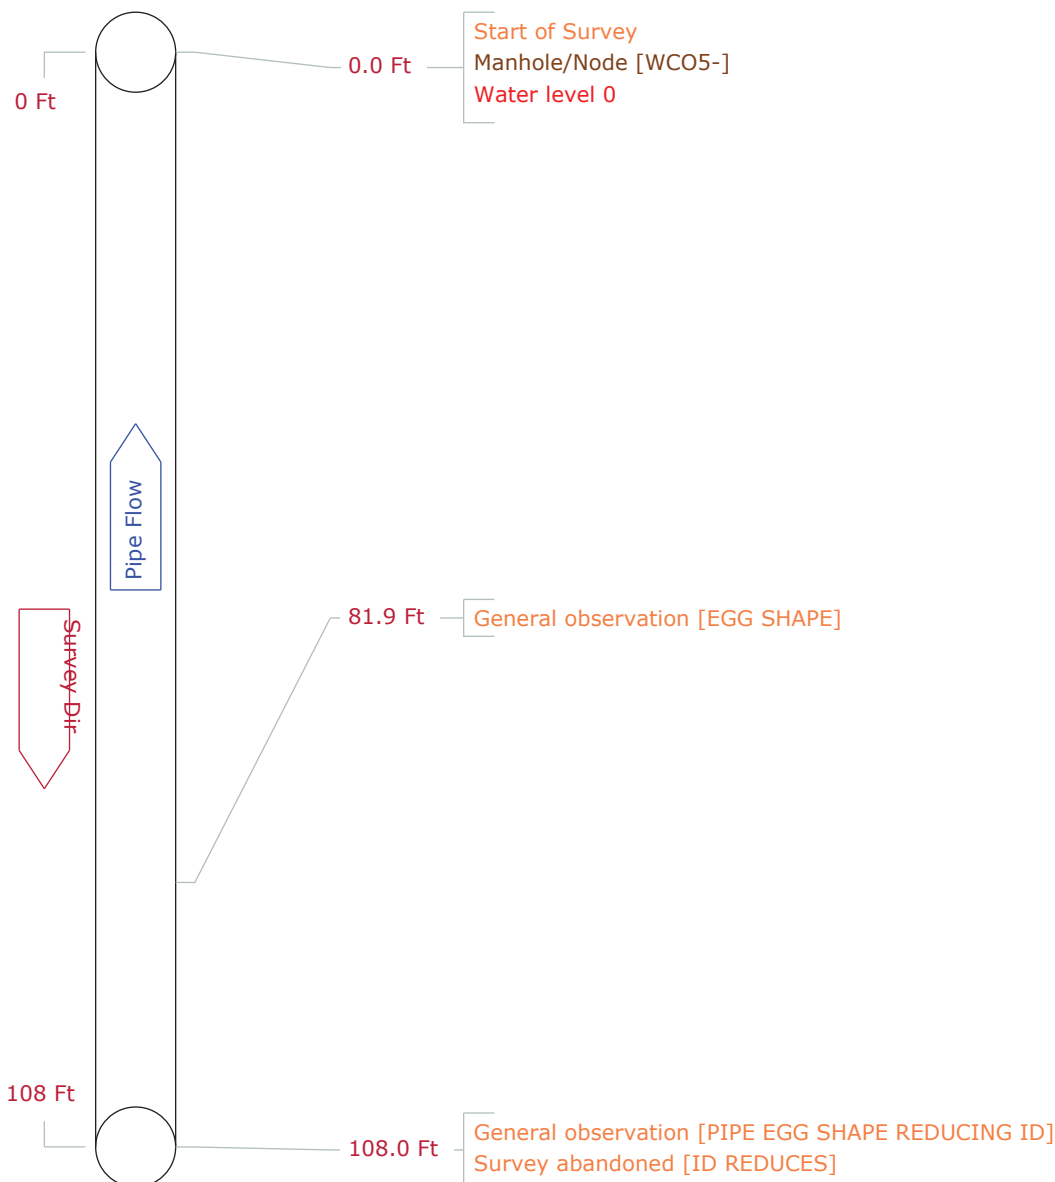
# Pipe Graphic Report of PLR ECO6 E for JEA

1. The partially crushed/egg-shaped pipe noted in Phase 1A of the 2020 Jetclean Report was also noted as partially crushed in the 2015 Jetclean Report. However, whereas the 2015 report noted that the water jet was able to pass the constricted pipe area, the 2020 report noted that the water jet stopped at this location.
2. In the Phase 2 pipe, the camera is noted as stopping at a different location in 2020 compared to 2015. The video commentary notes possible sand near the location where the camera stops.
3. The video inspection was able to proceed the entire length of the Phase 3 pipe in 2015, but the 2020 video inspection was only able to proceed a fraction of the total length from either direction. Sand was noted in the pipe in the 2020 inspection but not in the 2015 inspection.

Video Index Count 81.9 Ft  
 Code General observation  
 Remarks EGG SHAPE  
 File Name 18.jpg

Video Index Count 108.0 Ft  
 Code General observation  
 Remarks PIPE EGG SHAPE REDUCING ID  
 File Name 19.jpg

Video Index Count 108.0 Ft  
 Code Survey abandoned  
 Remarks ID REDUCES  
 File Name 20.jpg

The 2020 Jetclean Report noted that the high-pressure jet was unable to pass the Phase 1A blockage due to crushing, whereas the water jet was able to proceed in 2015. This may indicate that the pipe has become more constricted during this period, hindering its ability to convey leachate to the sump. Further investigation is recommended in the Phase 1A leachate pipe to determine the cause and severity of this issue.

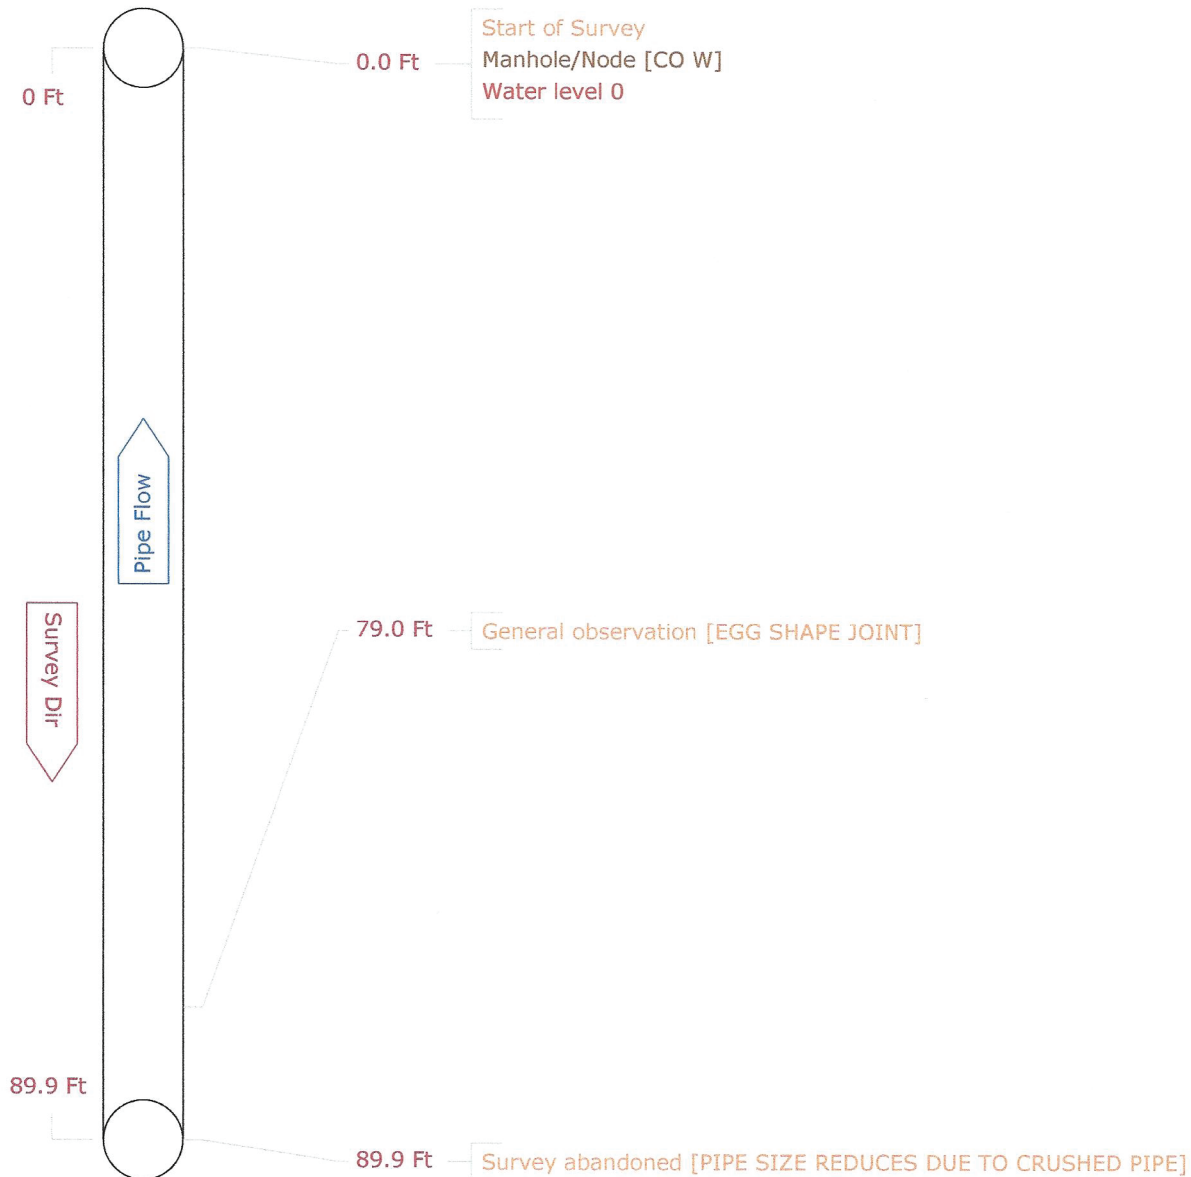
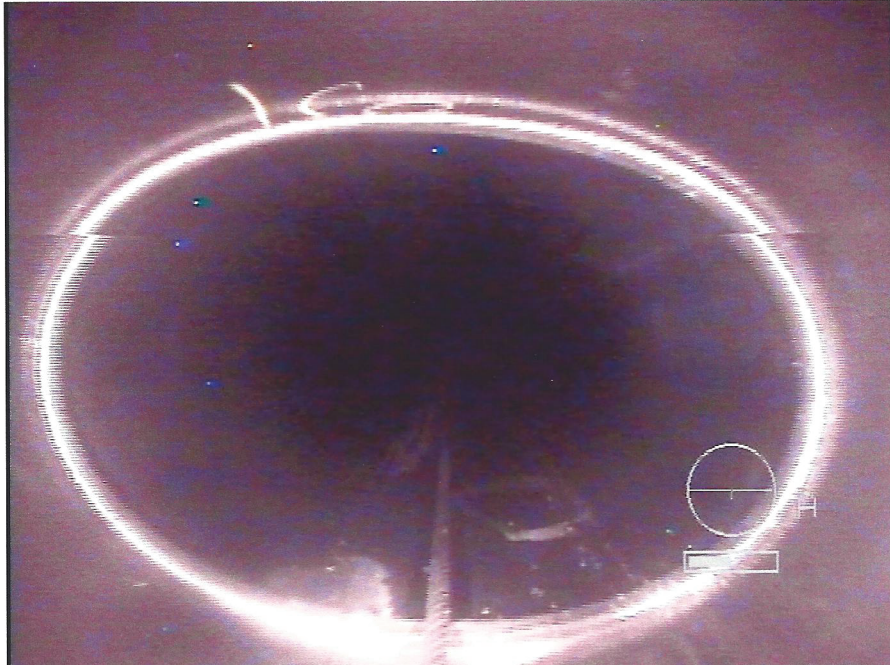
Pipe Graphic Report of PLR CO E C for CITRUS COUNTY SOLID WASTE

Work Order	Contract	Video	1	Setup	3
Facility	Operator	Van Ref		Surveyed On	04/28/2015
Street Name	CITRUS COUNTY PHASE 1A	City	CITRUS COUNTY LF		
Location type	Berm				
Surface					
Survey purpose	Other (state in comments)	Weather	Light rainfall		
Pipe Use	Other (state in comments)	Schedule length	Ft	From	CO W
Shape	Circular	Size	8 by	To	CO E
Material	Other (state in comments)	Joint spacing	Ft	Direction	Upstream
Lining		Year laid		Pre-clean	Y
				Last cleaned	4/27/2015
General note	JETTING=132 POSSIBLE CRUSHED PIPE			Structural	Service
Location note	VIDEO IN REVERSE VIDEO SHOWS PHASE 1			Miscellaneous	Hydraulic

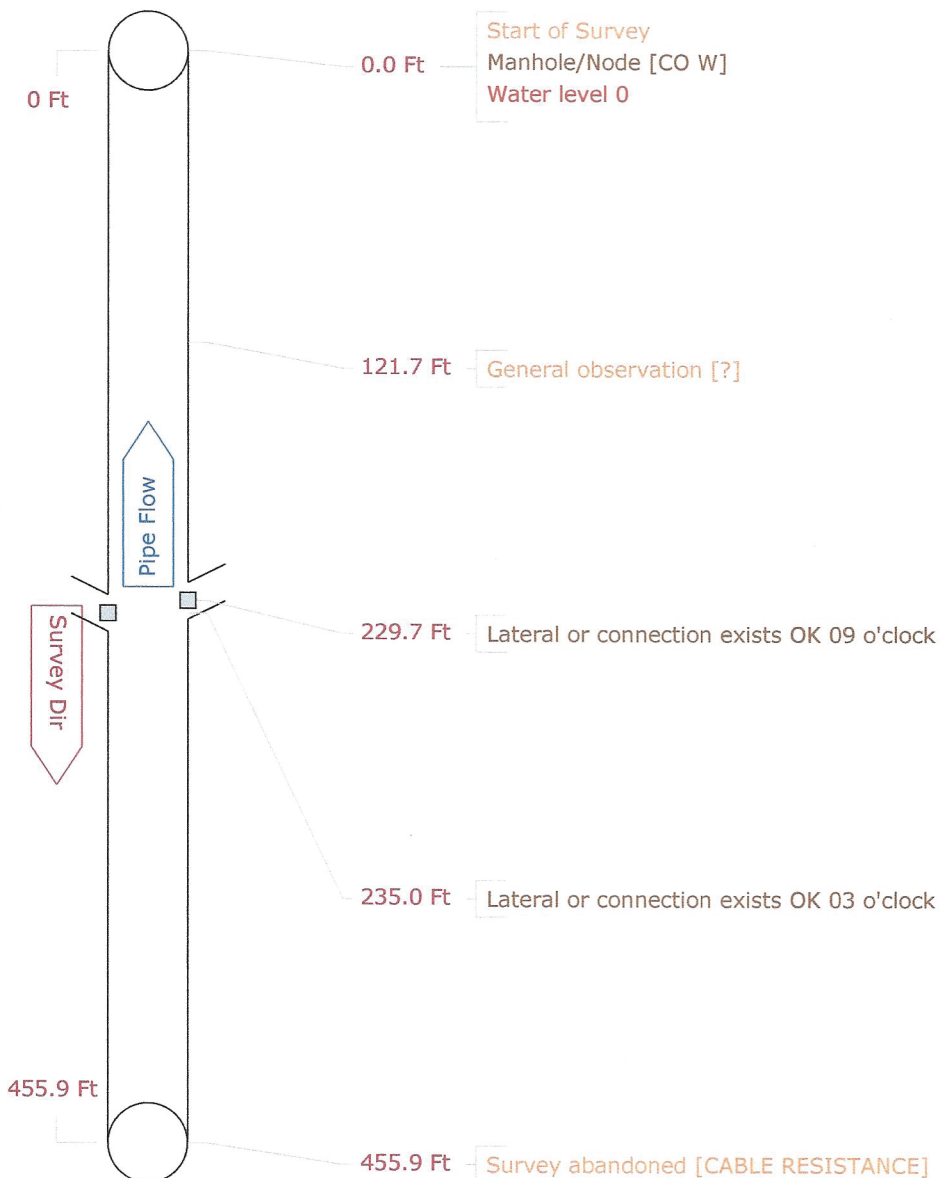
# Pipe Graphic Report of PLR CO E D for CITRUS COUNTY SOLID WASTE

Date: 04/28/2015  
 Distance: 455.9 Ft  
 Obs: Survey abandoned  
 Comments:  
 CABLE RESISTANCE
