SITE INSPECTION REPORT

NAME OF SITE: Florida Crushed Stone Company

INSPECTION DATE: January 29, 2009

PERMIT #: PA 82-17N

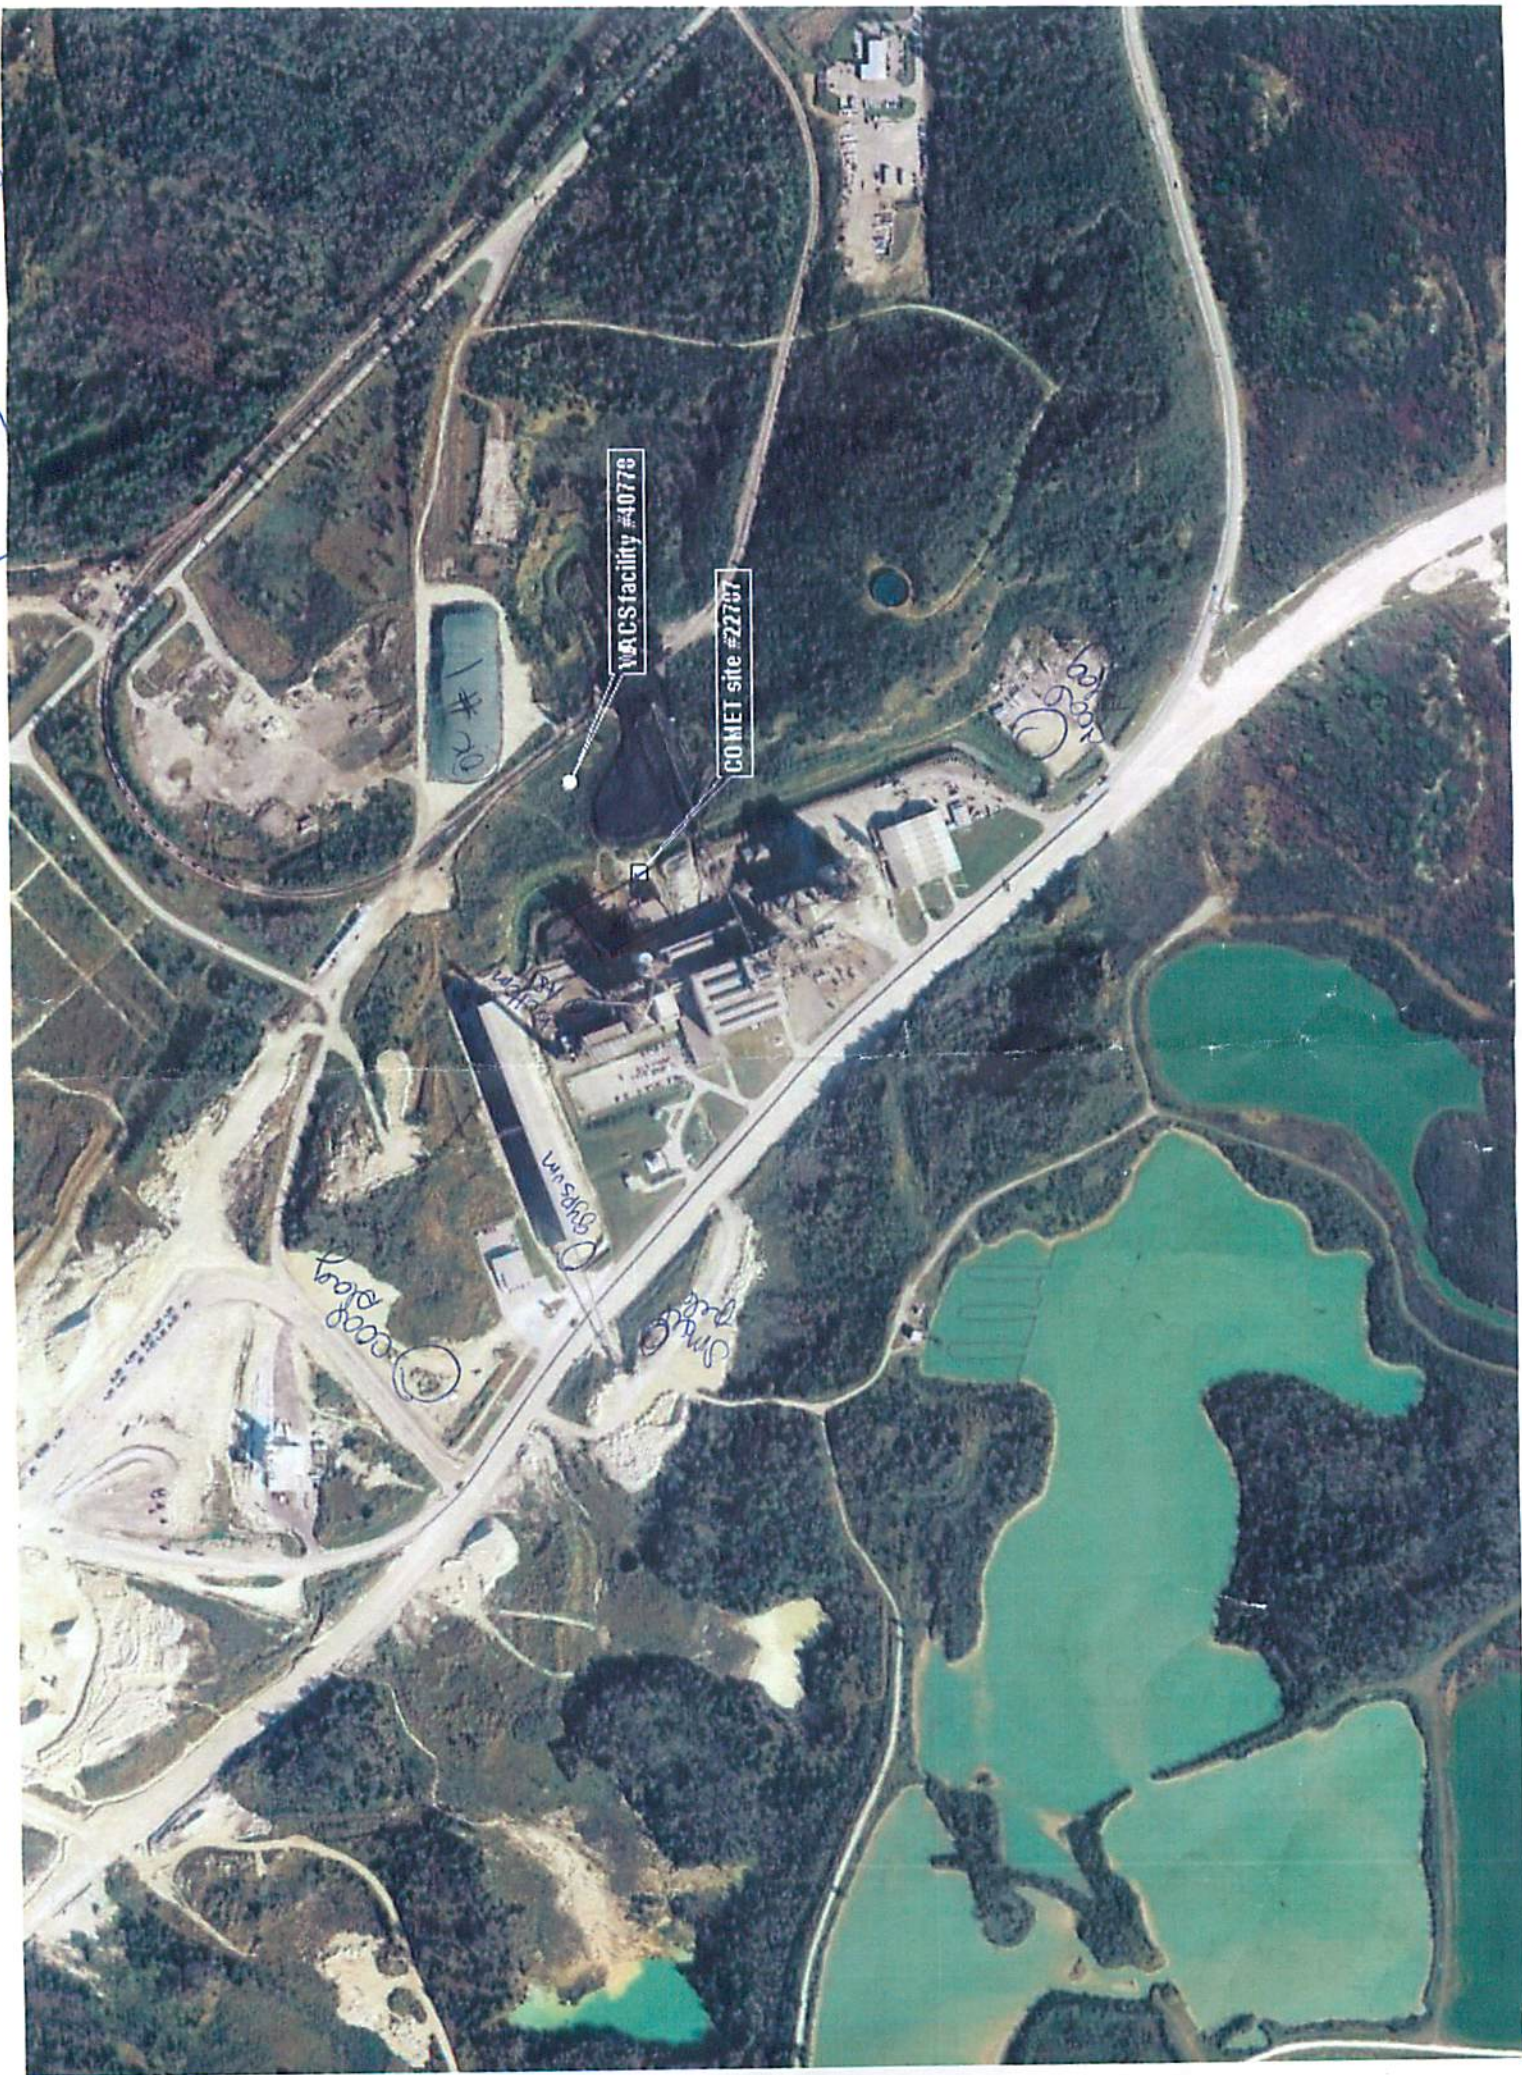
TECO GANNON
CONDITIONED ASH
SUG
TREES

few () + 3 - very steep

2. TECO Gannon Ash Pile #3 should be adequately graded (at least 3H:1V) under the tarp to allow for adequate stormwater flow and slope stability.
3. Provide details about the newly constructed A-frame building, including floor and containment features.
