## Section 7

**WATER RECOVERY, INC.**  
JACKSONVILLE, FL

**TANK 7P**  
**GENERAL ARRANGEMENT**

JOB NO.: 40563-1-0225 DWG. NO.: 0225-7P-01

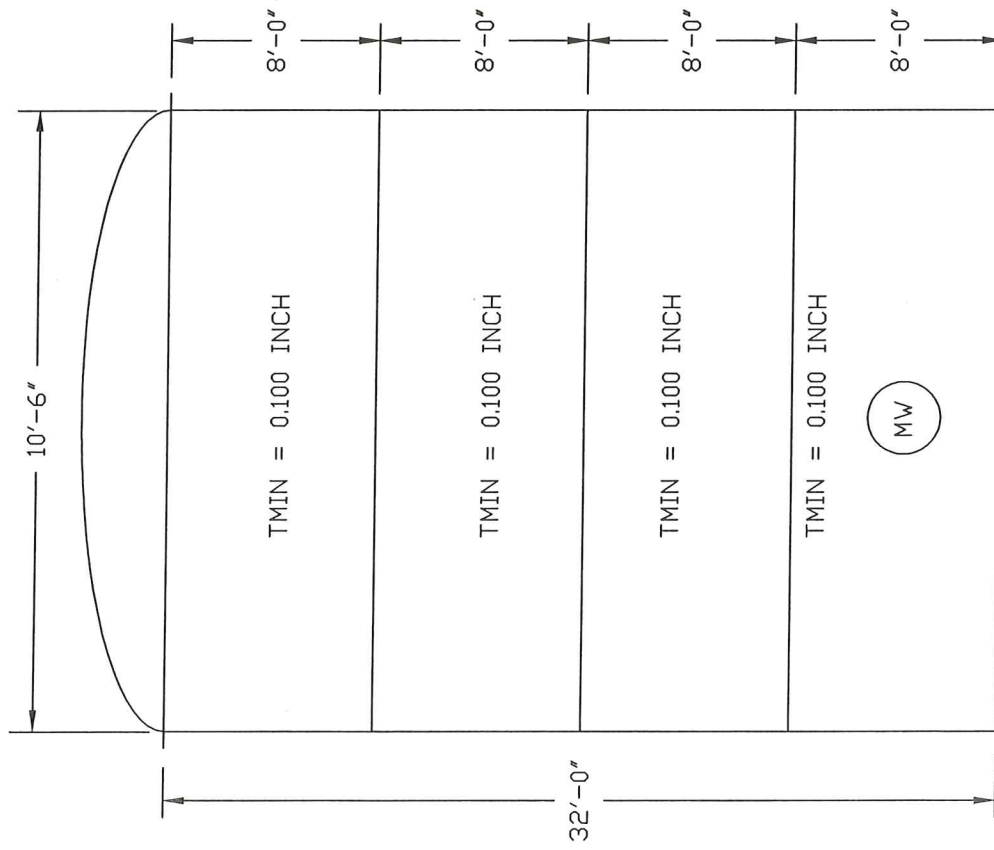
TMINS BASED ON FULL  
HYDROSTATIC LOAD OF 32 FEET

1. DRAWING NOT TO SCALE.
2. NOZZLES HAVE NO INSIDE DIAMETER WELDING.
3. SEE ATTACHED NOZZLE SHEET FOR NOZZLE UT READINGS.
