**RE: Warning Letter WL18-171
North Florida Shipyards, Inc.
EPA/DEP ID: FLD 093 598 548
Duval County – Hazardous Waste**

**Florida Department of
Environmental Protection
Hazardous Waste Inspection Report**

SIC CODE: 3731 - Manufacturing - ship building and repairing

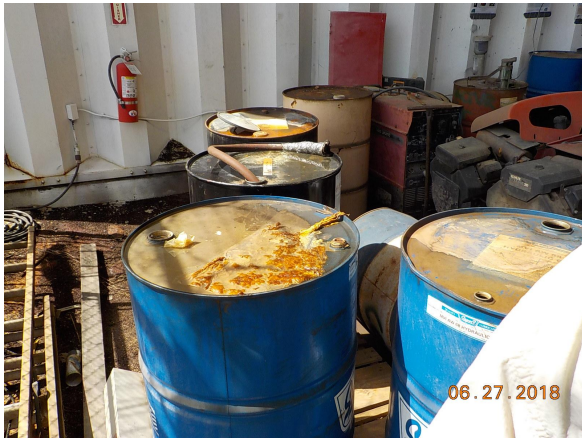
Photo 17

pans and accumulated in a poly tote located within secondary containment. The tote was properly labeled with the words "Used Oil." Adjacent to this tote, there were six drums of used oil that were not located within secondary containment (Photo 17) [62-710.401(6), FAC]. These drums were properly labeled with the words "Used Oil."

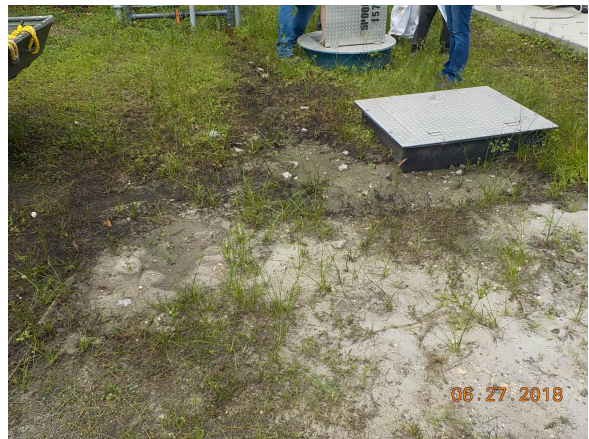
Photo 28

Near the WWTP was an area where it appeared as though oil had been discharged to the ground and had not been cleaned-up (Photo 28) [40 CFR 279.22(d)].
