#### FLORIDA DEPARTMENT OF Environmental Protection

SUBJECT: Department of Environmental Protection v. PACEM Defense, LLC

RE: Warning Letter WL21-201 (Significant Non-Complier)
PACEM Defense – AMTEC Less Lethal
EPA/DEP ID: FLR000201186
Taylor County – Hazardous Waste

#### **Hazardous Waste Inspection Report**

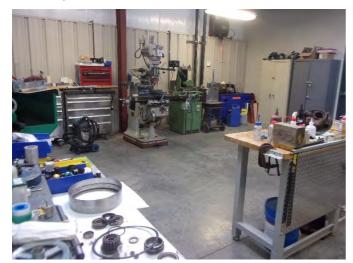
Photo 19

Routine maintenance on building equipment, machinery and landscaping equipment is performed in this building. Mr. Burt stated that maintenance on vehicles is performed off-site. A drill press, lathe, belt sander, and brake equipment are located in a separate room on the west side of the building (Photo 19). Metal shavings/grindings generated from metal work are thrown in the trash. The facility should either recycle these shavings as scrap metal or make a waste determination on the metal debris [40 CFR 262.11]. Acetone or IPA is used on wipes to clean surfaces. The wipes are collected in a 5-gallon step can and emptied into the regular trash.

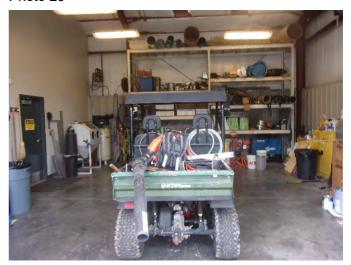
Photo 20

On the east side of the building there is an open bay with a roll-up door where small equipment is brought inside for maintenance (Photo 20). The room is used for product storage and has a small abrasive media glove box. Mr. Burt stated that the glove box was used infrequently and waste had not yet been disposed. The facility is reminded that an accurate waste determination should be made at the time that waste media is collected for disposal.

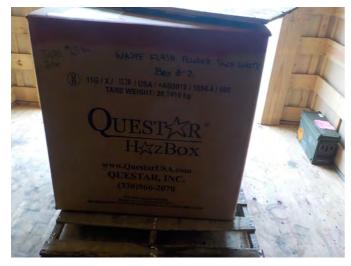
Photo 27

Magazine G is a small enclosed storage container that is located between Buildings #1 and #2 and is used as an HWAA for D001/D003 hazardous waste debris (Photo 26). There were two 1-CY lined, fiberboard accumulation containers located inside the magazine (Photos 27 and 28). The containers were closed but were not properly labeled with the words "Hazardous Waste" and were not marked with an indication of the hazards of the contents [40 CFR 262.16(b)(6)(i)(A), 40 CFR 262.16(b)(6)(i)(B)]. The facility attaches a written log to the container that includes the weight and date the waste was added to the container. The waste had been accumulating for less than 180-days. The facility was not performing weekly inspections of the accumulation containers and was not maintaining documentation [40 CFR 262.16(b)(2)(iv), 62-730.160(3), FAC]. The HWAA did not have all the required equipment since there was no spill kit or eyewash available in the area [40 CFR 262.16(b)(8)(ii)(C)].

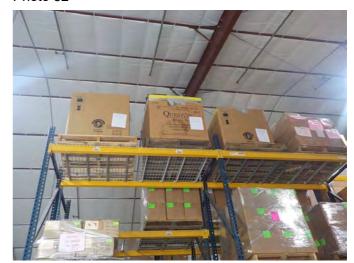
Photo 32

Inside the Warehouse on the top of one of the shelving units is an HWAA (Photos 32 and 33). In this location, approximately 18'-20' above floor level, the accumulation containers are not available for inspection and the written inspection documentation the facility maintained was incomplete [40 CFR 262.16(b)(2)(iv), 62-730.160(3), FAC]; and there was not adequate aisle space to allow for inspection [40 CFR 262.16(b)(8)(v), 62-730.160(4), FAC]. There were five 1-CY lined, fiberboard accumulation containers located in this area. All the containers appeared to be closed. None of the containers appeared to be properly labeled with the words "Hazardous Waste" and did not appear to be marked with an indication of the hazards of the contents [40 CFR 262.16(b)(6)(i)(A), 40 CFR 262.16(b)(6)(i)(B)]. The facility attaches a written log to the container that includes the weight and date the waste was added to the container. All five of the containers appeared to have a log attached to the container, but the accumulation start date could not be determined since the containers were not accessible for inspection [40 CFR 262.16(b)(6)(i)(C)]. One of the containers was marked with the accumulation state date and had been accumulating for less than 180-days. The HWAA had all the required equipment including a fire extinguisher, spill kit and eyewash.
