Enterprise Class III Landfill Angelo's Aggregate Materials, Ltd. 41111 Enterprise Road Dade City, FL 33525

Cell 3
Construction Completion Report
FDEP Permits: 177982-001-SC & 177982-002-SO

March 2007

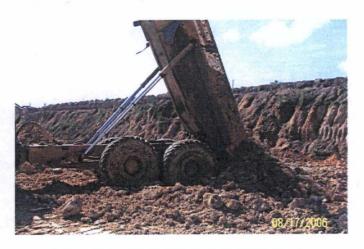
Picture 31

-						-
		_		<u> </u>				
		_						
		_					_	
							<u> </u>	
		_					-	
		_	P	hotographs	(explain	activity for each)		
Photo #	30	Trackhoe loa						
Photo #	31	End dump u			itoriui.			
Photo #	32	Buil dozer pu						
Photo #	52	Duii dozei pi	asimy mate	лгаі.				
F11010 #
