**CELL #5
SITE INSPECTION REPORTS
PICTURES
TEST RESULTS
TEST LOCATION MAPS**

Project #: 80540-001-02

Angelo's Aggregate Materials

DADE CITY LANDFILL CELL #5

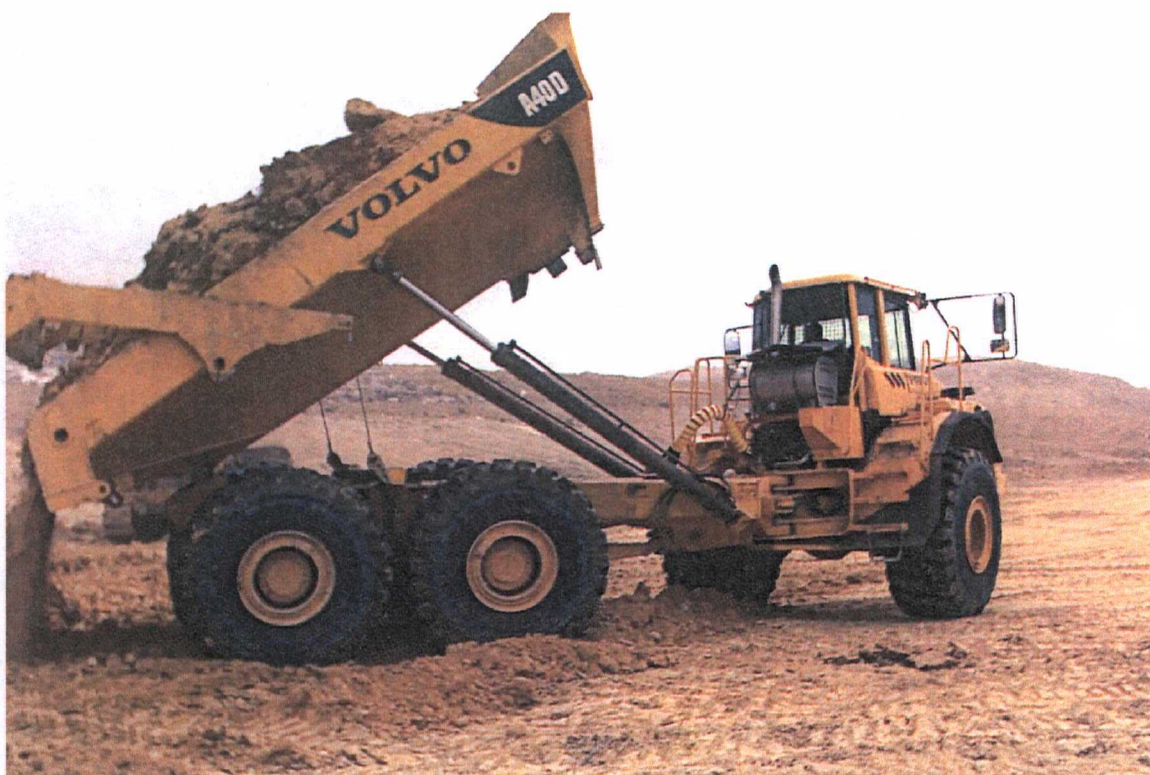
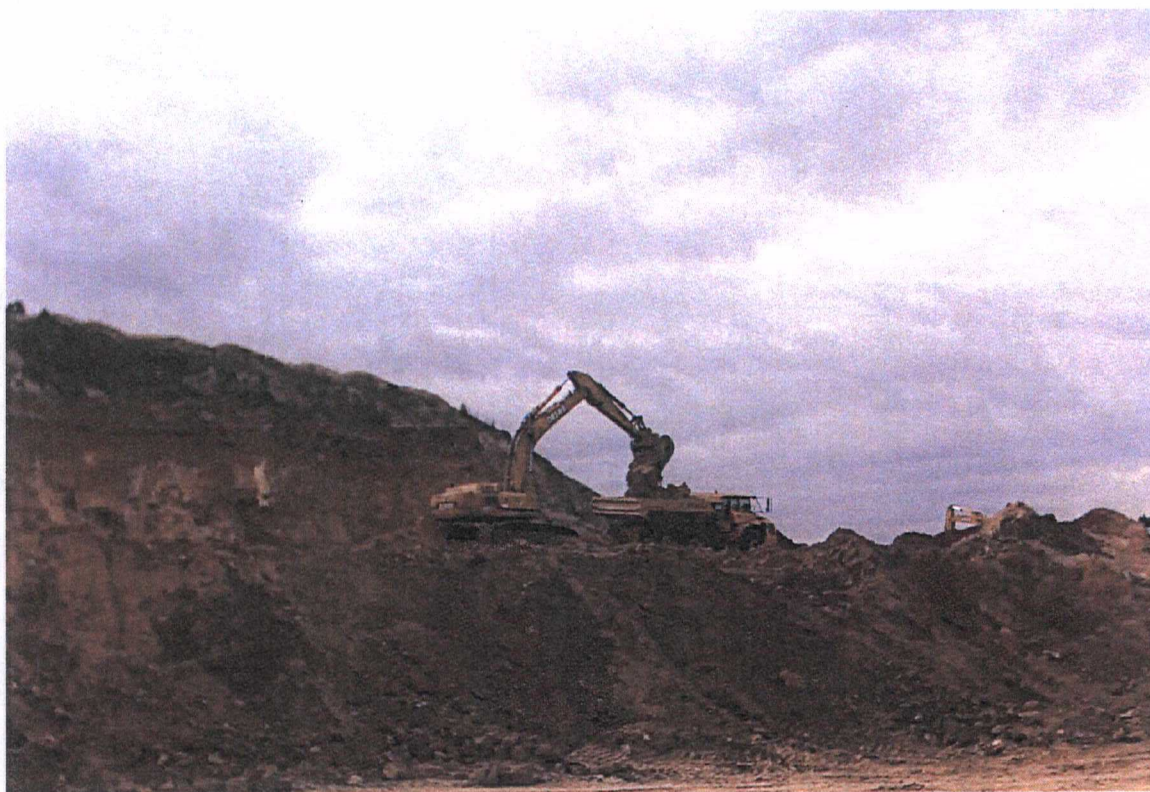
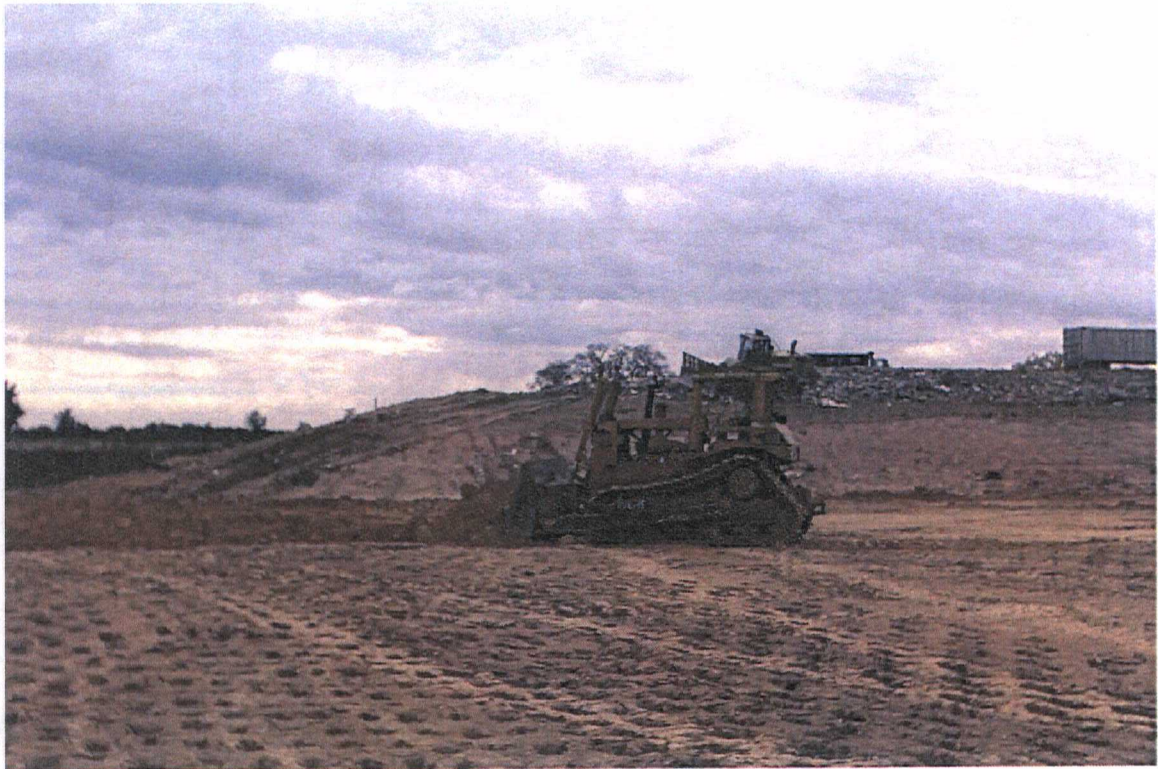
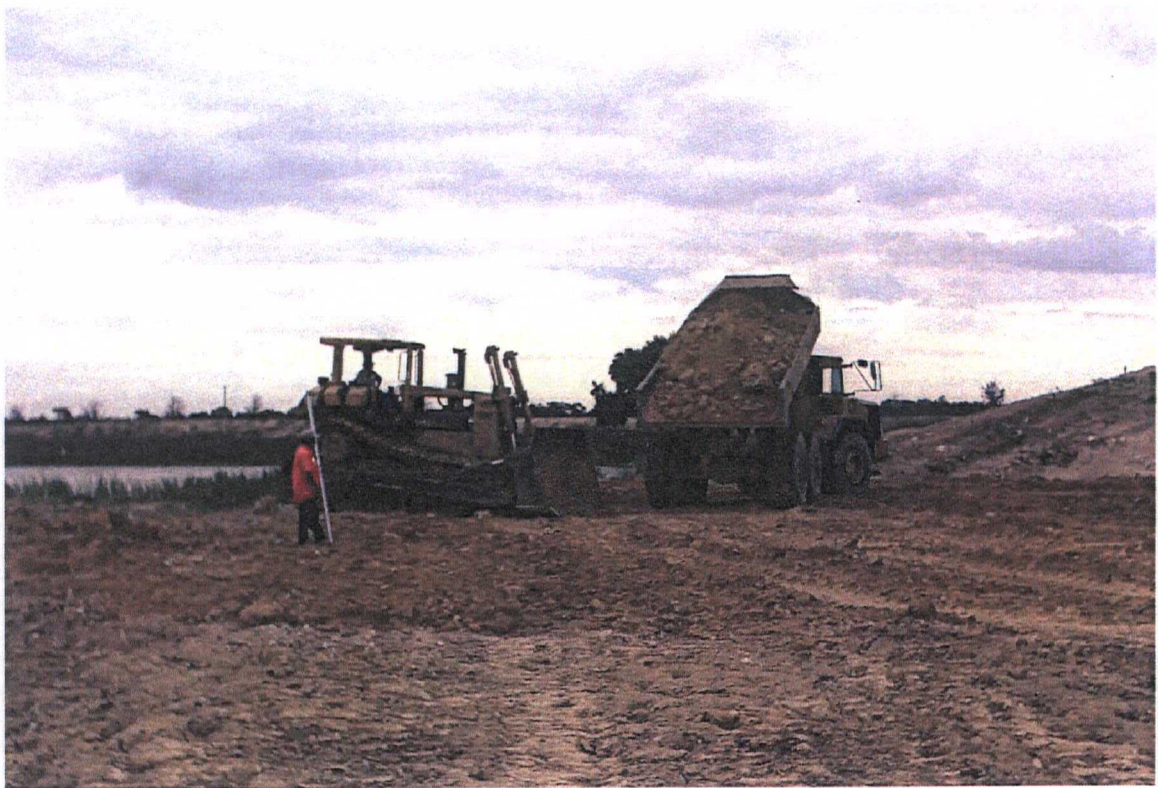
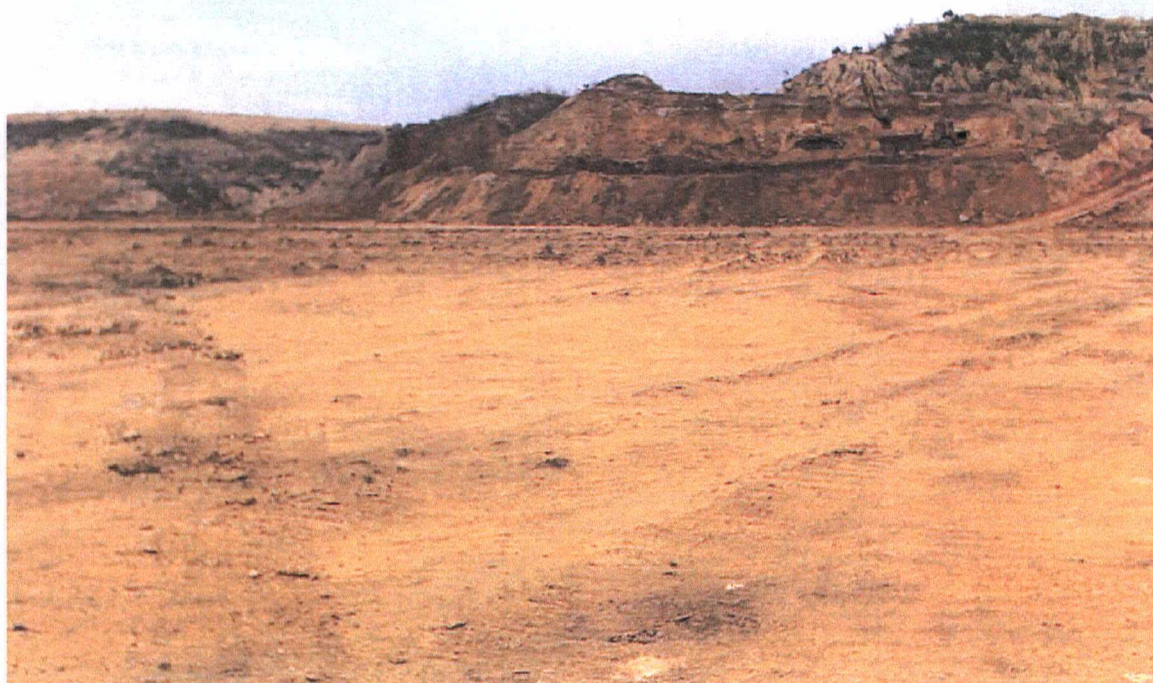
Construction Activity Observed

Area Constructed : Cell # 5

Material Used : Clay

Lift # 3

Lift Thickness : 12"

Location	% Compaction	Permeability	200 wash
3 - 6	112.2	10 -8	47.8%
3 - 7	112.6	10 -9	42%
3 - 5	105.1	10 -9	37.9%
3 - 1	108.5	10 -9	55.7%
