**CERTIFICATION REPORT  
CONSTRUCTION OF CELL 1B  
Oak Hammock Disposal Facility  
Osceola County, Florida**

Osceola County SW  
Oak Hammock Disposal Facility  
Certification of Construction Completion

Oak Hammock Disposal Facility  
Osceola County, Florida

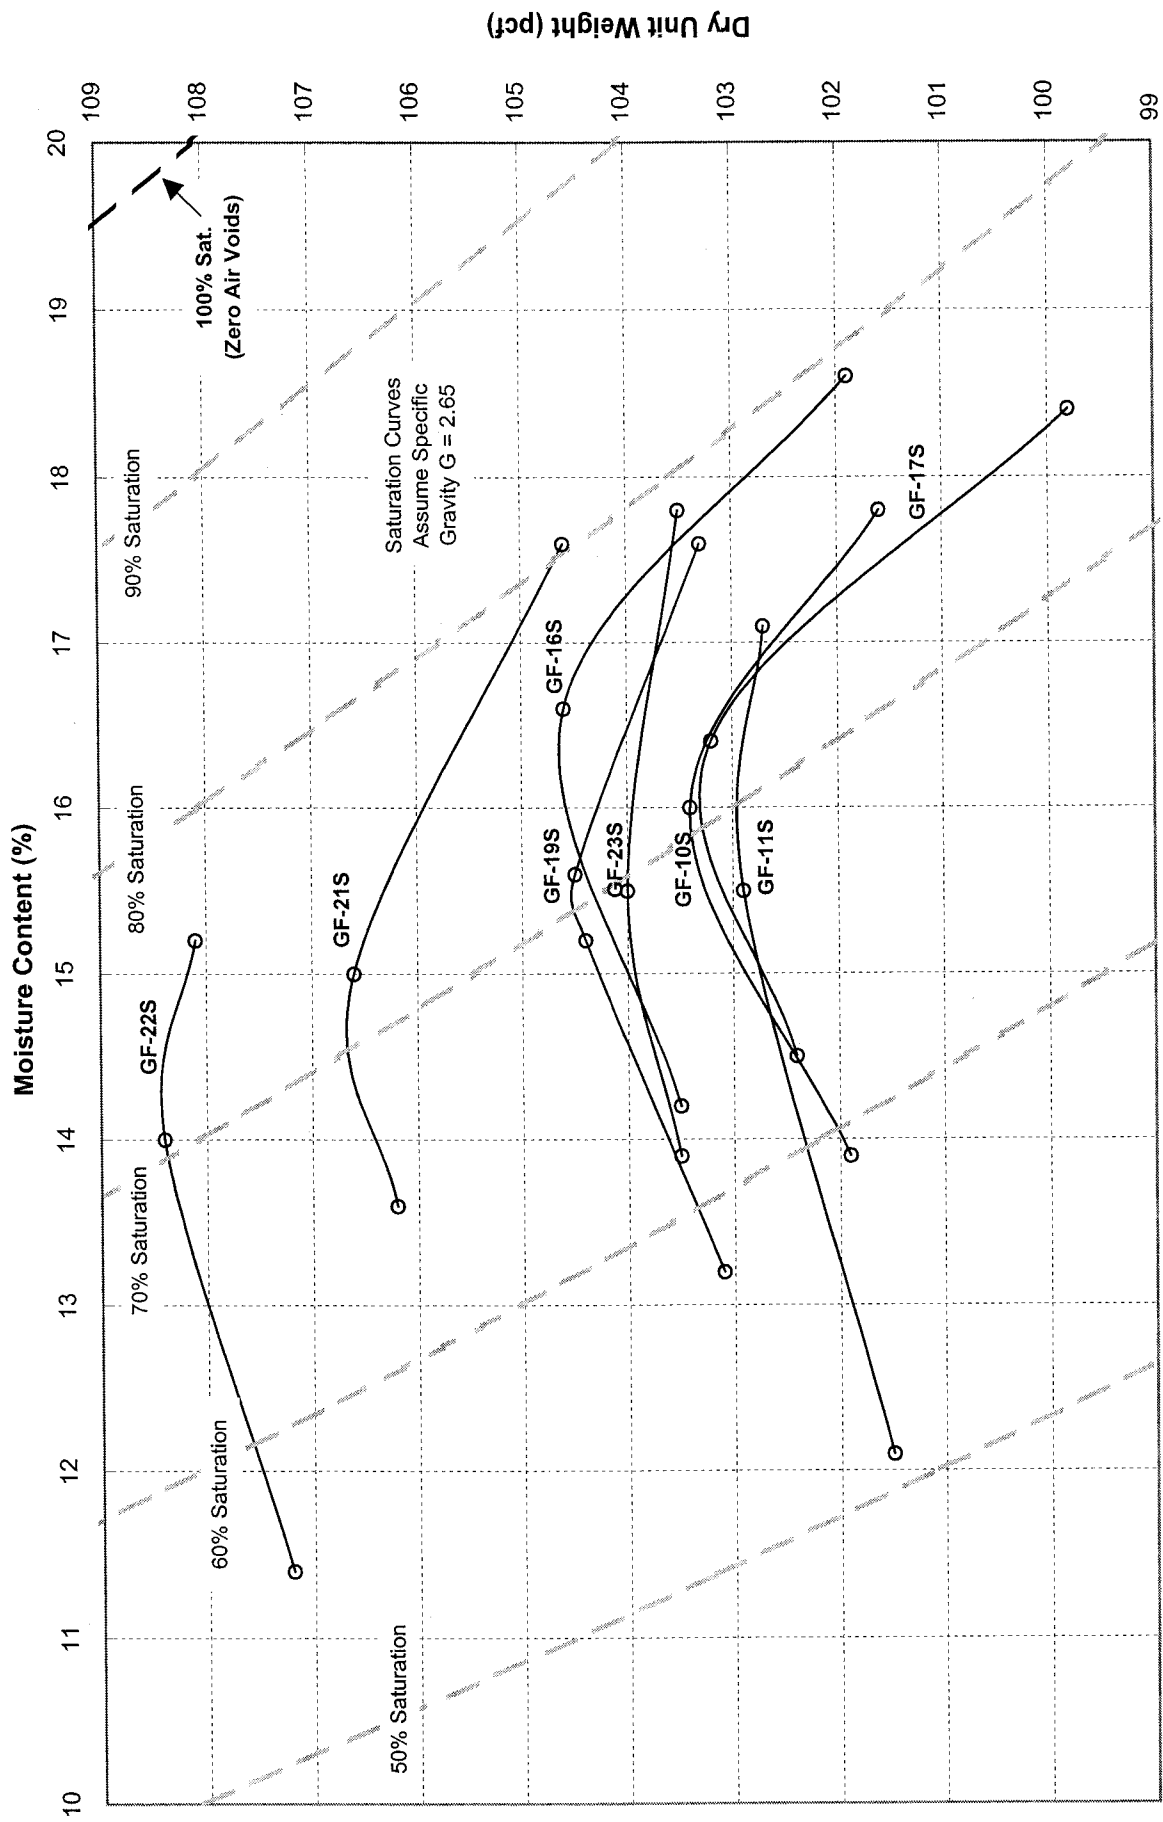
Figure 4-1: Standard Proctor Test Results for General Fill in Cell 1B

Eight standard Proctor tests were performed during construction for approximately 127,000 cyd of compacted general fill placed in Cell 1B. The CQA test frequency of 1 test per 16,000 cyd (approx.) of compacted general fill exceeded the minimum testing frequency required by the CQA Documents. The standard Proctor tests performed during construction are summarized in Table 4-1 and are presented in Figure 4-1. As noted, the maximum dry unit weight varied from 102.9 to 108.4 pounds per cubic foot (pcf) and the optimum moisture content varied from 14.0 to 16.2 percent.

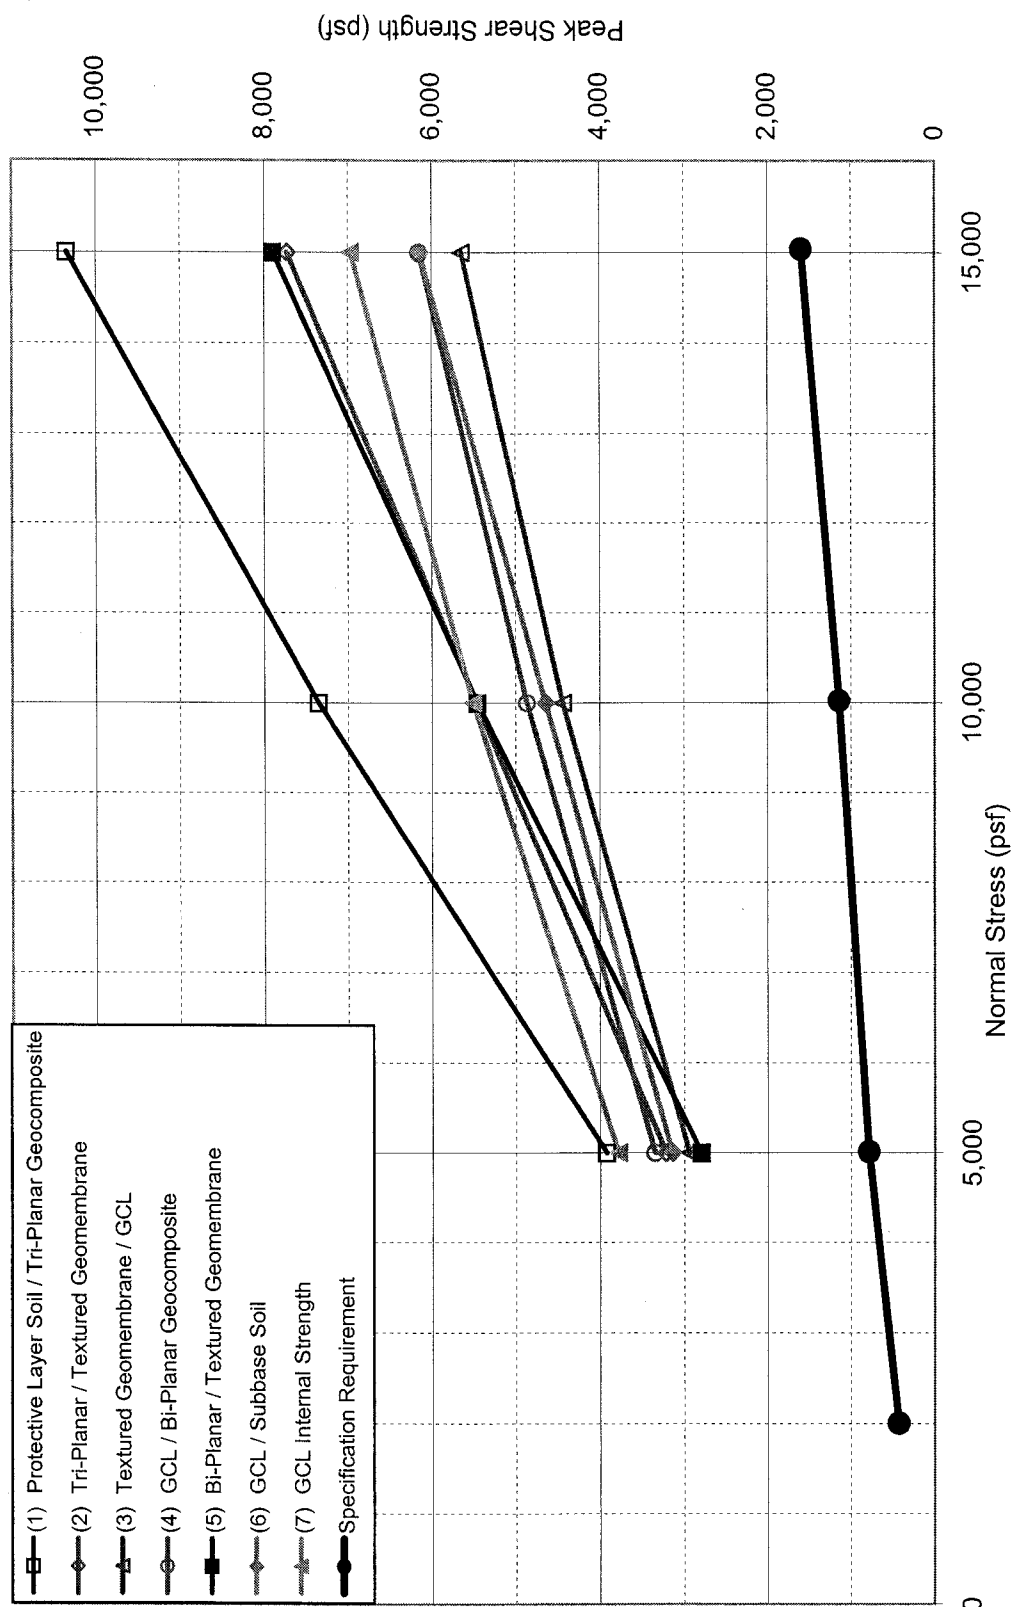
Figure 5-1: Peak Shear Strengths from Interface Friction Tests

The minimum shear strengths required by the CQA Documents are presented in Table 5-5A. The measured peak and residual shear strengths are summarized in Table 5-5B and are presented in Figures 5-1 and 5-2, respectively. As noted, the measured peak and residual shear strengths exceeded the minimum specification requirements.
