**Re: Permit No: 291114-003-SF/14 Pore Water Collection System - Video Inspection**

In compliance with Specific Condition # C.5.d., Alcoa World Alumina LLC is submitting this Video Inspection report of the Pore Water Collection System for CEAT-3.

# Project: CEAT 3

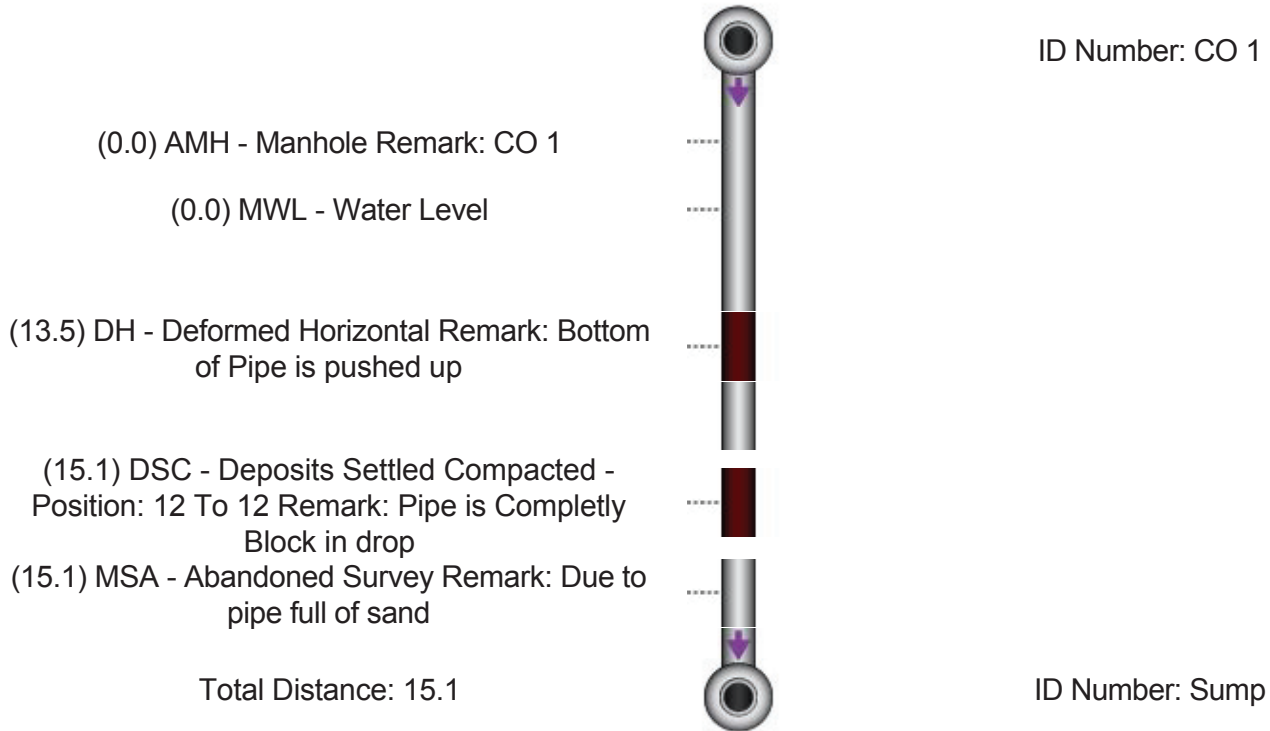
Grade	Structural	O&M	Overall
5	5	5	10
4	0	0	0
3	0	0	0
2	0	0	0
1	0	0	0
Overall	5	5	10
Number of Defects	1	1	2
Pipe Rating	5100	5100	5200
Pipe Ratings Index	5	5	5

Distance	Video Ref	Code	Cont Defect	Value			Joint	Circumferential Location	
				Dimension		%		At / From	To
				1st	2nd				
0	91	AMH - Manhole							
		CO 1							
0	106	MWL - Water Level				0			
13.5	391	DH - Deformed Horizontal				10			
		Bottom of Pipe is pushed up							
15.1	489	DSC - Deposits Settled Compacted				100		12 12	
		Pipe is Completly Block in drop							
15.1	531	MSA - Abandoned Survey							
		Due to pipe full of sand

- Attempt to execute a jet cleaning of the main line between CO1 and the sump. This comes with some potential risks, such as additional damage to the pipe joints and filter fabric which lines the piping system.
- Pump the sump dry and take additional video from the sump toward CO1, as with current condition, with the sump high due to winter moratorium on pumping (as has been the standard for the last few years) the camera could not run from the sump toward CO1.

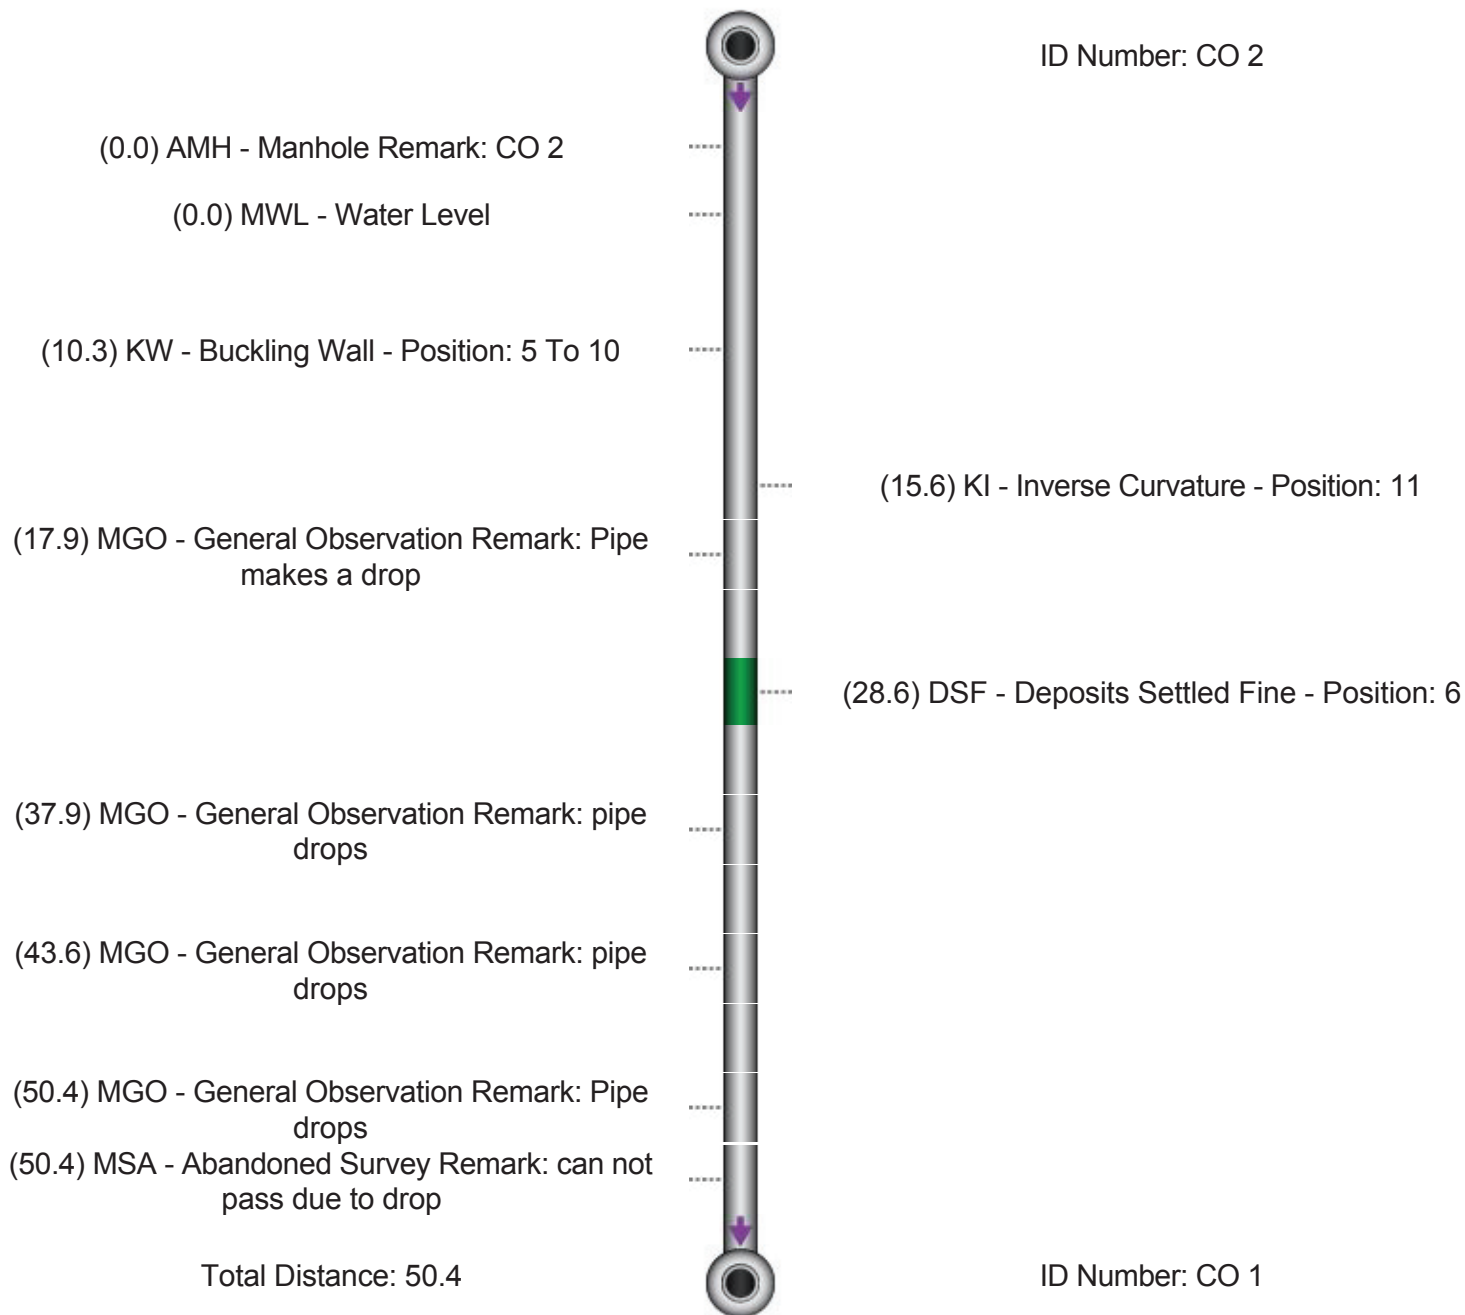
Grade	Structural	O&M	Overall
5	0	0	0
4	0	0	0
3	0	0	0
2	0	2	2
1	0	0	0
Overall	0	2	2
Number of Defects	0	1	1
Pipe Rating	0000	2100	2100
Pipe Ratings Index	0	2	2

Distance	Video Ref	Code	Cont Defect	Value			Joint	Circumferential Location	
				Dimension		%		At / From	To
				1st	2nd				
0	41	AMH - Manhole							
		CO 2							
0	55	MWL - Water Level				0			
10.3	173	KW - Buckling Wall				5	10		
15.6	236	KI - Inverse Curvature				5	11		
17.9	265	MGO - General Observation							
		Pipe makes a drop							
28.6	343	DSF - Deposits Settled Fine				0		6	
37.9	410	MGO - General Observation							
		pipe drops							
43.6	435	MGO - General Observation							
		pipe drops							
50.4	664	MGO - General Observation							
		Pipe drops							
50.4	1185	MSA - Abandoned Survey							
		can not pass due to drop

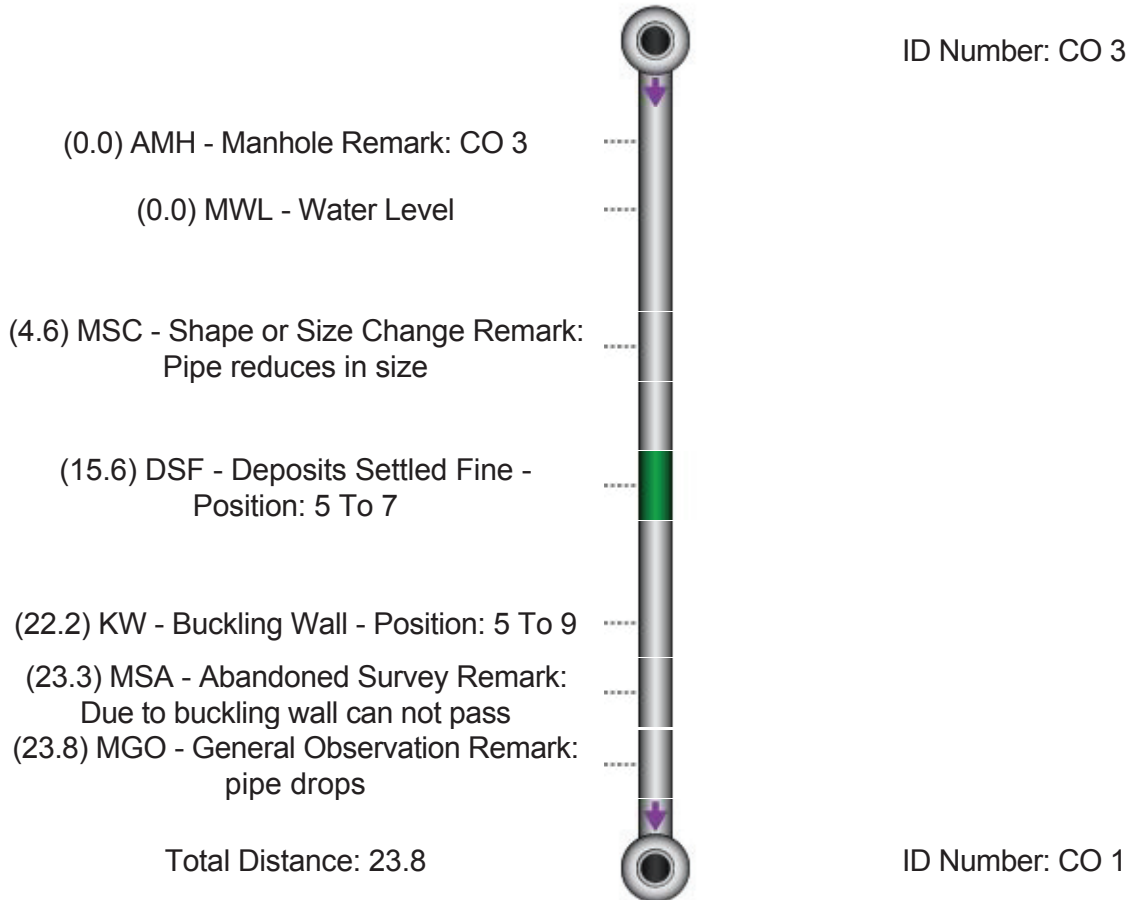
Grade	Structural	O&M	Overall
5	0	0	0
4	0	0	0
3	0	0	0
2	0	2	2
1	0	0	0
Overall	0	2	2
Number of Defects	0	1	1
Pipe Rating	0000	2100	2100
Pipe Ratings Index	0	2	2

Distance	Video Ref	Code	Cont Defect	Value			Joint	Circumferential Location	
				Dimension		%		At / From	To
				1st	2nd				
0	48	AMH - Manhole							
		CO 3							
0	58	MWL - Water Level				0			
4.6	157	MSC - Shape or Size Change	8						
		Pipe reduces in size							
15.6	217	DSF - Deposits Settled Fine				5		5	7
22.2	949	KW - Buckling Wall						5	9
23.3	1113	MSA - Abandoned Survey							
		Due to buckling wall can not pass							
23.8	878	MGO - General Observation							
		pipe drops

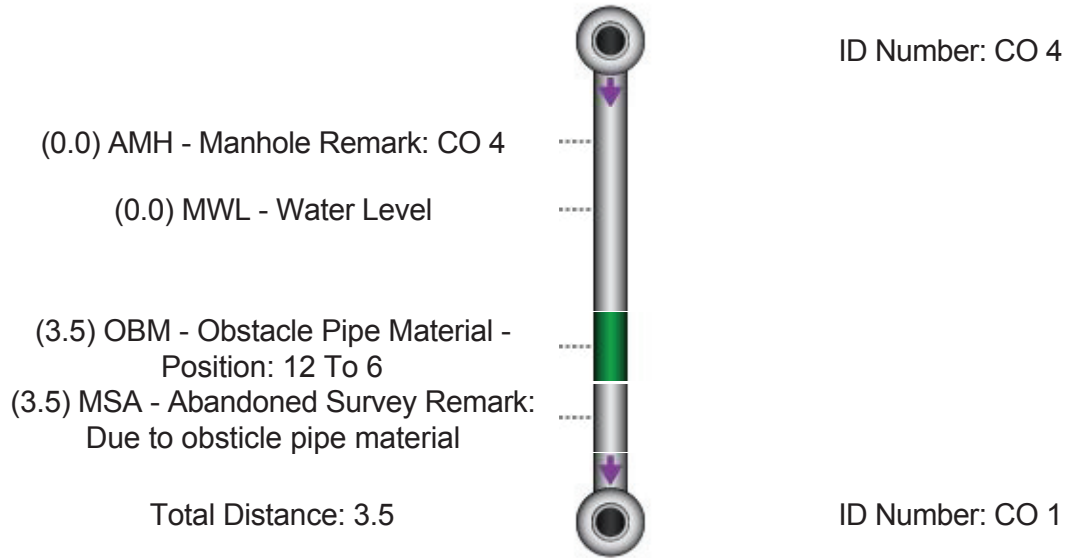
Grade	Structural	O&M	Overall
5	0	0	0
4	0	0	0
3	0	0	0
2	0	2	2
1	0	0	0
Overall	0	2	2
Number of Defects	0	1	1
Pipe Rating	0000	2100	2100
Pipe Ratings Index	0	2	2

Distance	Video Ref	Code	Cont Defect	Value			Joint	Circumferential Location	
				Dimension		%		At / From	To
				1st	2nd				
0	78	AMH - Manhole							
		CO 4							
0	91	MWL - Water Level				0			
3.5	170	OBM - Obstacle Pipe Material				5		12	6
3.5	208	MSA - Abandoned Survey							
		Due to obstacle pipe material
