# Leachate Collection and Removal System Effectiveness Evaluation

Pasco County Resource Recovery Facility

## Report Assessing the Effectiveness of the Leachate Collection and Removal System at the Pasco County Resource Recovery Facility

June 2016

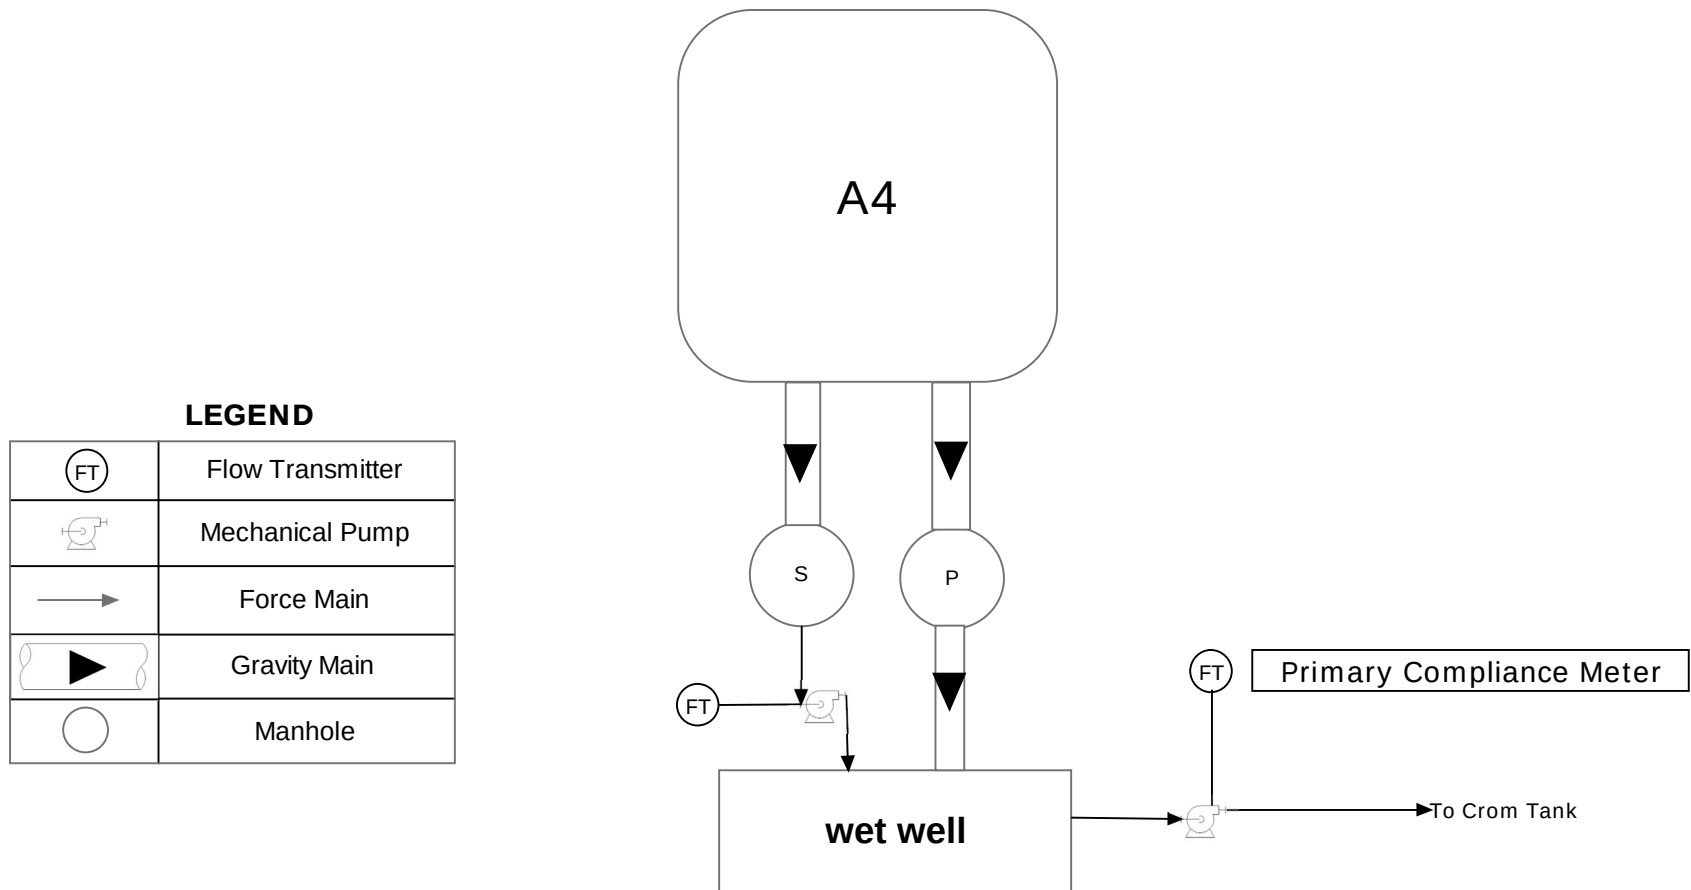
**FIGURE 2**  
**ASH DISPOSAL CELL A4 LEACHATE COLLECTION**

Ash disposal cell A4 was constructed in 2009 and is currently serving as the active cell for disposal of ash from the waste-to-energy facility. The leachate collection system is similar to that of A1, A2, and A3 in that leachate from each of the liner systems (primary and secondary) flows via gravity to manholes before being pumped (and metered) into a 6' diameter wet well for further pumping (and metering) to the 2 million gallon storage tank. **Figure 2** provides a simplified schematic of the leachate collection system for Ash Cell A4.
