| REV. | DATE | DESCRIPTION | DRN BY | APP BY |
|---|---|---|---|---|
| DES BY: | SLB | PROJECT: | TRAIL RIDGE LANDFILL | |
| DRN BY: | SLB | | PHASE IA AND IB | |
| REV BY: | DAS | PRIMARY GEOMEMBRANE PANEL | | |
| APP BY: | AK | LAYOUT AND SEAM REPAIR LOCATION | | |

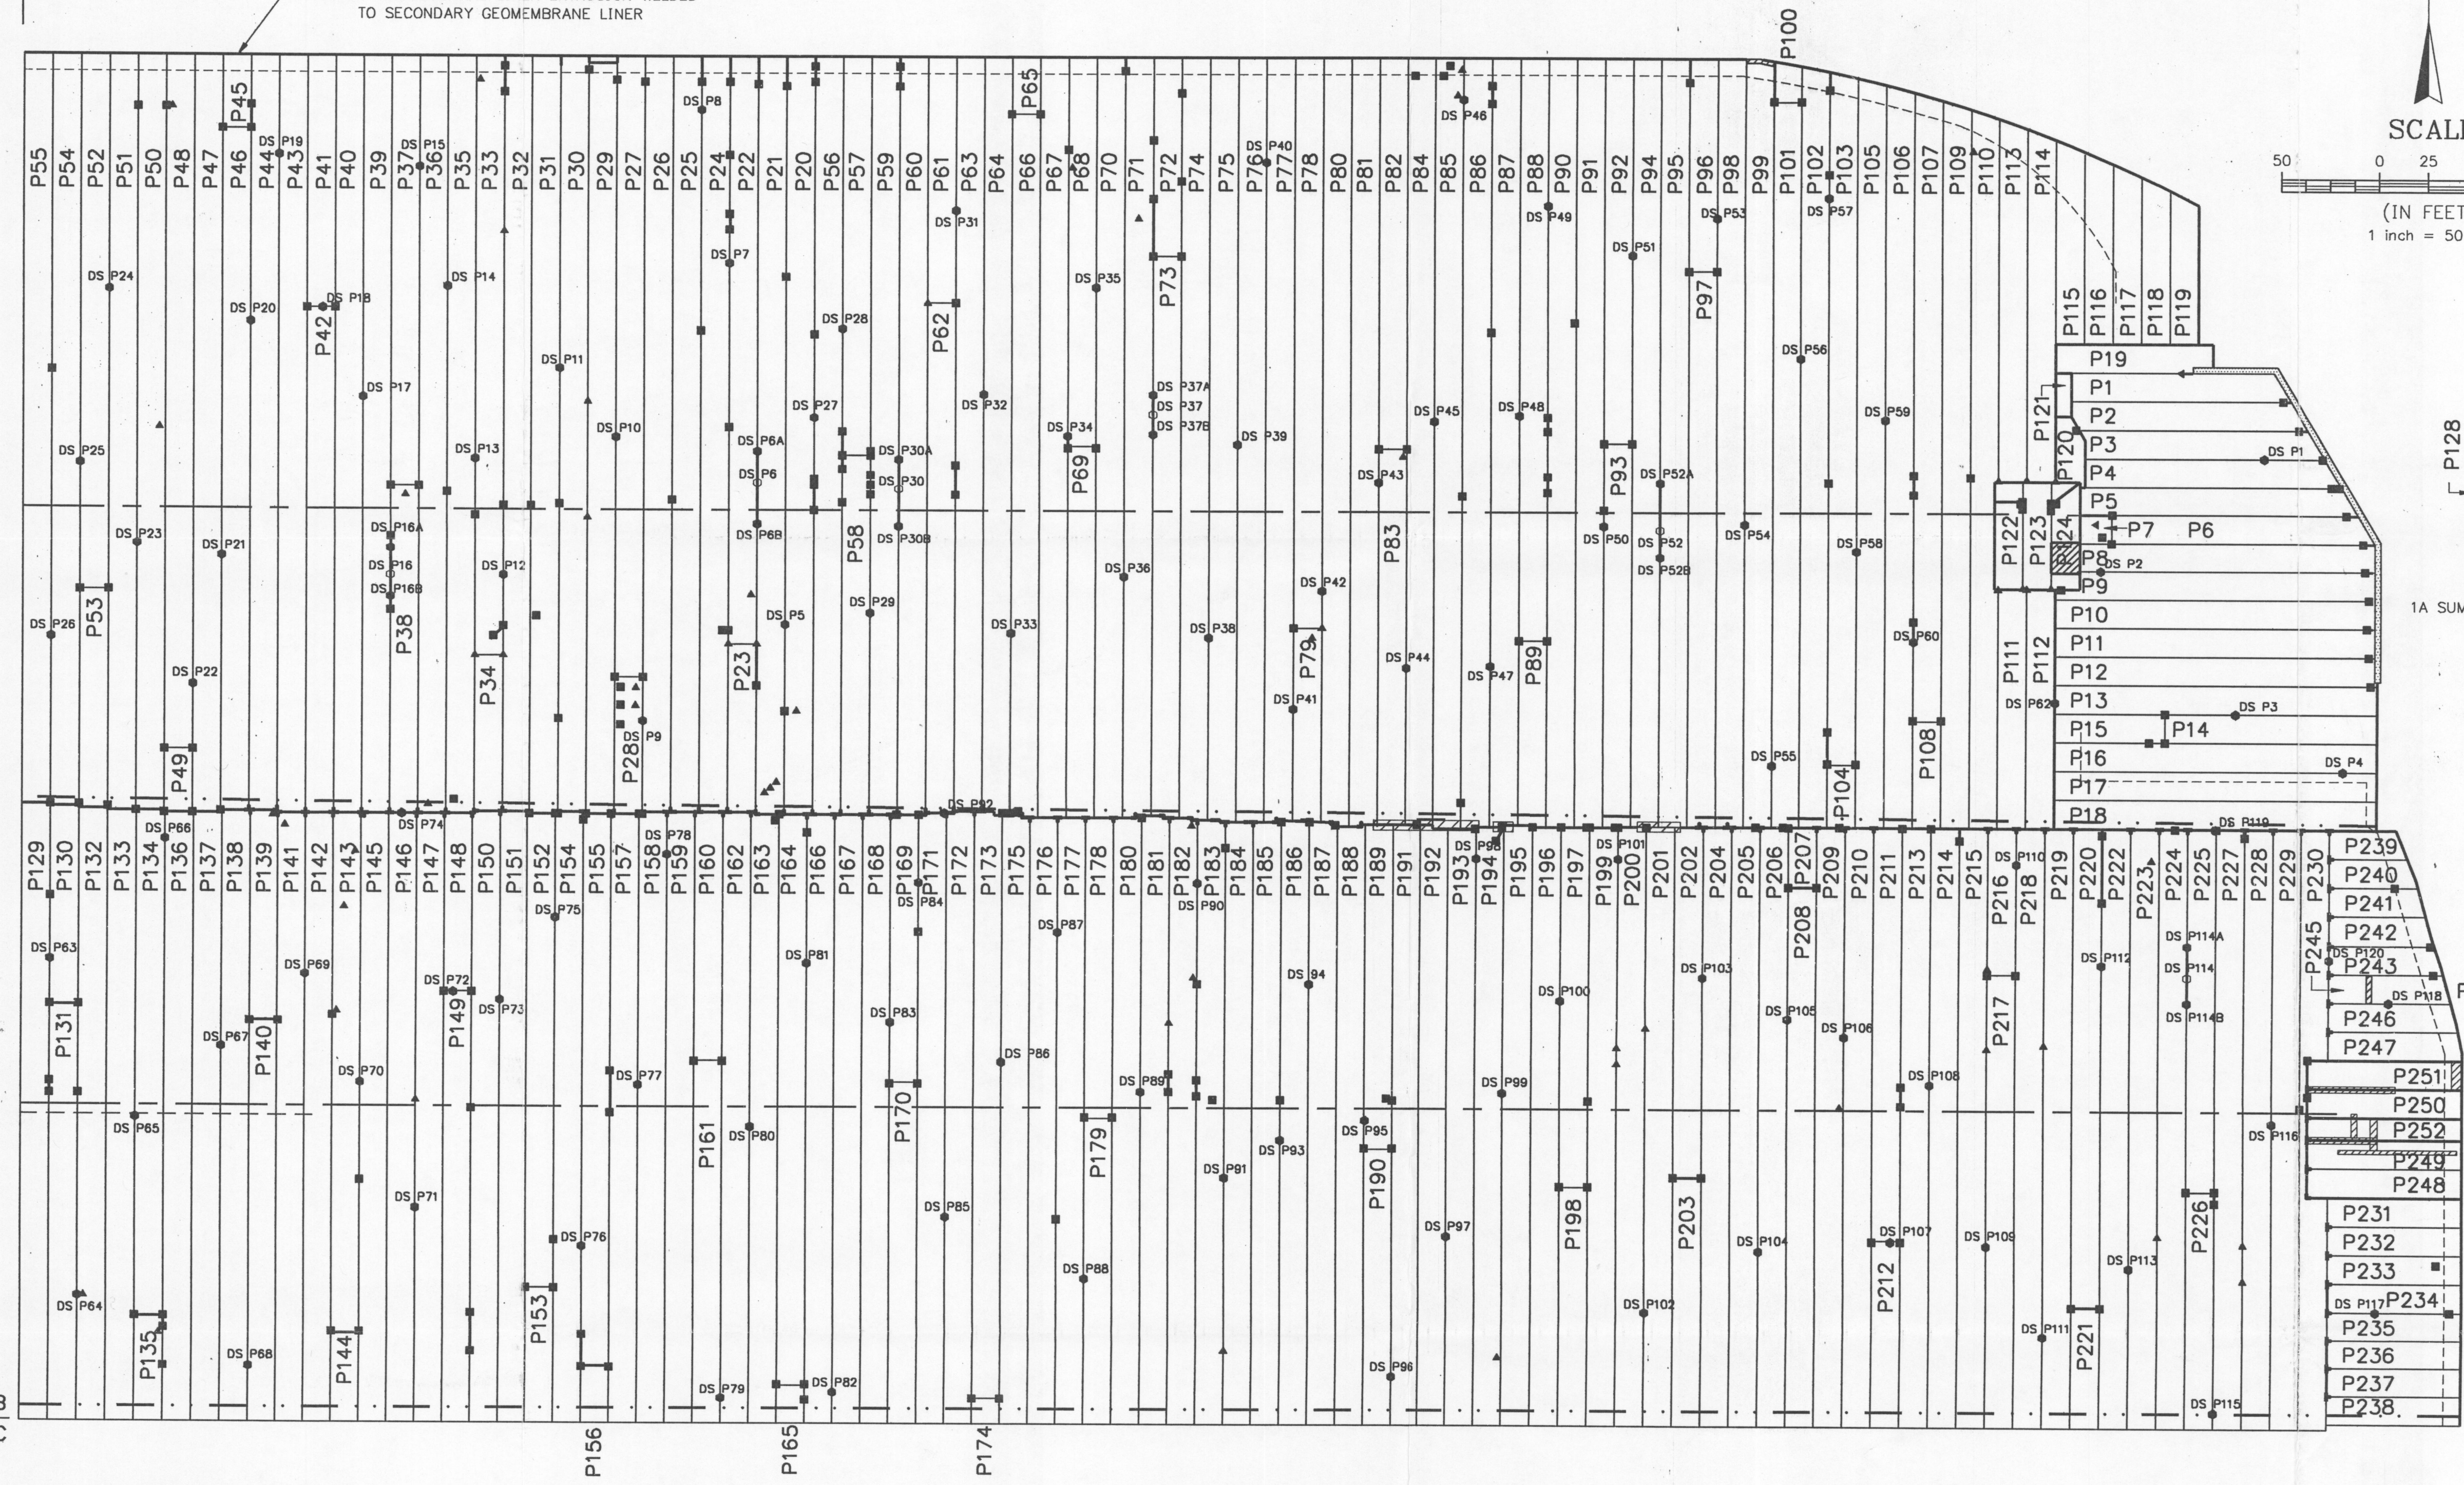
SHEET 2 OF 3  
DRAWING NO.

PRIMARY GEOMEMBRANE LINER EXTRUSION WELDED TO SECONDARY GEOMEMBRANE LINER

THIS RECORD DRAWING IS A GRAPHIC REPRESENTATION OF THE PRIMARY HDPE GEOMEMBRANE PANEL PLACEMENT AND DESTRUCTIVE SEAM SAMPLE LOCATIONS. FOR TRUE LENGTH OF THE HDPE GEOMEMBRANE PANELS, SEAMS, AND SAMPLE LOCATIONS, REFER TO APPENDICES OF GEOSYNTEC CONSULTANTS CQA FINAL REPORT DATED MAY 1992.
