STAGE III CLASS I LANDFILL

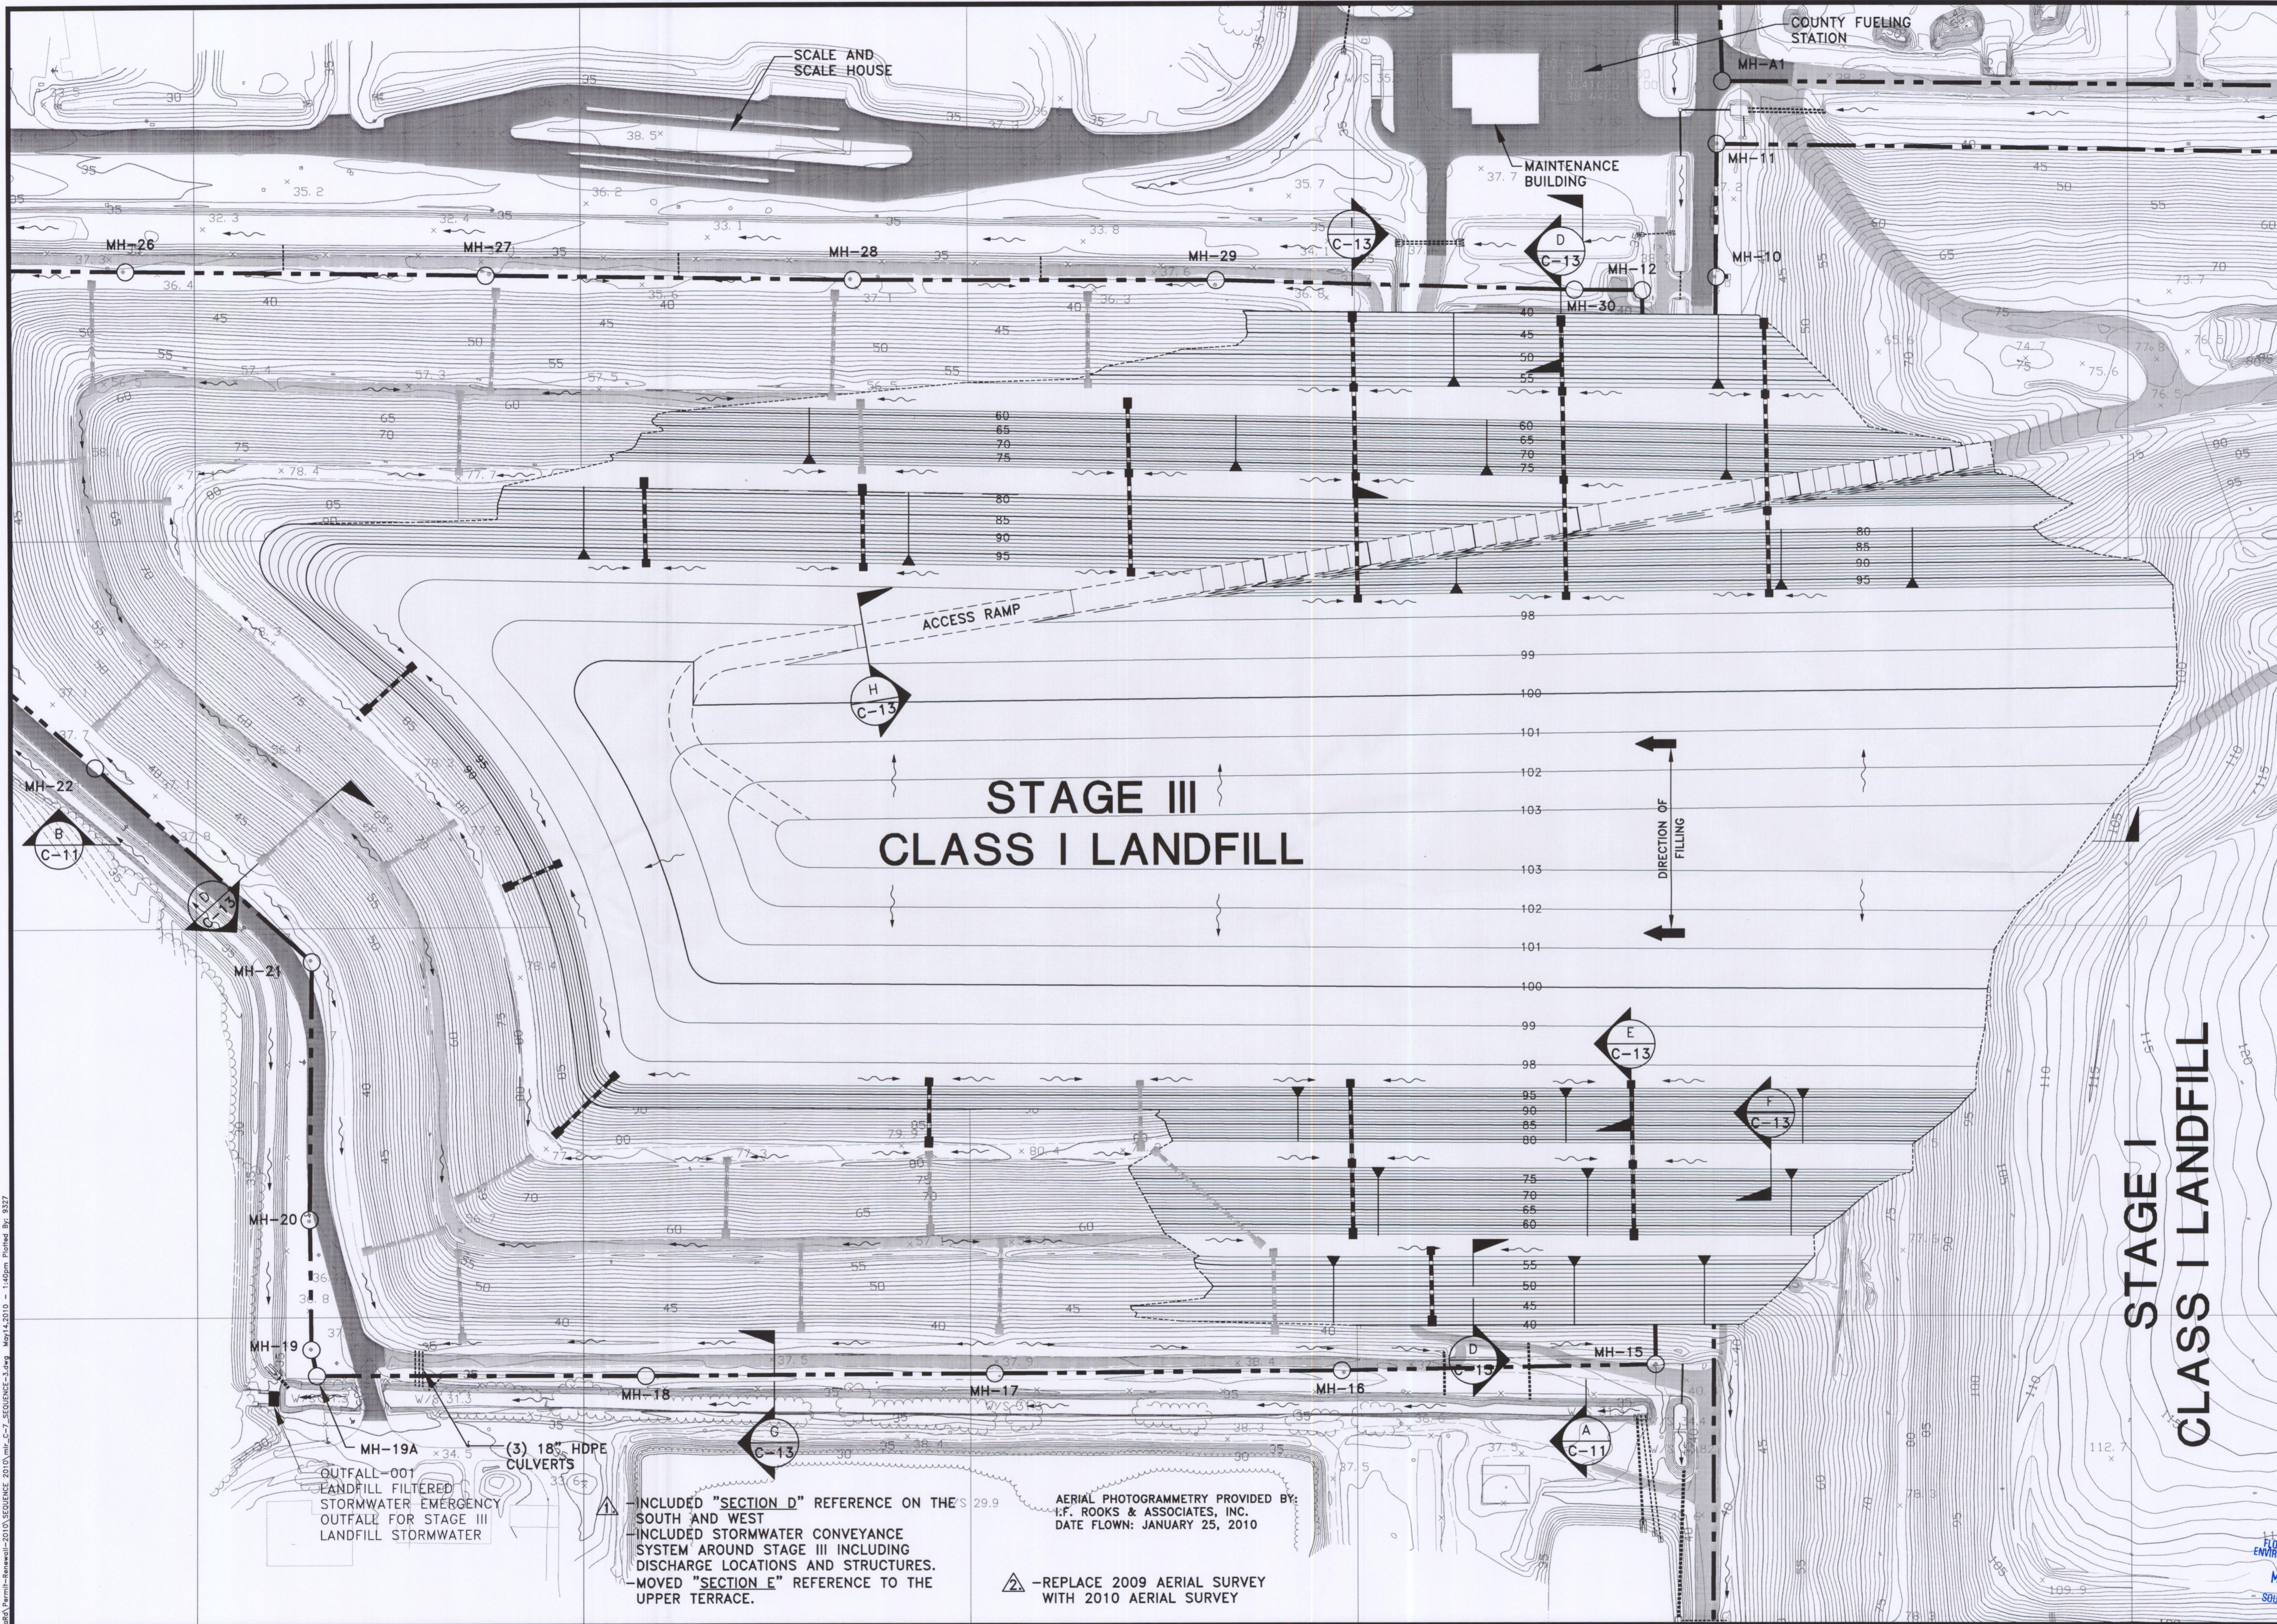
1. FILL WILL PROCEED TO THE WEST AND OVER OF THE PREVIOUS SEQUENCE.
2. REMOVED PAVED ACCESS ROAD, POWER LINES AND ANY UTILITY LINES TO THE NORTH OF PREVIOUS SEQUENCE.

3. WASTE SHALL BE PLACED AND COMPACTED IN LIFTS NO MORE THAN 10 FEET IN DEPTH AND AT A MAXIMUM SLOPES OF 5H TO 1V UNTIL ELEVATIONS SHOWN ARE REACHED. THE TOP TEMPORARY SLOPE SHALL BE NO LESS THAN 2% SUCH THAT THE STORMWATER RUNOFF SHALL FLOW TO THE PERIMETER OF THIS SEQUENCE.

4. A TEMPORARY WORKING FACE BERM SHALL BE LOCATED AS NECESSARY TO DIVERT THE FLOW TO 18" STORM DRAIN PIPES LOCATED AT LOW POINTS OF THE TEMPORARY BERM AS SHOWN ON THIS SEQUENCE PLAN.
