Florida Department of Environmental Protection Hazardous Waste Inspection Report

Facility Name: Howco Envi	ronmental Services			
On-Site Inspection Start Date	e: 08/10/2017	On-Site Insp	pection End Date:	08/10/2017
ME ID#: 61495		EPA ID#:	FL0001000611	
Facility Street Address:	2650A Edison Ave, Fo	ort Myers, FL 3	3916-5306	
Contact Mailing Address:	3701 Central Ave, St	Petersburg, FL	. 33713	
County Name: LEE				
NOTIFIED AS:

Routine Inspection for Used Oil Transfer Facility facility Routine Inspection for Used Oil Transporter facility

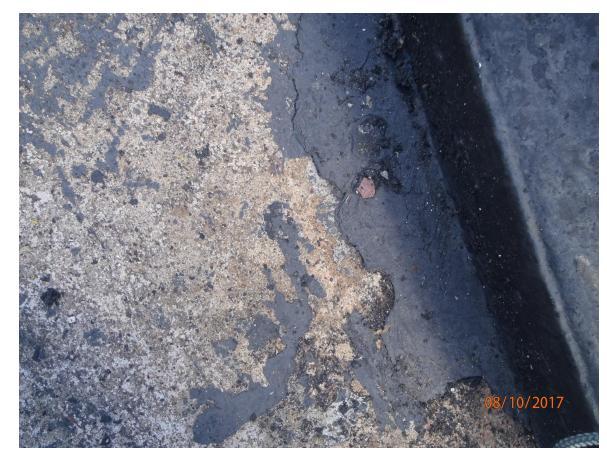
The black coating/sealant on the concrete floor of the containment structure is wearing away and cracking in areas.

Black coating/sealant worn off in containment structure

Corrective Action: The entire containment structure needs to be resealed with an impervious sealant.

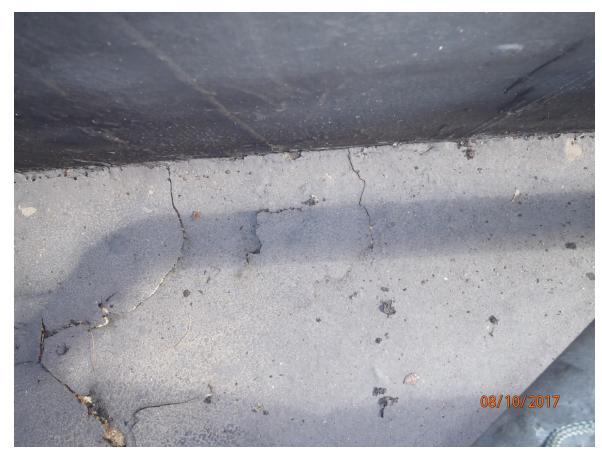
Black coating/sealant cracking in containment structure

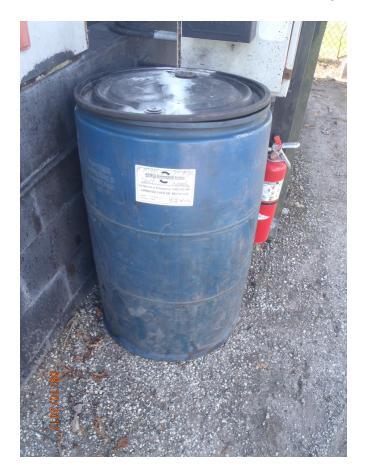
A closed, blue 55-gallon drum labeled 'Fort Myers yard waste' was noted outside the containment structure and approximately 1/3-full of used absorbent pads and trash (see photos). According to Mr. Bradley, absorbent pads are used to cleaning hands, trailer, etc. and for managing drips. Drums of used absorbent are transported to the Howco St Petersburg facility for disposal.

Blue drum labeled 'Ft Myers yard waste'

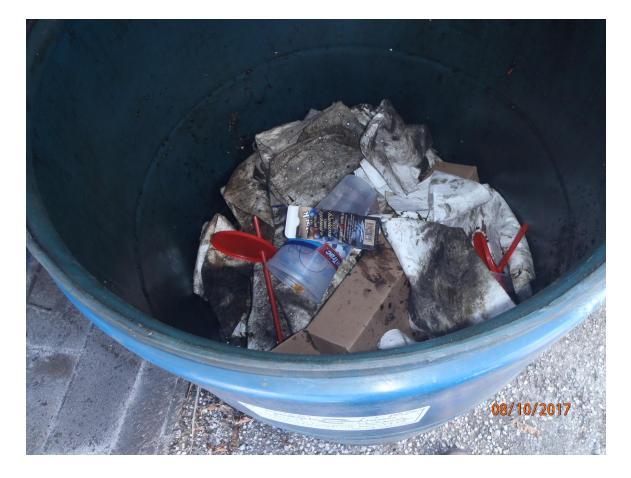
Blue 55-gallon 'Ft Myers yard waste' drum

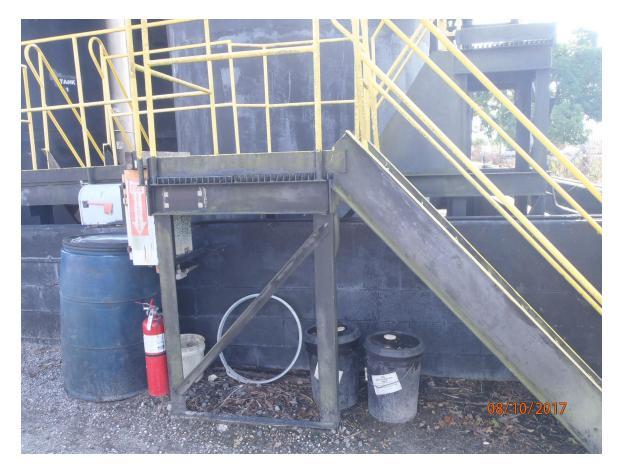
Also noted outside the containment structure was one approximate 200-gallon aboveground storage tank labeled 'empty' and a closed 55-gallon drum labeled 'new abs for yard use' (see photos). The storage tank appeared empty. Two empty closed 5-gallon buckets and an open two-gallon bucket approximately 1/4-full of what appeared to be rainwater was noted beneath the staircase leading into the containment structure (see photos).

Containers beneath staircase

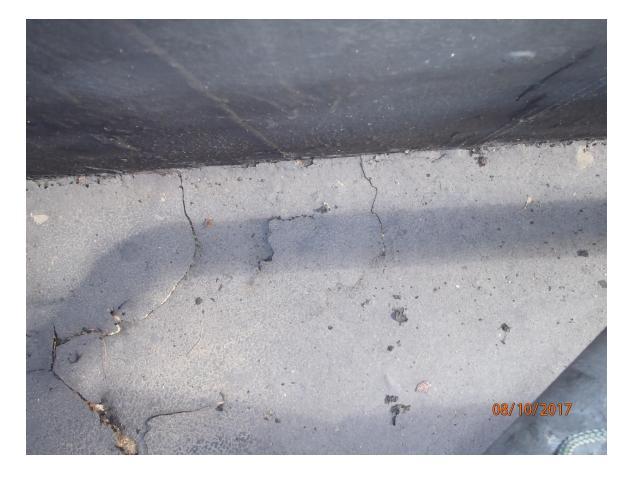
black coating/sealant cracking

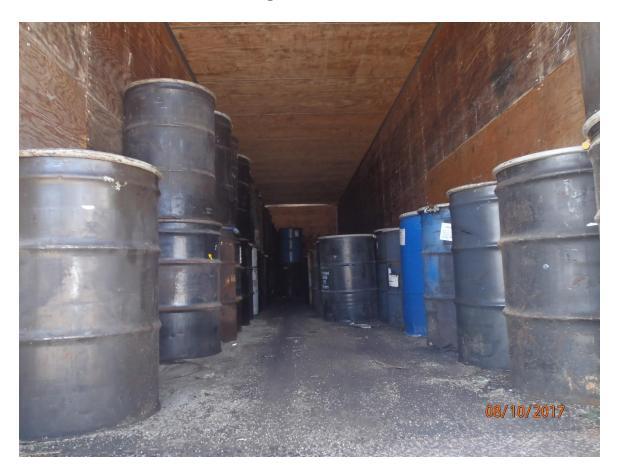
55-gallon drums of used oil filters are stored inside a 53-foot trailer parked over broken/cracked concrete surface. According to Mr. Bradley, the trailer is swapped out when full. The trailer was not inspected however it appeared that all drums were closed and labeled. What appeared to be granular absorbent covered the floor of the trailer around the drums. According to Mr. Bradley, the drums are on a wood surface situated on top of the metal base of the trailer; and that the wood floor of all used oil filter storage trailers are coated with an impervious sealant. There were no discharges or discolored areas noted beneath the trailer. A closed 55-gallon drum labeled 'new abs' was observed behind the trailer.

Used oil filter storage trailer

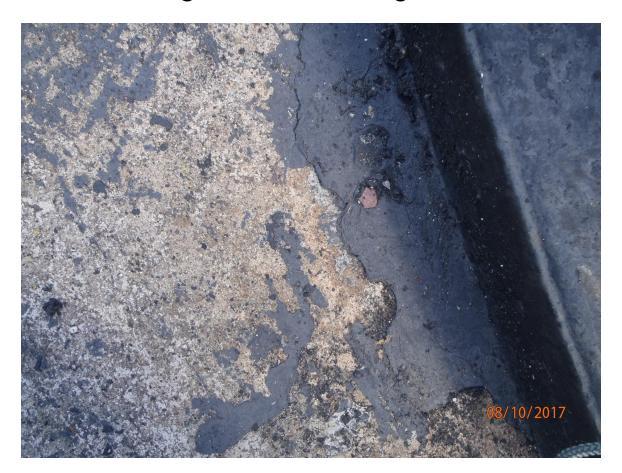
Black coating/sealant wearing off

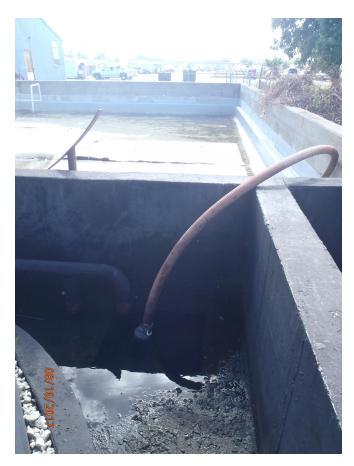
part of a larger containment unit that includes fuel tanks owned/operated by Ryan Petroleum. According to Mr. Bradley, the containment structure for the four tanks is capable of containing 110% of the largest storage tank. A sump pump is situated at the southeast corner of the containment structure. According to Mr. Bradley, rainwater that collects in the containment structure is either pumped into the PPW storage tank or vacuumed up and placed in the truck and transported to St. Petersburg. The secondary containment structure was inspected. It appeared that a black coating/sealant has worn away and cracking in areas (see photos). According to a record review, it appears the facility most recently applied an impervious sealant in the secondary containment structure 2013. Following the inspection, Mr. Bradley was provided photos of the worn away and cracking sealant in the containment structure and indicated he would review with other Howco representatives and initiate a work order to address the issue.

sump pump

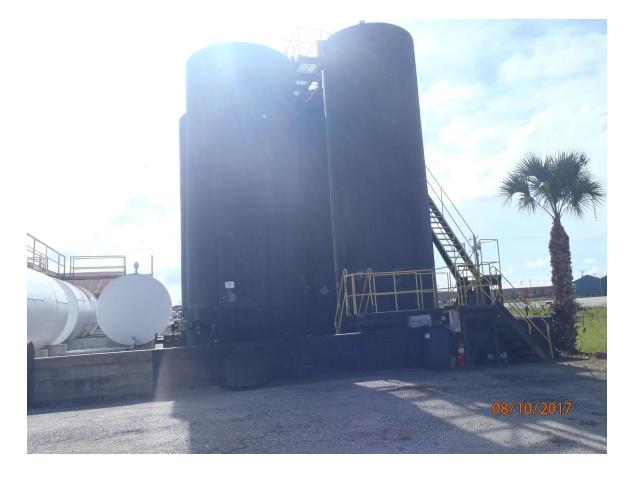
Each storage tank is a vertical aboveground, single-walled tank that is 20,000-gallons in capacity. The tanks are labeled according to the contents and numbered 1-4. Tanks 1 and 2 are labeled 'used oil'; tank 3 is labeled 'PPW' and tank 4 is labeled 'A/F' (see photos). According to Mr. Bradley, tank 3 contains petroleum, product and water (oily water), and tank 4 contains used antifreeze. It was discussed following the inspection that the tanks should be labeled with words identifying the contents. According to Mr. Bradley, waste fluids are transported weekly from this facility to the Howco St. Petersburg facility where the used oil is recycled and sold as burner fuel, used antifreeze is recycled, and oily water is separated, treated and either discharged to the city or burned. Mr. Bradley estimated that bulk loads are transported to the St. Petersburg facility anywhere from once every 10 days to three times a week depending on driver availability.

storage tanks

It is recommended to label tank 3 and tank 4 with words identifying their contents, 'petroleum product water' and 'used antifreeze'.

Please verify if the four storage tanks are equipped with a functioning tank monitoring/sensor system.

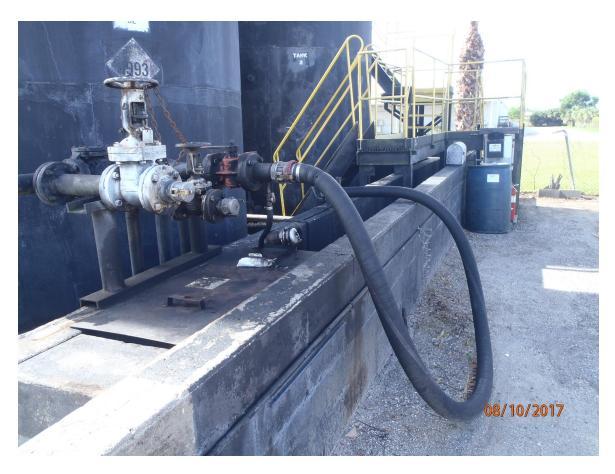
At the time of the inspection, the truck and driver were not at the facility. According to Mr. Bradley, the truck is off-loaded every day and pumped into the specified tanks. The driver offloads waste fluids by connecting a hose to a valve header which is situated within the containment structure. According to Mr. Bradley, the driver places a bucket beneath the hose to catch any drips outside the containment structure. What appeared to be staining was noted on the outside of the containment structure wall directly beneath the valve header (see photo). Beneath the valve header is a metal box to collect drips, etc. from the hoses. Drivers open the lid when loading/off-loading fuel. At the time of the inspection the lid was on the box which prevents rainwater from collecting and was not inspected. Fluids that collect in the box are removed and managed.

hose and valve header

Regarding the staining noted on the outside of the containment structure directly beneath the valve header, drivers should be cautious when loading/off-loading fluids to prevent spills from occurring.

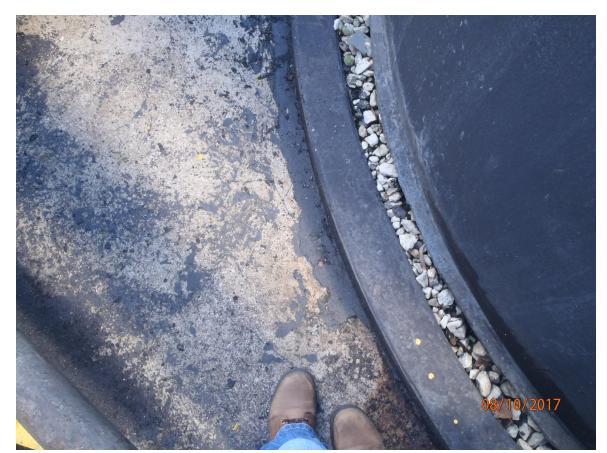
Black coating/sealant worn off in containment structure
