Florida Department of Environmental Protection Hazardous Waste Inspection Report

Facility Name: Ring Power	Corp			
<b>On-Site Inspection Start Dat</b>	e: 02/13/2019	<b>On-Site Inspection</b>	n End Date:	02/13/2019
ME ID#: 27798		EPA ID#: FLR0	00127274	
Facility Street Address:	330 Pecan Park Rd	Jacksonville, FL 322 <sup>2</sup>	18-1308	
Contact Mailing Address:	500 World Commer	ce Pkwy, St Augustine	, FL 32092-3788	
County Name: Duval		Contact Phone:	(904) 494-1417

# Ring Power Corp Inspection ReportInspection Date:02/13/2019

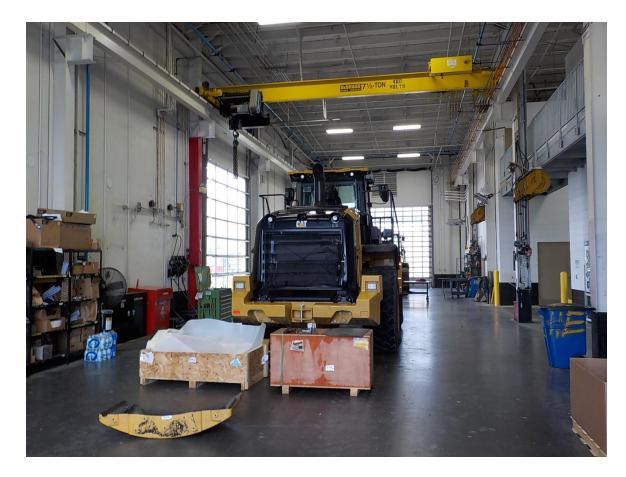
# Photo 1

Ring Power services heavy equipment, CAT rental equipment and over-road trucks in the Service Shop. There are two bays dedicated to rental fleet and customer owned heavy equipment service (Photo 1), eight bays dedicated to customer owned over-road truck service (Photo 2) and four bays dedicated to CAT rental fleet service (Photo 3). Used oil, used oil filters, used antifreeze and oily absorbents are generated by the facility's operations.

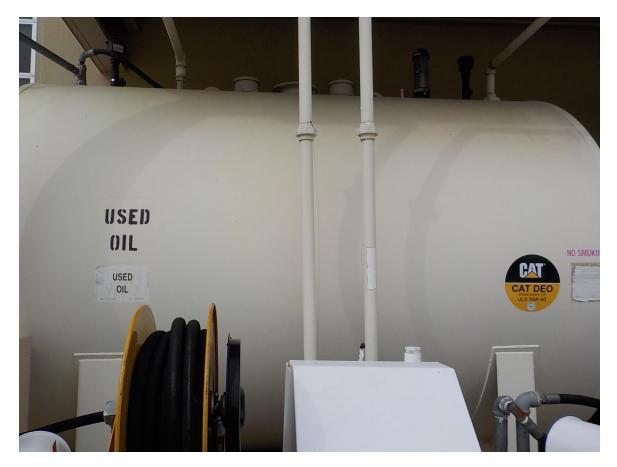
# Photo 5

Used oil is drained into portable drain containers (Photo 4) and then pumped into a 2,000-gallon doublewalled tank located outside (Photo 5). All of the used oil drain containers and the used oil tank were in good condition and properly labeled.

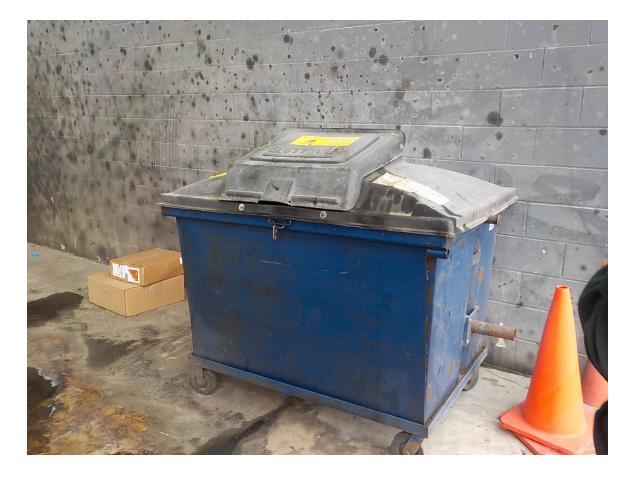
# Photo 7

Used oil filters are drained into portable drain containers before being accumulated in 30-gallon drums located in each area of the shop (Photo 6). Filters are transferred from the drums to a 330-gallon steel container located in the Wash Rack, as described below, once full (Photo 7). One 30-gallon drum of filters was labeled as "Used Filters." The facility re-labeled the drum correctly as "Used Oil Filters" during the inspection (Photo 8). Another 30-gallon drum was stored inside a cabinet labeled as "Used Oil Filters," but the drum was not labeled itself. The facility labeled the drum as "Used Oil Filters" during the inspection. All 30-gallon drums were in good condition. The 330-gallon container located in the wash rack was in good condition and properly labeled.

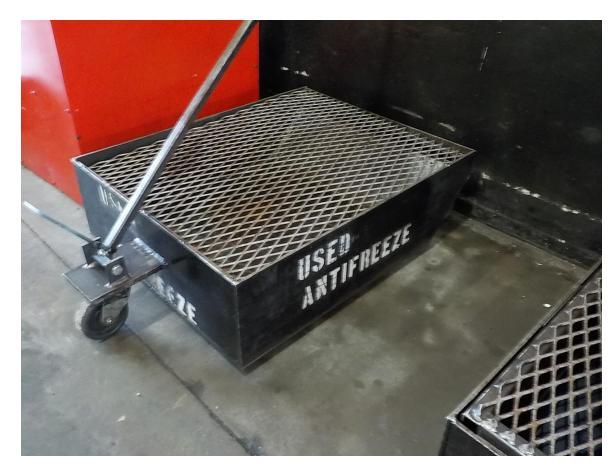
Photo 9

Used antifreeze is drained into portable drain containers (Photo 9) and then transferred into a 275-gallon tank located outside (Photo 10). All of the used antifreeze drain containers and the tank were in good condition and properly labeled.

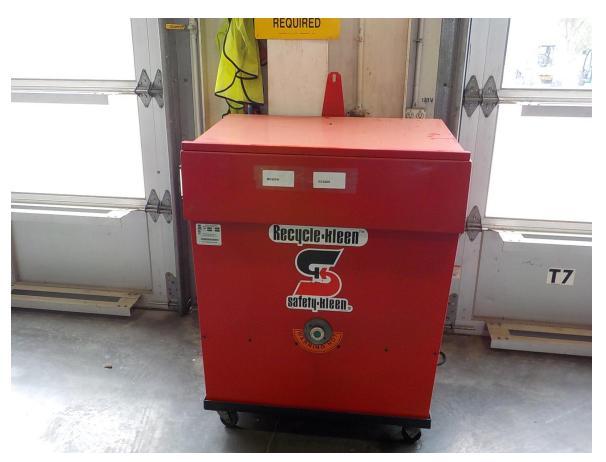
# Photo 11

The Service Shop operates four Safety-Kleen Model 250 parts washers that use Safety-Kleen Premium Solvent (hydrotreated light petroleum distillates 100%; flash point 148°F) (Photo 11). The units are on an 8-week service with Safety-Kleen, and waste solvent is managed as non-hazardous waste.

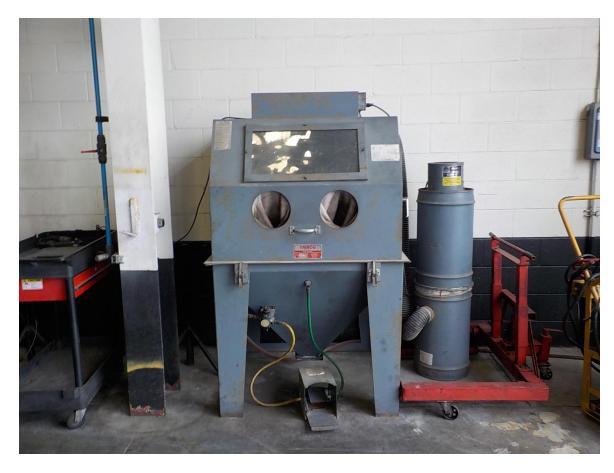
Photo 15

The facility operates one glove box bead blasting machine which is used to blast bare engine parts, and occasionally painted parts (Photo 15). The facility stated that spent blasting media was disposed of approximately two years ago by adding it to the Wash Rack soil. The facility provided Toxicity Characteristic Leaching Procedure (TCLP) analysis results for metals and volatiles which indicated the material is non-hazardous. The facility is reminded that if the process or materials used in the process change, additional analysis may be required.

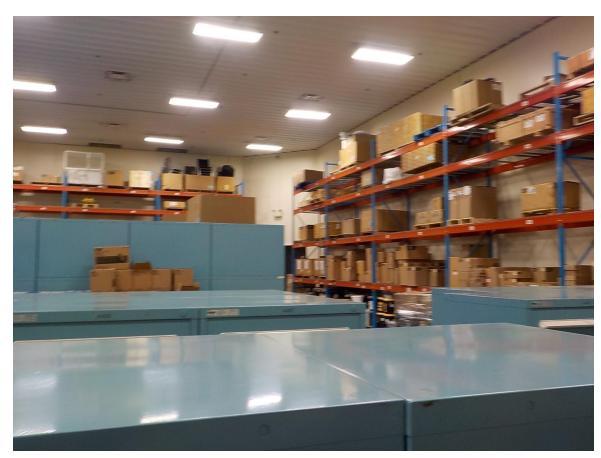
# Photo 17

There is a Parts Warehouse (Photo 17) located adjacent to the Service Shop. The Parts Warehouse stores parts, issues parts and performs work on hydraulic hoses.

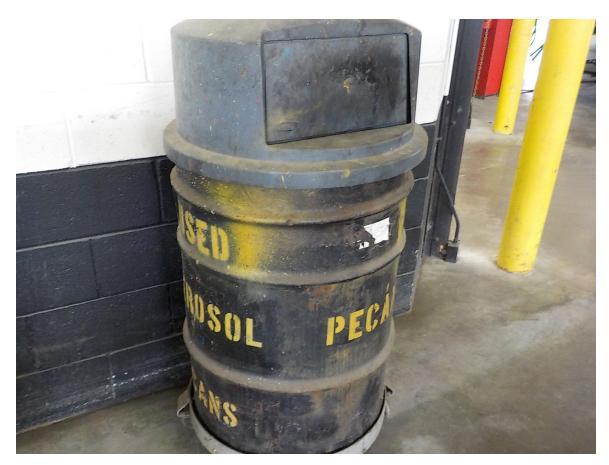
# Photo 14

turpentine oil 3-7%, 2-butoxyethanol 1-5%, 4-hydroxy-4methylpentan-2-one 1-5%, petroleum naphtha 1-5%, pine oil 1-5%; flash point 126°F), WD-40 (LVP aliphatic hydrocarbon 45-50%, petroleum base oil <35%, alphatic hydrocarbon <25%, carbon dioxide 2-3%; flash point 138°F) and Catepillar Yellow or Black Standard Performance Top Coat (flash points -20.2°F – 20.2°F) are used. Liquid generated from puncturing and draining non-empty aerosol cans of these products is D001 hazardous waste. Aerosol cans of Turtle Wax Oxy Power Out Upholstery Cleaner (water >85%, propane 1-2%, isobutane 1-2%, sodium lauroyl sarcosinate 1-5%, alkylpolyglucoside <1%; flash point not available) may also generate D001 hazardous waste liquid from non-empty aerosol cans, depending on the flash point. Non-empty aerosol cans of PB Penetrating Catalyst (Bulk) (petroleum distillates 65-85%, naphthalene 0.2-2.1%, dinonylphenol 0.5-1.5%; flash point 150°F) generate a non-hazardous liquid waste when punctured and drained. Aerosol cans are accumulated in a 55gallon drum with a swing lid (Photo 14). When a significant number of cans have accumulated, the cans are removed from the drum, absorbent pads are placed into the bottom of the drum, the cans are punctured and drained into the bottom of the drum, and the absorbent pads are disposed of with the non-hazardous oily absorbent waste. This is not ensuring proper disposal of hazardous waste [40 CFR 262.14(a)(5)]. Mr. Davis stated that a 35-gallon can puncturing system was currently on order from Safety Kleen and was scheduled to be delivered the following day.

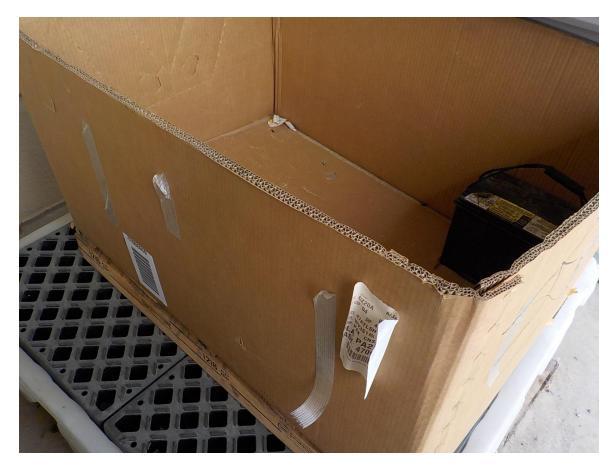
# Photo 16

Batteries are stored adjacent to the tank area outside on a spill pallet (Photo 16). Batteries are picked up for recycling by Deka Batteries when new batteries are delivered.

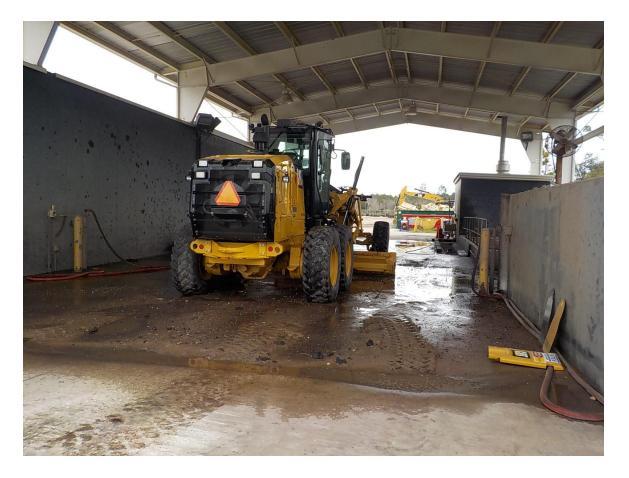
# Photo 19

The Wash Rack is a covered area used to wash equipment potentially contaminated with oil prior to service with Mean Green 9 and/or heated water (Photo 19). The Wash Rack is equipped with a rough clean area on the west side of the structure and a polishing area on the east side of the structure. The rough clean and polishing areas are separated by a change in elevation. The rough clean area is a closed-loop system where dirt/debris is washed from equipment with high pressure water. Dirt and debris is separated from water by a weir and is removed and accumulated as needed in a three-wall pit in the Wash Rack area. Equipment is cleaned with Mean Green 9 in the polishing area. Delta Foremost 615-ES Super Transpo Wash (potassium hydroxide, sodium hydroxide; pH 11.6 – 12) is also being used on a trial basis. Water drains to a trough which is pumped to a biofiltration unit that treats the water with microbes and a defoaming agent prior to discharge to the POTW. The biofiltration unit filters are pressure washed in the rough side area of the Wash Rack as needed. Sludge that accumulates in the biofiltration unit is cleaned out approximately once per year

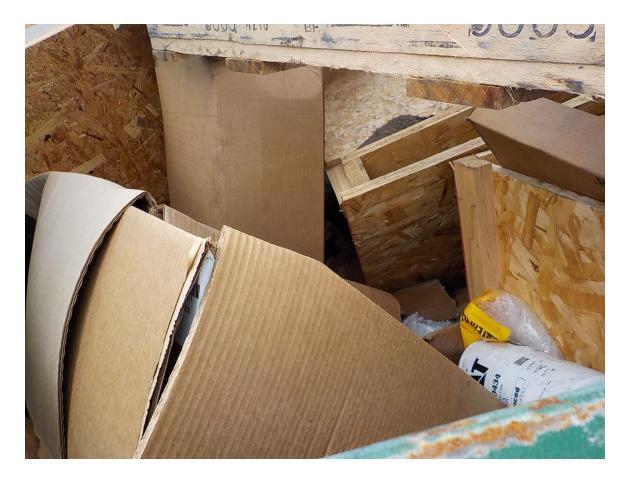
There were two solid waste dumpsters observed adjacent to the Wash Rack area. One dumpster contained solid waste and several marine used oil filters (Photo 20) [62-710.850(1), FAC]. The filters were removed from the dumpster at the time of inspection for management with the facility's used oil filter waste stream. The second dumpster appeared to only contain solid waste.

Туре:	Violation
Rule:	262.14(a)(5)
Explanation:	Spent hazardous waste liquid from aerosol cans is being managed with non-hazardous oily waste absorbent material.
Corrective Action:	No further action is required. The facility returned to compliance via two emails dated 4/24/19 that included a photo of the new drum-top aerosol can puncturing device and a statement that the device had been placed into operation and all aerosol cans would be punctured in the device and the drained liquid managed as hazardous waste.
Туре:	Violation
Rule <sup>.</sup>	00.740.050(4)
Traio.	62-710.850(1)
Explanation:	Used oil filters were observed in a solid waste dumpster at the facility.
