Re: Compliance Assistance Offer Ring Power (Lake City) EPA/DEP ID: FLD 984 206 854 Columbia County – Hazardous Waste

Hazardous Waste Inspection Report

Facility Name:Ring Power CorpOn-Site Inspection Start Date:07/15/2020ME ID#:40828EPA ID#:Facility Street Address:390 SW Ring Ct, Lake City, Florida 32025-3148Contact Mailing Address:500 World Commerce Pkwy, St Augustine, Florida 32092-3788County Name:ColumbiaContact Phone:(904) 494-1417

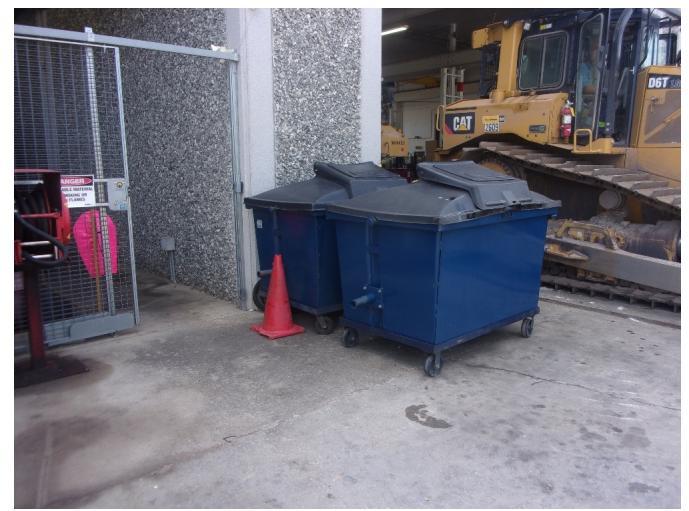
Photo 5

Used oil filters generated by Maintenance and Repair Shop operations are drained into used oil containers and then accumulated in 330-gallon steel containers. There was one 330-gallon container accumulating used oil filters in the Truck Shop area (Photo 4). The container was in good condition, closed and properly labeled as "Used Oil Filters." There were two 330-gallon containers accumulating filters just outside of the Heavy Equipment area for Heavy Equipment and Rental Shop use. Both containers were in good condition and closed. One of the two containers was properly labeled as "Used Oil Filters." The second container was labeled only as "Oil Filter Bin," but was immediately properly labeled as "Used Oil Filters." Both containers were stored on what appeared to be an unsealed concrete surface that contained large cracks (Photo 5) [62-710.850(5)(a), FAC].

Explanation: Corrective Action:	The facility failed to clean up a small release of used oil on the dirt/gravel portion of the Rental Yard in the area adjacent to the dumpster pad. No further action is required. The facility returned to compliance via an email dated September 22, 2020, indicating that the release had been cleaned up.	
Туре:	Violation	
Rule:	62-710.850(5)(a)	
Explanation:	Used oil filters were accumulating in containers located on an unsealed concrete surface that contained large cracks outside of the Heavy Equipment area of the Maintenance and Repair Shops.	
Corrective Action:	No further action is required. The facility returned to compliance via an email dated September 21, 2020, indicating that the containers had been relocated to an oil-impervious surface.

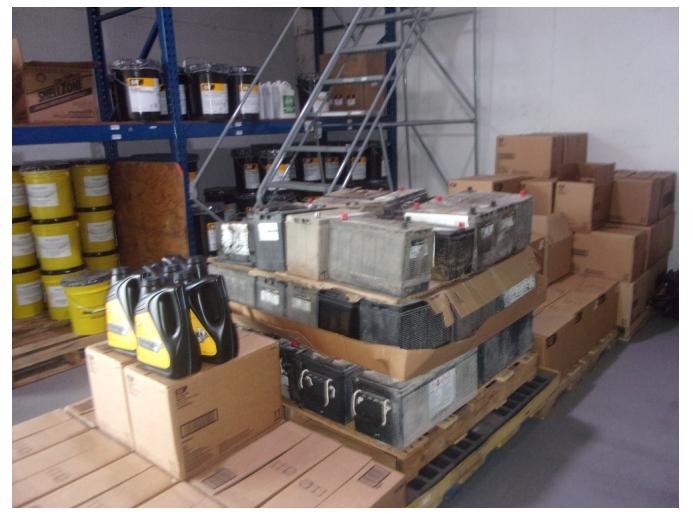
Photo 9

The Parts Warehouse contains parts, equipment and materials for shipping and receiving. Lead acid batteries generated by the Maintenance and Repair Shops are accumulated in the Parts Warehouse on a spill pallet. There was one pallet of lead acid batteries accumulating in the Parts Warehouse (Photo 9). The batteries are transported by East Penn Manufacturing, Inc. for recycling approximately once per year.

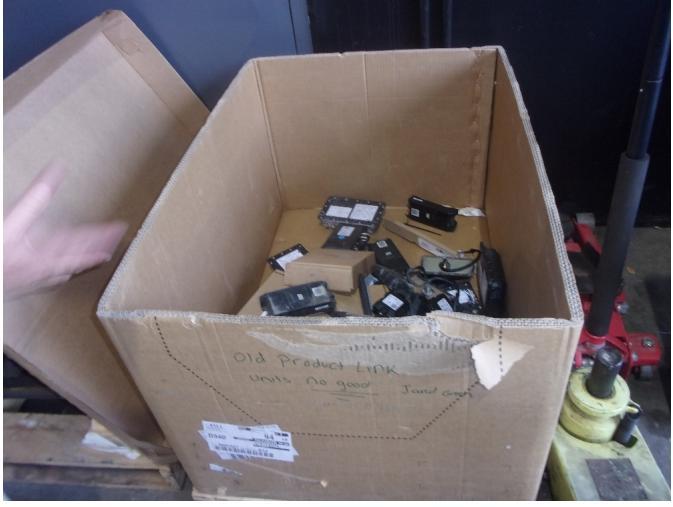
Photo 8

GPS and product link electronic units are removed from vehicles during facility maintenance operations. There was one box of these units accumulating in the Heavy Equipment area (Photo 8). The units are sent to the Ring Power Tampa facility where they are picked up for recycling.

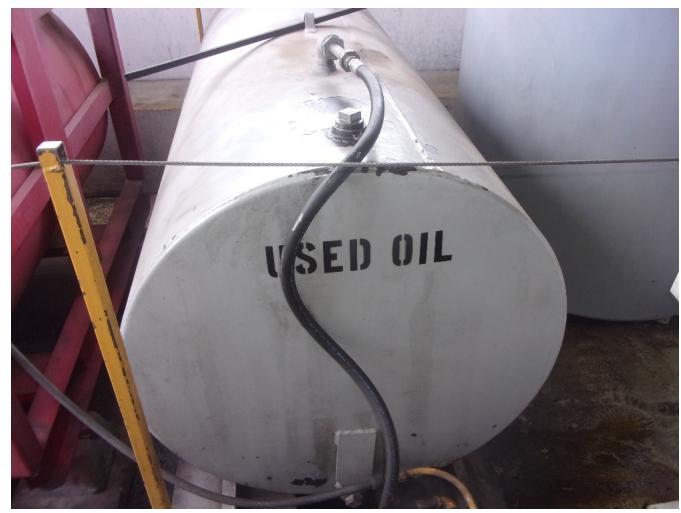
Photo 10

RPLC has one 500-gallon used oil tank located within a secondary containment structure located outside in a covered area on the northwest side of the main building (Photo 10). The tank appeared to be in good condition, was closed and properly labeled as "Used Oil." Mr. Vaughn stated that there have been no residues cleaned out from the used oil tank since at least the last inspection. There are also four additional tanks within the secondary containment structure used to store product diesel and product oil.

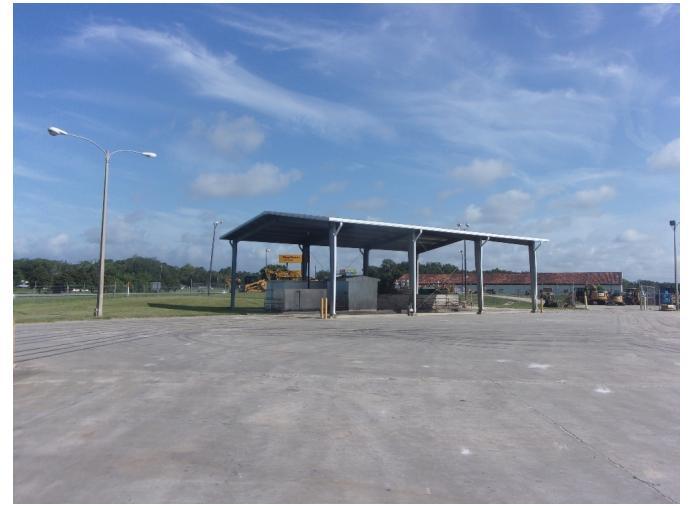
Photo 11

The Wash Rack is a covered, closed-loop system used to wash equipment or vehicles that have been potentially contaminated with oil and dirt prior to repairs (Photo 11). Mean Green 9 and heated water are used to pressure wash the equipment on a concrete pad. Wash water drains to an aerated collection pit. The collection pit contains weirs that filter particulate matter from the wash water. The accumulated dirt/debris is cleaned out of the collection pit as needed and dried in an accumulation area adjacent to the Wash Rack (Photo 12). Dirt/debris collected from the collection pit is disposed of as non-hazardous waste at Evergreen Landfill in Valdosta, Georgia. Analysis of the dirt and debris indicates that it does not contain TCLP volatile, semi-volatile, metal, or pesticide constituents above the regulatory limits. The dirt and debris were analyzed for TCLP herbicides as well, however, the method detection limit for Silvex was above the regulatory limit, so a complete hazardous waste determination was not conducted [40 CFR 262.11]. Analysis indicated that the dirt and debris did not contain the herbicide dichlorophenoxyacetic acid above the regulatory limits. Water is directed from the collection pit to an oil water separator. The skimmed oil accumulates in a sump where it is removed and added to used oil from other facility operations. The water is then pumped to a biofiltration unit that treats the water

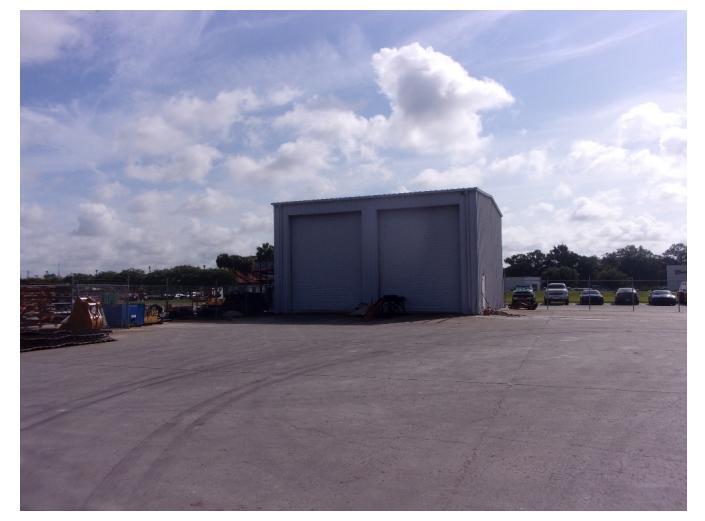
Photo 13

In the 40x40 Building (Photo 13), the facility no longer performs the new equipment tracks installation that generated paint chips. At the time of inspection, this building was being used for storage. No hazardous waste is generated in this area.

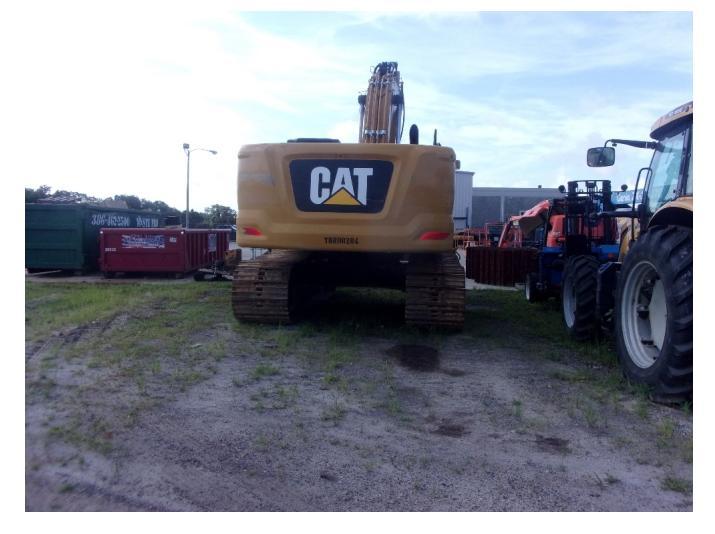
Photo 14

The Rental Yard is an outside temporary staging area for heavy equipment and vehicles. The Yard contains both paved and dirt/gravel areas. The Yard also contains one scrap metal dumpster and one standard dumpster. There was what appeared to be a small release of used oil on the dirt/gravel portion of the yard in the area adjacent to the dumpster pad that had not been cleaned up (Photo 14) [40 CFR 279.22(d)(3)].
