RE: Warning Letter No. WL22-131 (Significant Non-Complier) Ring Power Corporation EPA/DEP ID: FLR 000 119 347 St. Johns County – Hazardous Waste

Hazardous Waste Inspection Report

Facility Name:Ring Power CorpOn-Site Inspection Start Date:02/22/2022On-Site Inspection End Date:02/22/2022ME ID#:36377EPA ID#:FLR000119347Facility Street Address:500 World Commerce Pkwy , St Augustine, Florida 32092-3788Contact Mailing Address:500 World Commerce Pkwy , Saint Augustine, Florida 32092-3788County Name:St. JohnsContact Phone: Data is missing from FIESTA

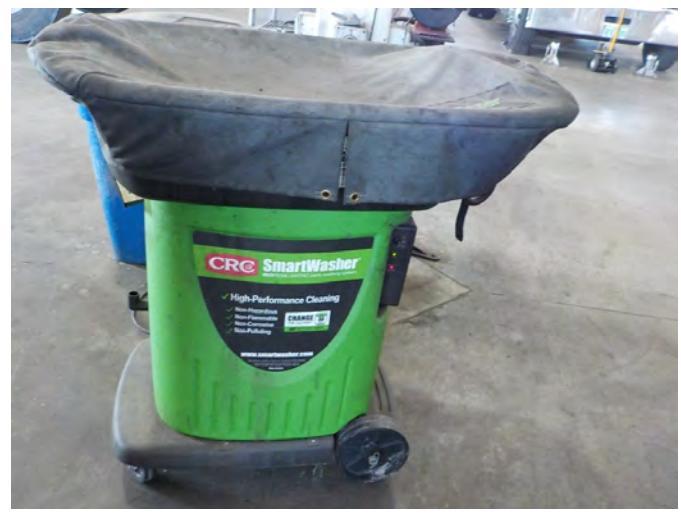
Photo 3

Since the previous inspection, the facility installed a CRC SmartWasher in the Truck Shop (Photo 3). The parts washer uses Ozzy Juice (flashpoint 148°F). Ozzy Juice is designed to be a self-cleaning solution and is therefore not typically disposed of. The facility is reminded that a hazardous waste determination should be conducted prior to disposal of the spent solvent, if ever required. Ozzy Juice parts washers are also equipped with an Ozzy Mat. The Ozzy Mat traps large particles of grease and oil cleaned off dirty parts, as well as any particulate matter. The facility representative stated that the Ozzy Mats are disposed of as non-hazardous waste determination to support this action at the time of inspection [40 CFR 262.11]. Subsequent to the inspection, the facility provided analytical data for an Ozzy Mat sample collected on March 14, 2022, which indicated that spent Ozzy Mats are a D008 hazardous waste [40 CFR 262.20(a)(1)].

/iolations	
Туре:	Violation
Rule:	262.11
Explanation: Corrective Action:	 The facility has not conducted a complete hazardous waste determination on the following wastestreams: 1. Truck Shop - Smartswasher spent Ozzy Mats 2. MCRC Engine Tear Down Area - Tank 1 sludge 3. MCRC Engine Tear Down Area - Torrent 500 parts washer spent solvent 4. MCRC Engine Tear Down Area - Torrrent 500 parts washer spent filters 5. Blasting and Painting Shop - Tape contaminated with Hempel Acrylithane 2.8 6. Blasting and Painting Shop - Paint booth filters contaminated with Hempel Acrylithane 2.8 7. Blasting and Painting Shop -Distillation bottoms generated by solvent recovery process 1. Truck Shop - Smartswasher spent Ozzy Mats No further action is required. The facility returned to compliance via an email dated May 6, 2022.
	 MCRC Engine Tear Down Area - Tank 1 sludge In order to return to compliance, the facility should perform and fully document a hazardous waste determination prior to disposal by having a representative sample of the sludge analyzed by a Florida certified laboratory for the following: TCLP for: RCRA metals, pursuant to 40 CFR 261.24, via method 6010.

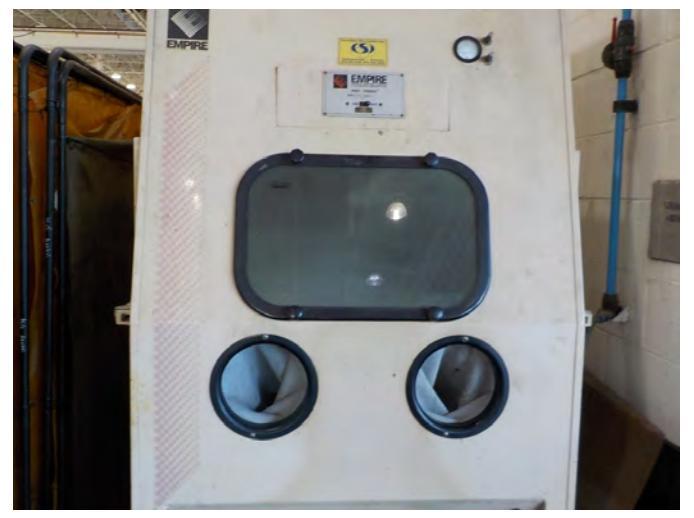
Photo 13

There is one glovebox blasting unit installed in the Track Shop (Photo 12) and one unit installed in the CAT Rental Store Shop (Photo 13). Both Ring Power and customer painted and unpainted parts are blasted in the units. Spent blasting media is added to the Wash Rack dirt/sludge, described below, for disposal at Evergreen Landfill in Valdosta, Georgia. Analysis of the Track Shop and CAT Rental Store Shop spent blasting media has

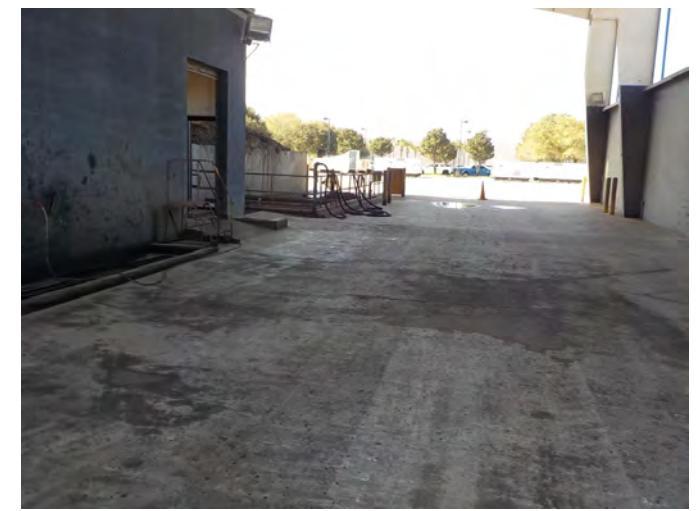
Photo 14

The Wash Rack is a covered area used to wash equipment that has been potentially contaminated with oil and dirt prior to repairs (Photo 14). The Wash Rack is equipped with a rough clean area on one side of the structure and a polishing area on the other side of the structure. The rough clean and polishing areas are separated by a change in elevation. The rough clean area is a closed-loop system where dirt/debris is washed from equipment with high pressure water. Dirt and debris are separated from water by a weir and are removed and accumulated as needed in a walled pit in the Wash Rack area. Equipment is cleaned with Mean Green 9 in the polishing area. Water drains to a trough which is pumped to a biofiltration unit that treats the water with microbes and a defoaming agent prior to discharge to the POTW. The biofiltration unit filters are pressure washed in the rough side area of the Wash Rack as needed. Analysis of the sludge has indicated that it does not contain TCLP volatile, semi-volatile, metal, pesticide or herbicide constituents above the TCLP regulatory limits. Dirt and debris collected from the rough clean area is disposed of as non-hazardous waste at Evergreen Landfill in Valdosta, Georgia. Analysis of the dirt and debris has indicated that they do not contain TCLP volatile, semi-volatile, metal, pesticide constituents above the TCLP regulatory limits.

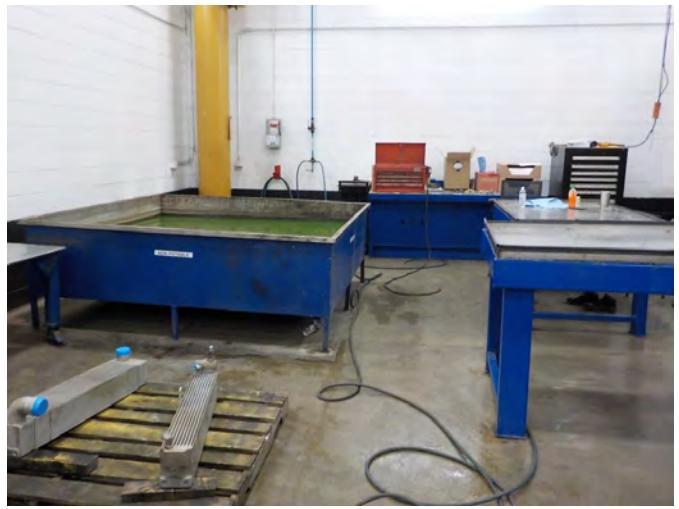
Photo 15

Radiators are pressure tested in a large tank containing Barbee #54/56 Tank Block/Powder (sodium carbonate 95%, pylakor fluorescene >5%) and water (Photo 15). Air pressure is placed on radiators placed into the tank where bubbles indicate potential leaks. When the liquid is no longer usable, it is released to the floor drain. The floor drain is piped to the Wash Rack, described above. Analysis of the spent liquid has indicated that it does not contain TCLP volatile, semi-volatile, metal, pesticide or herbicide constituents above the TCLP regulatory limits.

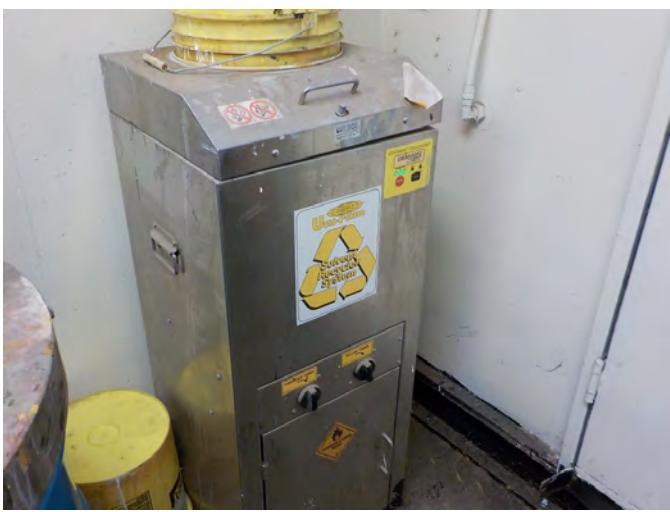
Photo 22

The facility operates one Uni-ram Solvent Recycler System (Photo 22). Approximately three gallons of liquid from the paint/thinner drum, described above, is recycled in the unit approximately 1-2 times per month for use on rags. The facility is reminded that the liquid recycled in the unit must be counted toward the facility's generator status because it is accumulated before being recycled. The recycling process generates solvent distillation bottoms that appear to be managed as D006/D007/D008 hazardous waste. Distillation bottoms, however, generate an F005 and possibly a D005 hazardous waste. Therefore, the facility has not conducted an adequate hazardous waste determination on the distillation bottoms [40 CFR 262.11]. Subsequent to the inspection, the facility provided analytical data for a sample of the distillation bottoms collected on March 14, 2022, indicating the distillation bottoms did not contain RCRA metal constituents above the regulatory levels, however the F005 code still applies.
