SUBJECT: Department of Environmental Protection v. Liquid Environmental Solutions of Florida, LLC OGC File No. 24-0068 EPA/DEP ID: FLD981928484

RE: Warning Letter No. WL23-225 (Significant Non-Complier) Liquid Environmental Solutions of Florida, LLC EPA/DEP ID: FLD981928484 Duval County – Hazardous Waste

Hazardous Waste Inspection Report

FACILITY INFORMATION:Facility Name: Liquid Environmental Solutions of Florida LLCOn-Site Inspection Start Date: 08/17/2023On-Site Inspection End Date: 08/17/2023ME ID#: 33798EPA ID#: FLD981928484Facility Street Address: 1640 Talleyrand Ave, Jacksonville, Florida 32206-5485Contact Mailing Address: 1640 Talleyrand Ave, Jacksonville, Florida 32206-5485County Name: DuvalContact Phone: (904) 438-2138

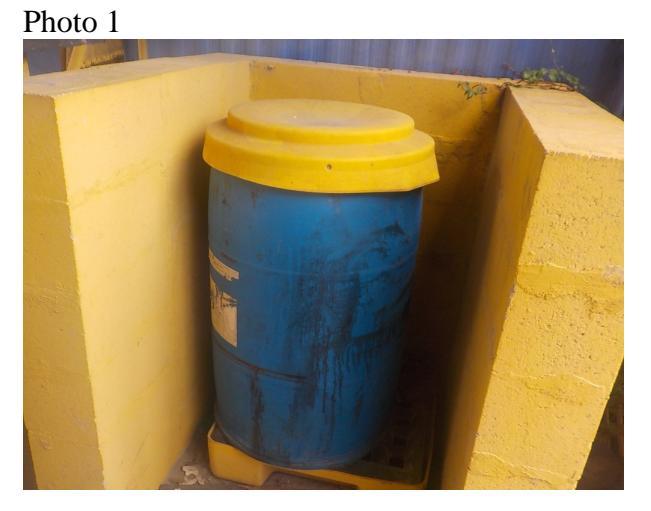
Wastewater is tested by the Receiving Laboratory prior to discharge to ensure compliance with the wastewater permit. Chemical Oxygen Demand (COD) 20-1500 mg/l test kits (mercuric sulfate 1%, water 25%, chromic acid 1%, silver sulfate 3%, sulfuric acid 90%; flashpoint listed as not applicable) are used in this process. Spent COD vials are D002/D007/D009/D011 hazardous waste. Spent COD vials are collected in a 55-gallon drum stored on a spill pallet just outside of the Receiving Laboratory (Photo 1). The drum was closed, in good condition and labeled.

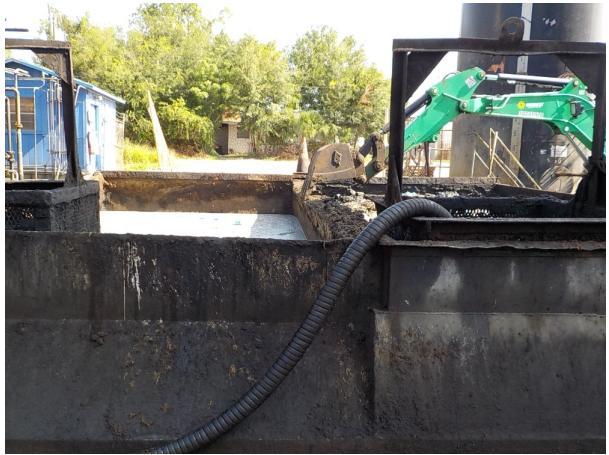
Photo 6

Two open, concrete and steel lined Tanks, 61 and 62, are dedicated for solids and sludge solidification and have a total capacity of 16,000 gallons (Photo 6). The facility solidifies materials such as non-hazardous wastewater with high solids content, and occasionally, latex paint, etc. The facility uses the waste profile, SDS and/or analytical testing to ensure that the waste is non-hazardous. The facility is reminded that it is not permitted to accept any hazardous waste. A heavy screen cage is used to physically separate the liquids from the solids in each tank. Facility staff use a large suction hose to transfer the liquid portion of wastewaters to one of the oily water tanks. Removal of liquid oily waste from the tank during the solidification process reduces the overall waste volume. Off-specification products, paints and other non-wastewaters would not be suctioned and would be solidified directly. Bails of absorbent paper dust material are used for solidification. Waste solids are placed into a roll-off container that is transported by Hull's Environmental to the Camden County, Georgia Municipal Waste Landfill approximately 10 times per month. The facility currently analyzes the waste solids

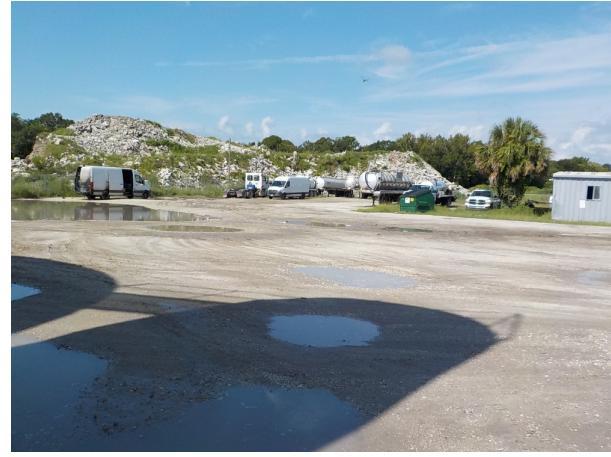
Photo 11

The Transportation Area is a large sand lot where the facility parks its tanker trucks, disconnected semi-truck trailers and tankers (Photo 11). A small building located in this area has been converted into office space and a shop for transportation activities since the previous inspection. This area is located on a separate parcel and leased from a separate party. No hazardous waste is generated in this area. Vehicles are serviced off site. There were no containers accumulating in this area.
