## HAZARDOUS WASTE INSPECTION REPORT

**FACILITY NAME:** Ring Power Corporation

**DATE:** 04/18/2007 **TIME:** 9:30 A.M.

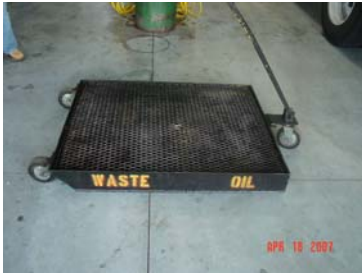
The Truck Shop services large trucks, tractor trailers and RV's. This area uses portable used oil collection pans labeled "waste oil". Used oil is drained into the pans and then taken to one of two pump stations to be pumped directly into the used oil tank located outside the facility. Unlabeled buckets are stored under the nozzles to prevent spillage of oil. Used Oil filters are drained over the portable pans or taken to a pan underneath one of the pump stations and allowed to drain for several days then placed into a labeled 55-gallon drum. The used oil in this drain pan is only pumped out when needed and does not have secondary containment. We recommended that RP drain filters over the portable containers that are pumped out daily. Two labeled 55-gallon drums of oil filters are located inside this shop area. RP utilizes the green parts washers from Safety Kleen that are part of the Continued Use Program which use Premium Gold Solvent. There are a total of 8 parts washers in the truck shop. RP uses non chlorinated brake/carb cleaner. This product is sprayed on and wiped off with rags. The rags are sent to Cintas for cleaning. The floors are cleaned daily with a floor cleaner and the dirty water is taken to the wash rack. One ¼ full aerosol can of "Fabulous Blaster" was found in the trash. We inquired about disposal of aerosol cans and Mr. Carlson explained that they should only be thrown away if empty. We discussed a couple different disposal methods for aerosol cans.

Portable used oil collection

- a) RP needs to label all used oil containers with the words "Used Oil".
- b) RP needs to ensure that the hydraulic shop used oil collection system has secondary containment or is emptied daily.
- c) RP needs to ensure that waste fluorescent lamps are stored and labeled properly.

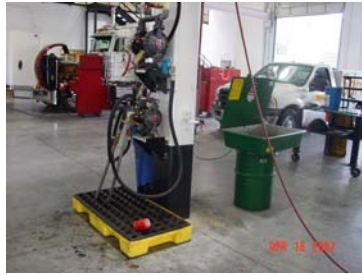
Pump station for used oil

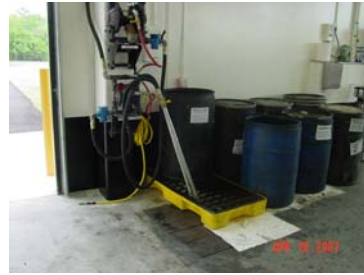
Used oil filter storage

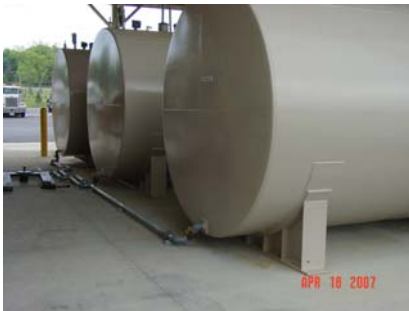
Used oil and used antifreeze are stored in one of two 15,000 gallon double walled labeled tanks. Hoses and pump stations are located within secondary containment.

Used Oil Storage Tanks

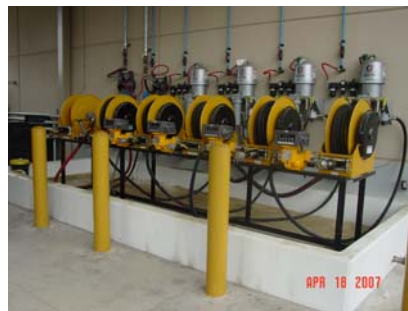
Pump Station

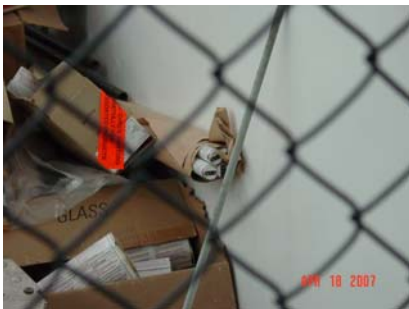
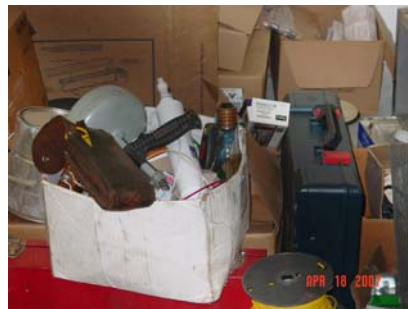
Used fluorescent lamps are stored in a separate room above the truck shop. Lamps were stored in boxes or wrapped in paper, none were labeled. We discussed the appropriate storage, labeling and recycling requirements for this waste stream.

Waste fluorescent lamp storage

A small quantity handler of universal waste must contain any lamp in containers or packages that are structurally sound, adequate to prevent breakage, and compatible with contents of lamps. Containers must remain closed and must lack evidence of leakage, spillage or damage that could cause leakage. Each lamp or container must be labeled with one of the following: "Universal Waste Lamp(s)" or "Waste Lamp(s)" or "Used Lamp(s)".

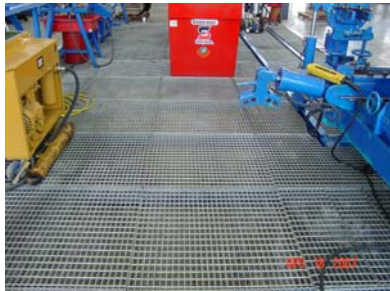
The Heavy Equipment Shop services large equipment and contains the Cat Rental Store repair shop and hydraulic shop as well. This area has 19 bays. Used oil is collected in the same manner as the Truck shop. Most used oil containers were labeled "waste oil" some newer collection containers were not labeled. The hydraulic shop contains a sealed grated, sunken concrete floor approximately 20 x 30 where hydraulic components are pulled apart and the used oil is allowed to drain into the floor. A sump

pump is located to one side but the floor does not flow to the sump. When enough oil has collected on the floor, it is then pumped out with a portable pump every couple of weeks or as needed. One parts washer was located in this area that is not part of the CUP program. This parts washer contains a recycler unit, and Mr. Carlson was not sure what happens to the sludge or if they have yet to remove any. In a phone conversation with Mr. Brimblecombe, he stated that this System 1 unit contains a distillation unit for solvent. Make-up solvent is added to the system when needed and there should be a weekly draw off of 1 pint of oily residue. This oily residue is a hazardous waste and should be collected as such. This waste stream contains silver, naphthalene and 1,2,4 Trimethylbenzene. In a follow up phone conversation, Mr. Carlson confirmed that this facility has not drained off any residue from this parts washer. He stated the machine has an automatic shut-off that shows when it is ready to be drained. Mr. Brimblecombe has ordered a drum for storage of this hazardous waste.

Hydraulic shop used oil collections system

No person may store used oil in tanks or containers unless they are clearly labeled, in good condition (no severe rusting, apparent structural defects or deterioration) with no visible oil leakage. If tanks or containers are not stored inside a structure, the contents shall be closed, covered or otherwise protected from the weather. If tanks or containers are not double-walled, they shall be stored on an oil impermeable surface such as sealed concrete or asphalt, and must have secondary containment which has the capacity to hold 110% of the volume of the largest tank or container.

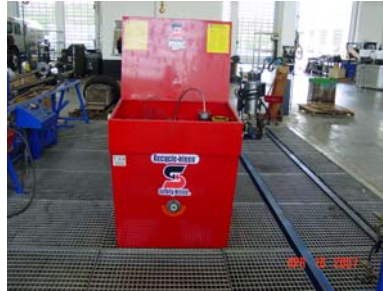
Parts washer with distillation unit

- d) RP needs to ensure waste aerosol cans are empty before placing into trash or managed appropriately per State and Federal regulations.
- e) RP needs to ensure that the System 1 parts washer/distillation units' oily waste is being managed as a hazardous waste.

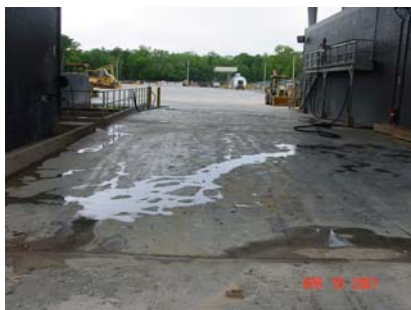
The Wash Rack is located in a separate building at the facility. This area is used to wash off all vehicles and equipment before entering the repair facility and after repair. Wash water goes into a large settling tank and then the water is run through a filter system. The sludge from the settling tank is scooped out when needed and stored in a bin located next to the settling tank. This sludge is collected by Ray City Remediation and burned. In a phone conversation with Mr. Brimblecombe he stated samples are taken when requested by Ray City; to date he is not aware of any hazardous constituents within this dirt.

Wash rack

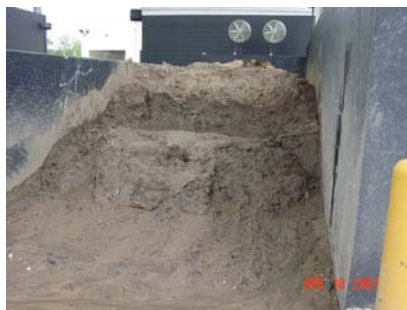
Sludge

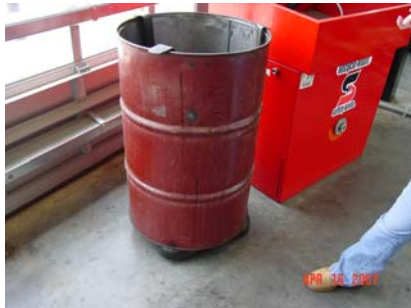
The Utility Building contains truck rebuild, fabrication and welding shop. This area collects used oil in the same manner as the rest of the facility. One unlabeled used oil collection drum was located inside the shop. This area has its own used oil and used antifreeze collection tanks. A 500 gallon, double walled, labeled used oil and used antifreeze tank is located behind the facility. Used batteries are stored under cover in an unlabeled box.

Unlabeled used oil drum

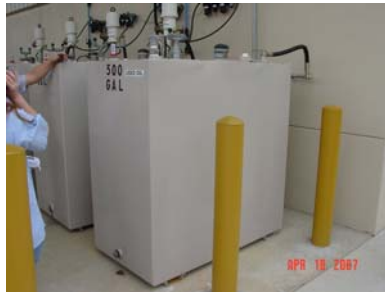
Used oil storage
