Re: Mudhill Closed Landfill
WACS ID No.: 16127
Washington County

**Florida Department of
Environmental Protection
Inspection Checklist**

Facility Name: MUDHILL LANDFILL
On-Site Inspection Start Date: 08/23/2018
On-Site Inspection End Date: 08/23/2018
WACS No.: 16127
Facility Street Address: 2.5MI SW WAUSAU, MUD HILL RD
City: CHIPLEY
County Name: WASHINGTON
Zip: 32428

Routine Long Term Care Inspection for Landfill - Class I Closed - Long Term Care

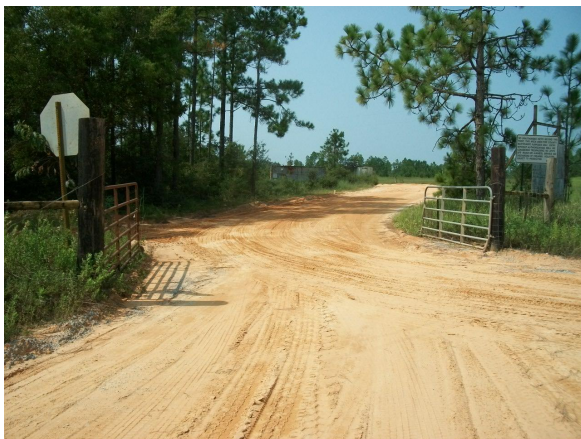
Photo 1 - taken August 23, 2018

- Photo 1 shows the lockable entrance gate.
- Photo 2 shows the settling pond for treated groundwater.
- Photo 3 shows the closed, vegetated cap.
- Photo 4 shows Recovery Well No. 3.
- Photo 5 shows Recovery Well No. 6 (out of service).
