# Florida Department of Environmental Protection

Florida Department of  
Environmental Protection  
Hazardous Waste Inspection Report

**Facility Name:** Safety - Kleen Systems Inc  
**On-Site Inspection Start Date:** 06/07/2010 **On-Site Inspection End Date:** 06/07/2010  
**ME ID#:** 20821 **EPA ID#:** FLD982133159  
**Facility Street Address:** 4426 Entrepot Blvd, Tallahassee, Florida 32310-8740  
**Contact Mailing Address:** 3003 W Breezewood Lane, Neenah, Wisconsin 54957-0368  
**County Name:** Leon **Contact Phone:** (800) 558-5011

Inspection Date: 06/07/2010

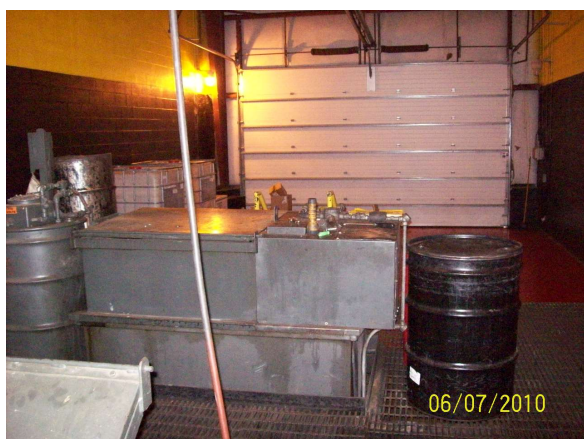
A. Return/Fill Dumpster

The area was inspected early-morning when no loading/unloading activity was underway. The loading/unloading area was well maintained and located with easy access to emergency and safety equipment installed in this area. Both the hazardous waste drain dumpster and Continued Use Program (CUP) drain dumpster lids were closed. One satellite accumulation area contained a 55-gallon drum for hazardous waste solids/sludge from the dumpster/drum washing unit and CUP drain dumpster. This drum was labeled, in good physical condition and closed. Sludge from the drum washing unit is removed at the end of every day. Several empty drums were being stored in this area for later use.

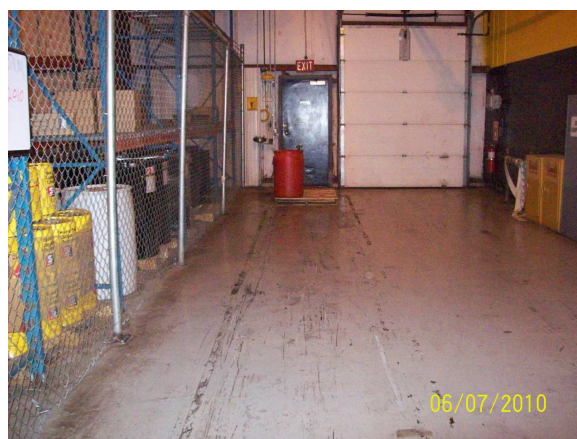
B. Transfer Area

One container of hazardous waste was located in this area. It was labeled, dated and within the 10 day time period. Records were pulled for this drum (I.D. 2489813) with no deficiencies noted. This area was well kept and organized. The stripping on the floor to indicated the physical location of the transfer area was highly worn or missing. Emergency equipment has been inspected and is easily accessible.

S-K needs to ensure that the stripping for the physical location of the Transfer Area is present and in good condition.

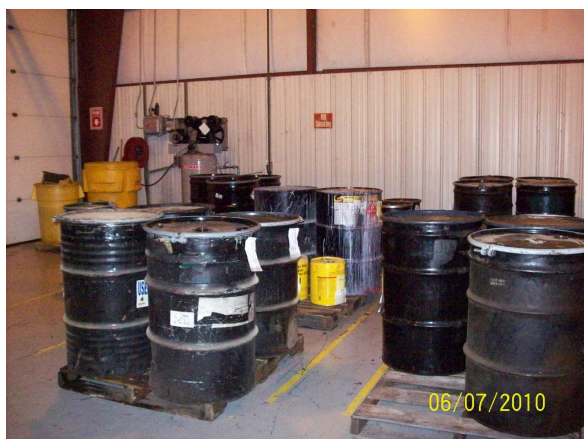
C. Storage Area

The TSD Storage Area was well organized and appropriate aisle space is maintained. A total of 28 drums/containers were in this location. Two containers with manifest number (2409896) paperwork was pulled to review, with no deficiencies noted. All containers were in good physical condition, closed, dated and labeled. Located in this area is the Universal Waste storage area. Seven boxes of waste universal fluorescent lamps and one 5-gallon bucket of waste universal batteries were labeled, dated and closed.

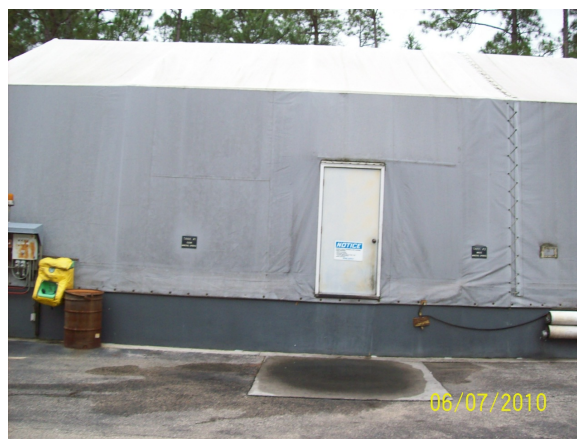
D. Tank Storage

The covered and enclosed tank storage area contains a used oil, 105° solvent and permitted hazardous waste storage tank. Outside this area are a 150° solvent tank and a used antifreeze tanks. All tanks and the load/unload pipe manifold area appeared to be in good condition and well maintained with no visible evidence of any tank leakage. The waste mineral spirits solvent management system equipage (piping, valves, flanges, pumps, etc) was color coated to distinguish it readily from the other equipage in the facility. Red piping is for dirty hazardous waste solvent, orange for 105° solvent and green piping represents 150° solvent. This coloring scheme along with the valve tagging system, allows the daily inspector of the system to track the equipage and inspect for liquid leaks.

If changes are made to this S-K process, S-K needs to ensure that the permit is updated to include those changes at the facility; including the fate of the used oil tank, used antifreeze tank and the outside non-hazardous vacuum waste tanker.
