**Florida Department of
Environmental Protection
Hazardous Waste Inspection Report**

Facility Name: Safety-Kleen Systems Inc

On-Site Inspection Start Date: 12/20/2010

Routine Inspection for TSD Facility Unit Type(s)

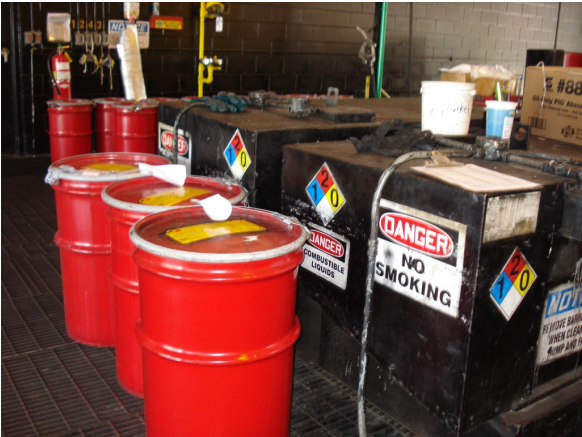
Figure 1: HW Parts washer drums

At the time of the inspection, there were three 30-gallon drums of hazardous waste parts washer containers on the dock and destined for the hazardous waste storage tank via the drum washer (Figure 1). Also on the dock, were seven 30-gallon drums and one 5-gallon container destined for the CUP tank (Figure 2).

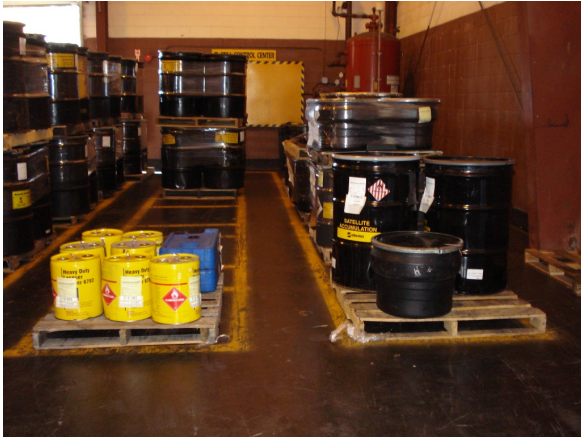
Figure 3: Transfer area

All containers were organized according to compatibility, and were stored with adequate aisle space at a maximum height of two containers. The containers were managed according to the approved "Container Management Plan", as identified in section 8.4 of the permit. The containers were marked with the date the waste entered the transfer area, labeled hazardous waste (if appropriate) and closed (Figures 3-4). The amount of waste in the storage area was under the allowable storage capacity of the facility.
