SUBJ: RCRA Compliance Evaluation Inspection
Environmental Quality Company-Florida
Tampa, Florida 33619
EPA ID. No.: FLD 981 932 494

RCRA Inspection Report

Environmental Quality Company-Florida
7202 East 8th Avenue
Tampa, Florida 33619

EPA ID. No.: FLD 981 932 494
NAICS: 562211

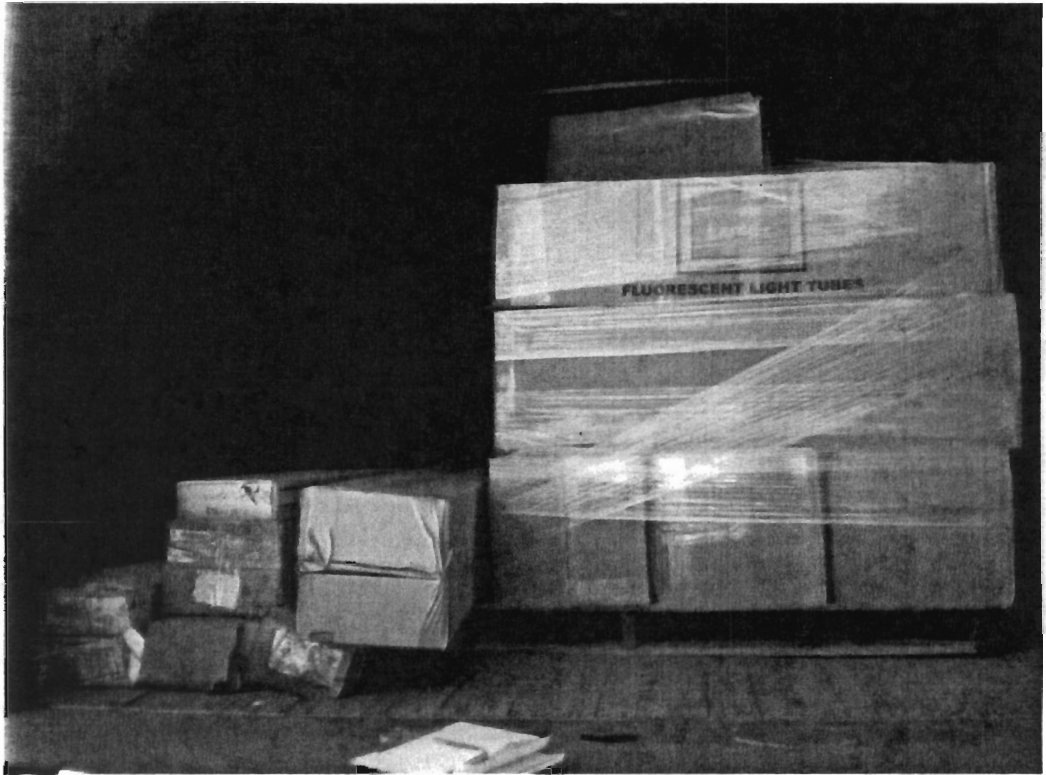
Figure 1 - Trailer storing UW lamps

EQ stores universal waste mercury lamps inside a trailer truck. The trailer is permanently parked across from the Hazardous Waste Storage Building (HWSB). At the time of the inspection, ten boxes of spent lamps that were shrink-wrapped in a pallet and seven boxes of spent lamps were being stored in the trailer. The inspection team noticed that the trailer was open, four boxes were in poor condition and one box was not properly closed (See Figure 1 &2).

Pursuant to F.A.C. 62-730.185(1) - Standards for Universal Waste Management, the Department adopts by reference 40 C.F.R. Part 273 revised as of July 1, 2008. Therefore, EQ is in apparent violation of F.A.C. 62-730.185(1) (40 C.F.R. § 273.33(d)(1)) for failing to properly containerize universal waste lamps in structurally sound containers or packages that prevent breakage and are compatible with the contents of the lamps. Such containers and packages must remain closed and must lack evidence of leakage, spillage or damage that could cause leakage under reasonably foreseeable conditions.

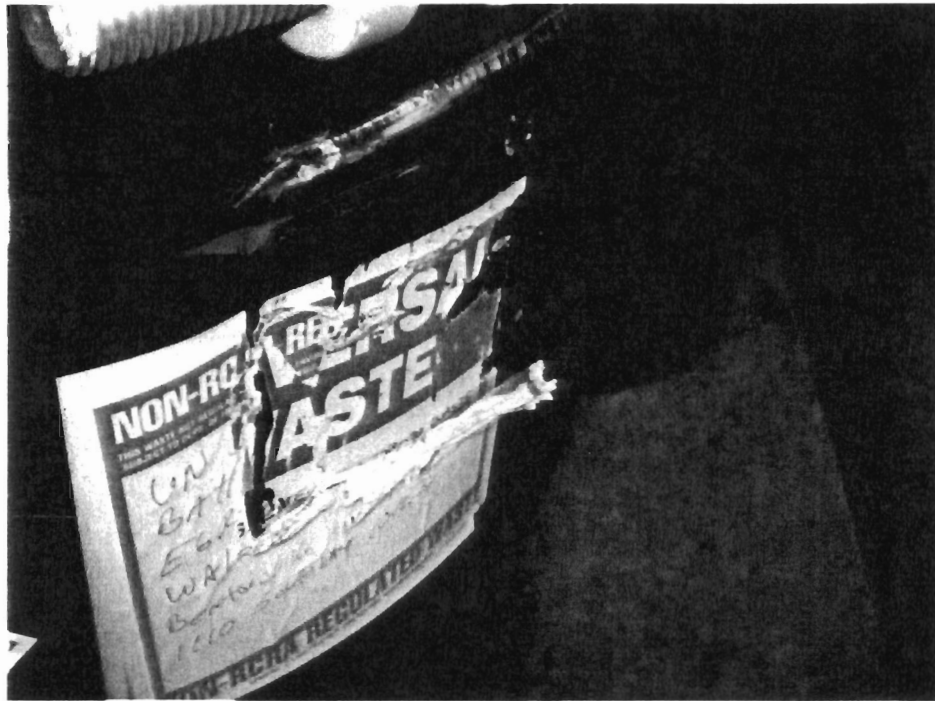
Figure 3 - UW Battery container

EQ stores universal waste mercury batteries outside of the HWSB and in front of one of the loading/unloading bays (Bay 3). The area has a sloped concrete floor and at the time of the inspection, the area was storing approximately twenty-five 55-gallon drums containing universal waste batteries. The inspection team noticed that the drums were labeled "Non-RCRA Regulated Waste." Apparently, the transporter (in this case EQ) was covering the universal waste labels after the pick-up of the drums (See Figure 3).

Pursuant to F.A.C. 62-730.185(1) - Standards for Universal Waste Management, the Department adopts by reference 40 C.F.R. Part 273 revised as of July 1, 2008. Therefore, EQ is in apparent violation of F.A.C. 62-730.185(1) (40 C.F.R. ' 273.34(a))for failure to label or mark the universal waste to identify the type of universal waste as specified below: Universal waste batteries (i.e., each battery), or a container in which the batteries are contained, must be labeled or marked clearly with any one of the following phrases: "Universal Waste - Battery(ies)", or "Waste Battery(ies)," or "Used Battery(ies)."

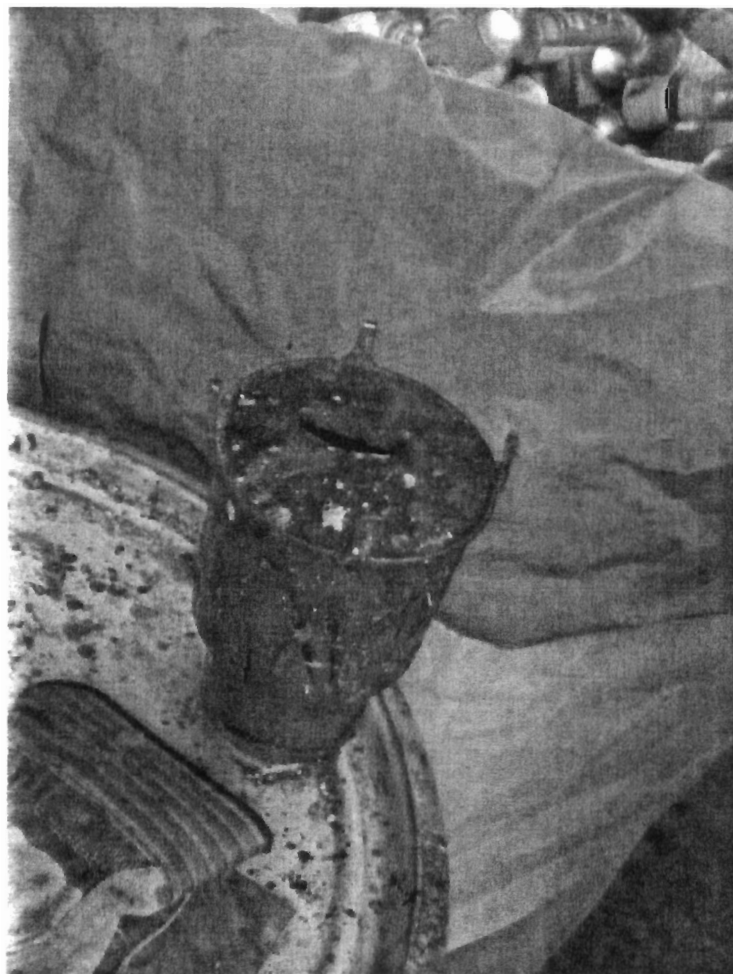
Figure 4 - Damaged air filter from one of the aerosol cans crusher

As explained before, the facility recycles used aerosol cans by processing them through a 55-gallon drum aerosol can crusher. The can crusher has a filter system which removes Volatile Organic Compounds (VOCs) that is emitted when the cans are depressurized. In accordance with 40 C.F.R. Part 264 Subpart CC defines the filter as a “control device.” During the inspection, the filter was damaged and not removing $\geq 95\%$ of VOC.

Pursuant to F.A.C. 62-730.160(1), the Department adopts by reference 40 C.F.R. Part 262 revised as of July 1, 2009, including the Appendix with the exception of 40 C.F.R. 262.34(e) and Subparts I and J. Therefore, EQ is in apparent violation of F.A.C 62-730-160(1) (40 CFR §§ 264.1080 and 264.1086(b), as referenced in 40 C.F.R. § 262.34(a)(1)(i)). This regulation requires the owner or operator shall control air pollutant emissions from each container subject to this section.

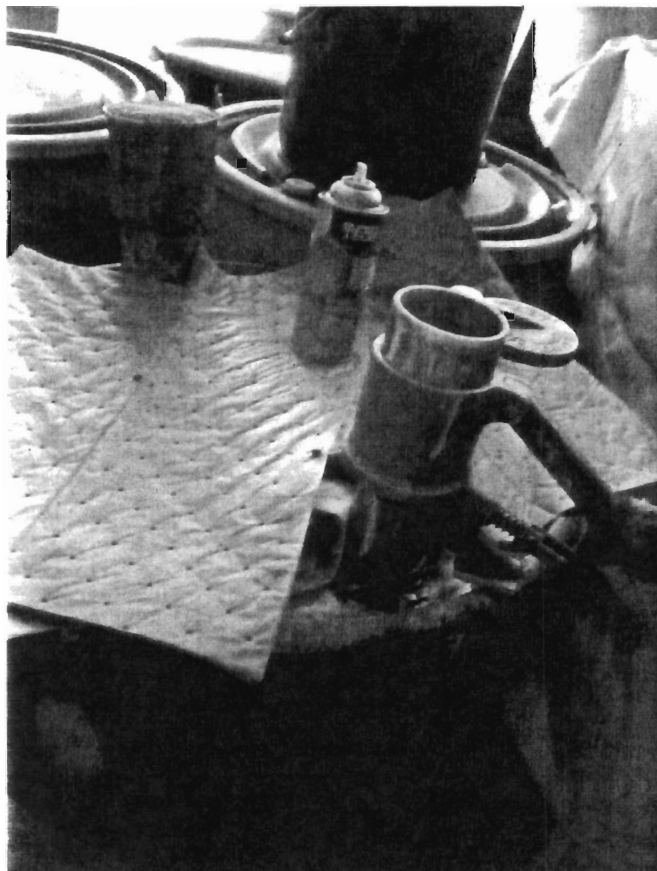
Figure 5 - Open aerosol can crushers drum

Outside of the HWSB, and in front of one of the loading/unloading bays were one paint can crusher and two 55-gallon drum aerosol can crushers. This area deals with a lot of the household hazardous waste. Personnel wearing Tyvek personal protection equipment (PPE) were operating this activity. During the inspection, personnel were sorting aerosol cans and crushing them in one of the drum crushers. The inspection team noticed that the air filter from one of aerosol can crushers was damaged (or open) and the other drum crusher was open (See Figures 4 and 5). Additionally, a cubic-yard sack that was storing aerosol cans was open and damaged in a corner of the box.

Pursuant to F.A.C. 62-730.160(1), the Department adopts by reference 40 C.F.R. Part 262 revised as of July 1, 2009, including the Appendix with the exception of 40 C.F.R. 262.34(e) and Subparts I and J. Therefore, EQ is in apparent violation of F.A.C 62-730-160(1) (40 C.F.R. § 265.173(a), as referenced in 40 C.F.R. § 262.34(a)(1)(i)). This regulation requires that containers holding hazardous waste must always be closed during storage, except when it is necessary to add or remove waste.

Pursuant to F.A.C. 62-730.160(1), the Department adopts by reference 40 C.F.R. Part 262 revised as of July 1, 2009, including the Appendix with the exception of 40 C.F.R. 262.34(e) and Subparts I and J. Therefore, EQ is in apparent violation of F.A.C 62-730-160(1) (40 C.F.R. § 265.173(b)), as referenced in 40 C.F.R. § 262.34(a)(1)(i)). This regulation requires the containers of accumulated hazardous waste must not be opened, handled or stored in a manner which may rupture the container or cause it to leak.

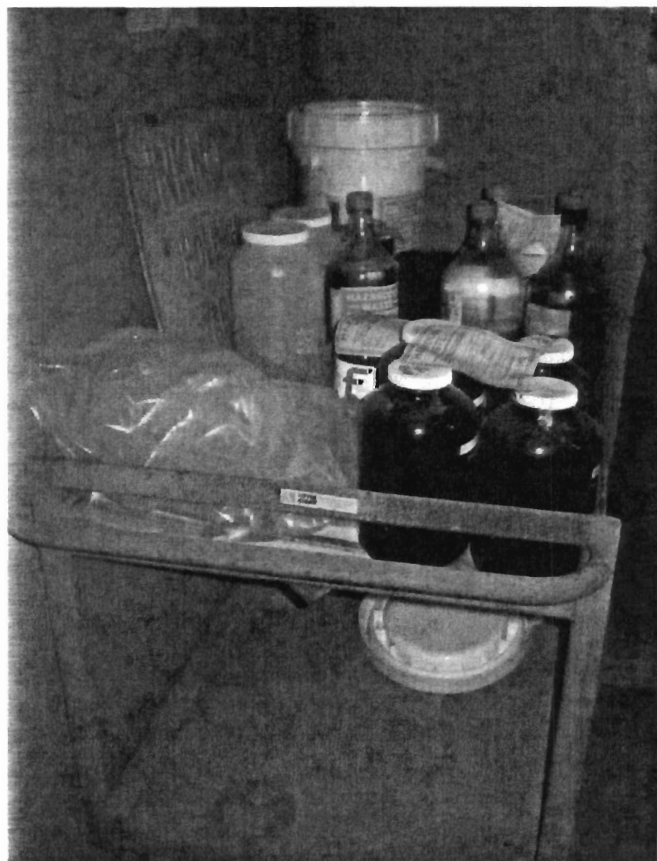
Figure 6 - Cart storing unknown hazardous waste

At the time of the inspection, the inspectors broke up into teams and inspected the three bays of hazardous waste container storage. The inspectors noticed in Bay 2, two carts storing a number of unknown hazardous waste containers (See Figure 6). The containers were dated and labeled "hazardous waste." Personnel indicated that the waste was placed on the carts because the material was declared unknown or during consolidation the material would react (bubble, smokes). The materials are left in the carts to conduct testing and determine the proper profile. The oldest waste in the cart was dated 2/11.

40 C.F.R. § 264.177(c) requires a storage container holding a hazardous waste that is incompatible with any waste or other materials stored nearby in other containers, piles, open tanks, or surface impoundments must be separated from the other materials or protected from them by means of a dike, berm, wall, or other device.

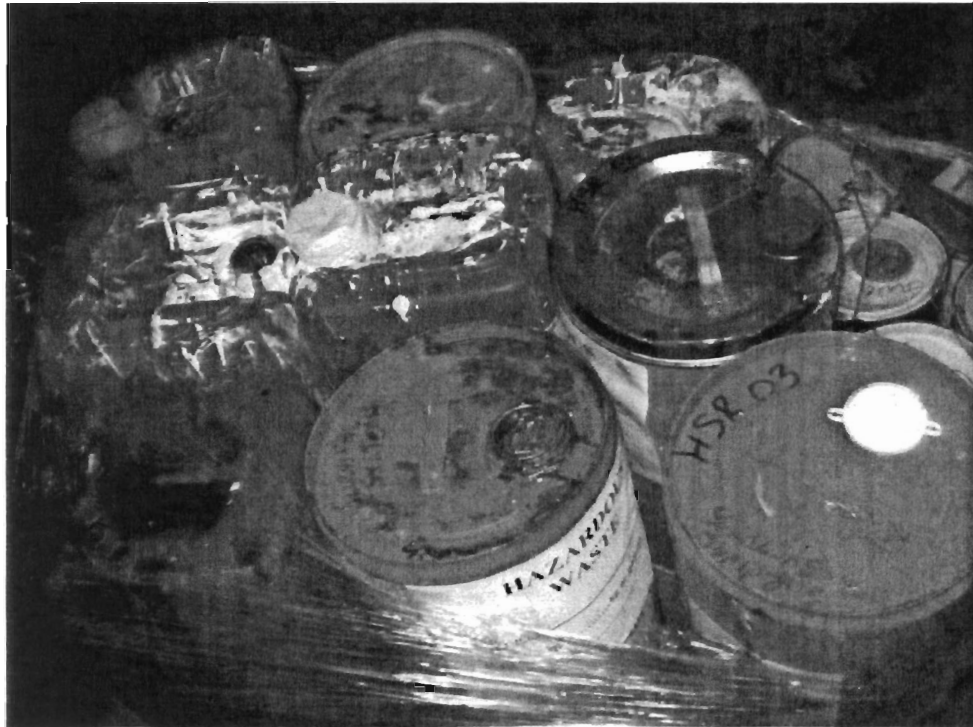
Figure 9 - Pallet of hazardous waste material with material pooled and on top of the containers

In Bay 3, the inspection team found a pallet of hazardous waste material. Some of the containers had some of the material pooled and on top of the containers (See Figure 9).

40 C.F.R. § 264.31 requires that facilities must be maintained and operated to minimize the possibility of a fire, explosion, or any unplanned sudden or non-sudden release of hazardous waste or hazardous waste constituents to air, soil, or surface water which could threaten human health or the environment.

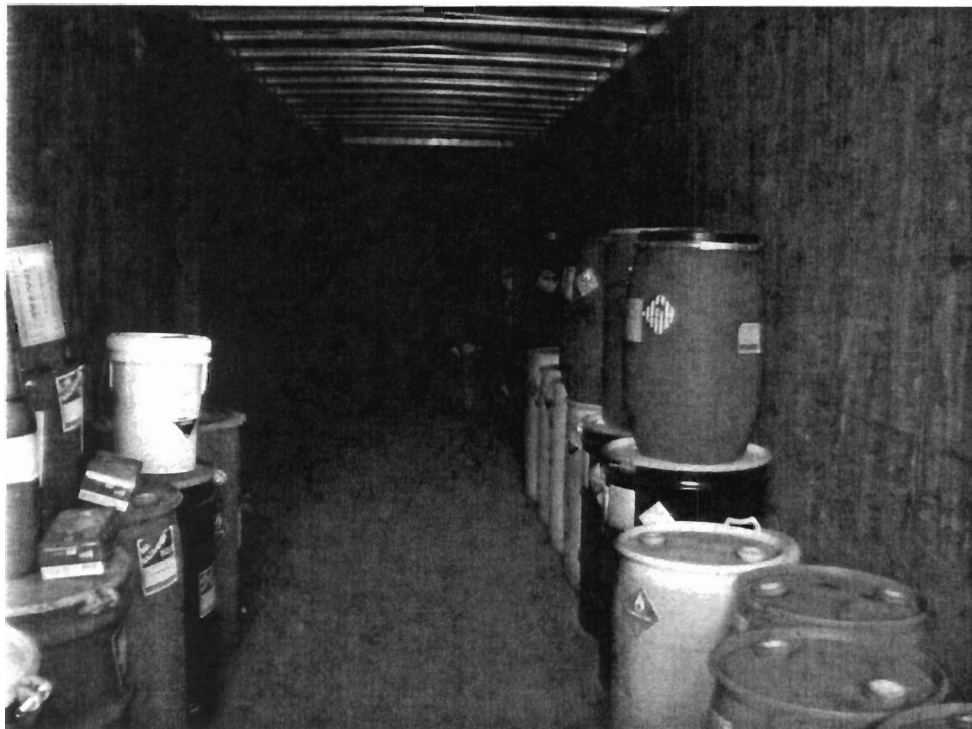
Figure 13 - Trailer storing hazardous waste containers

EQ uses two trailer trucks for temporarily storing containers that during the processing/finger printing the waste, a discrepancy or out- of- dated waste profile is discovered. The trailers have a plastic secondary containment and they appear to be permanent in this location. At the time of the inspection, the inspection team found approximately twenty- seven 55-gallon drums and sixteen 5-gallon containers (See Figure 13). Some of the containers were dated as far back as 2/11. The trailer truck storage is not part of the area permitted to store hazardous waste.

EQ is in apparent violation of 403.727(1)(c). This condition allows containers storage not to exceed 50,000 gallons at the HWSB. Storage of hazardous waste outside the permitted storage building is an apparent violation of permit condition S.C.II.1, as such in apparent violation of 40 C.F.R. Part 270.
