**Florida Department of  
Environmental Protection  
Hazardous Waste Inspection Report**

**Facility Name:** McKenzie Tank Lines Inc

**On-Site Inspection Start Date:** 09/13/2012

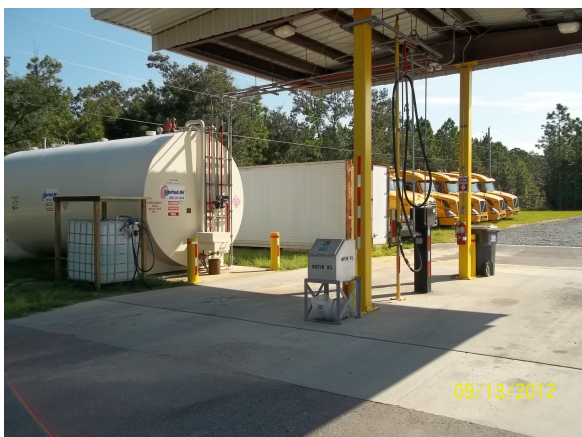
MTL has a truck re-fueling station that is registered with the Departments Storage Tanks Programs (ID # 9812547).

Fueling station

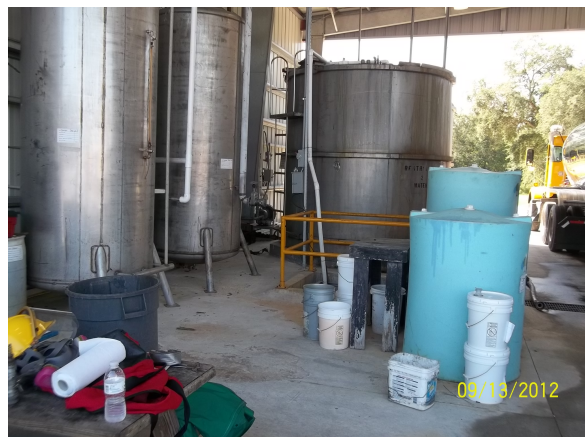
MTL has a totally enclosed wash rack system for washing the interior and exteriors of their tanker trucks. Wash water is collected in either a restricted 5,000 gallon tank or a general 5,000 gallon wastewater collection tank. The restricted tank generally collects the interior wash water. General tank collects the exterior wash water. The restricted wastewater is sent to Mobile, AL waste watertreatment plant and the general tank is sent to Pace Water (Pace, FL) for treatment. Wastewater is periodically sampled to ensure it meets water quality standards for the designated treatment plant. Wastewater is analyzed for pH, metals, nitrate, nitrite, bio & chemical oxygen demand.

MTL has a leak detection system for testing the pipes/couplings and other equipment located on the tankers. This system utilizes two scrubbers for capturing/treating any residuals remaining in the lines during testing. Mr. Johnson was unaware of the life span of the scrubber unit or what waste would be generated from this process.

Restricted wastewater tank and leak detection scrubber system

MTL was unclear when the truck leak detection system scrubbers would need to be changed or what the disposal method would be. It is the facilities responsibility to ensure hazardous waste determinations are conducted on all waste streams generated. If a hazardous waste stream is identified then proper disposal and disposal documentation is required.

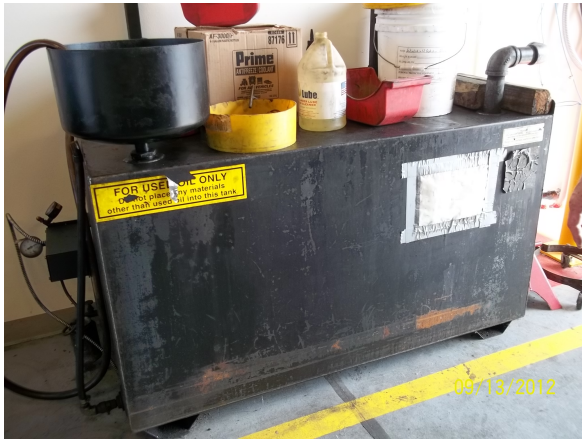
All major mechanical repair is conducted on site for MTL's fleet of trucks and other fleet vehicles. No paint and body work is performed on site. Used oil is stored in a 250-gallon tank that is not double walled and not located within secondary containment. At the time of inspection, the used oil tank was open. Used antifreeze and transmission fluid is placed into the used oil tank for disposal. Used oil filters are collected in a unlabeled container. Portable drain pans are used to collect used oil on a daily basis. MTL has two parts washers that are routinely serviced by Safety Kleen. MTL uses non-chlorinated brake cleaner. Rags are collected and sent to Cintas for laundering. Floor mop water is taken to the wash rack system for disposal. Used oil, used oil filters are transported by Safety Kleen.

Explanation: One 250-gallon used oil tank was open, and lacked secondary containment.

Used oil collection tank

Corrective Action: Facility needs to ensure that used oil is stored in accordance with the following: No person may store used oil in tanks or containers unless they are clearly labeled with the words "used oil" and are in good condition (no severe rusting, apparent structural defects or deterioration) with no visible oil leakage. If tanks or containers are not stored inside a structure, the contents shall be closed, covered or otherwise protected from the weather. If tanks or containers are not double-walled, they shall be stored on an oil-impermeable surface such as sealed concrete or asphalt, and must have secondary containment which has the capacity to hold 110% of the volume of the largest tank or container within the containment area.

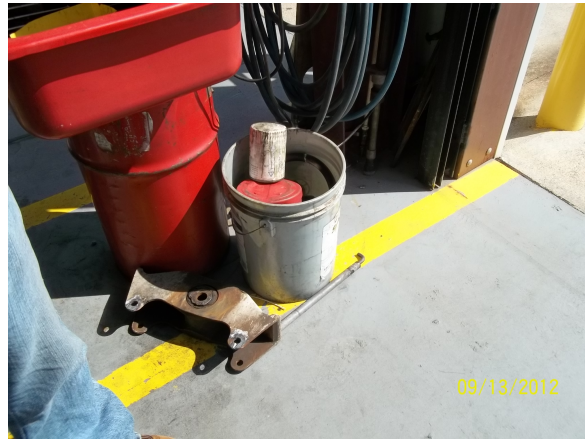
Used oil filter collection container
