**FLORIDA DEPARTMENT OF  
ENVIRONMENTAL PROTECTION**

**Re: Cliff Berry, Inc  
EPA/DEP ID: FLR 000 119 784  
Duval County – Hazardous Waste**

Florida Department of  
Environmental Protection  
Hazardous Waste Inspection Report

**Facility Name:** Cliff Berry Inc - Jacksonville Facility  
**On-Site Inspection Start Date:** 09/20/2012      **On-Site Inspection End Date:** 09/20/2012  
**ME ID#:** 42441      **EPA ID#:** FLR000119784  
**Facility Street Address:** 1518 Talleyrand Ave, Jacksonville, Florida 32206-5436  
**Contact Mailing Address:** PO Box 13079, Fort Lauderdale, Florida 33316-0100  
**County Name:** Duval      **Contact Phone:** (954) 763-3390

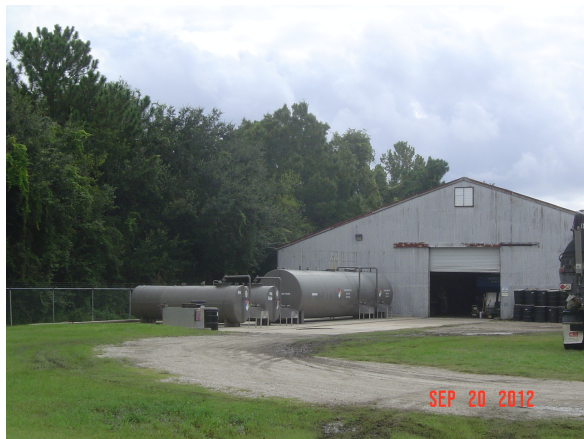
DEP. The new permit application includes an expansion of the current used oil storage area to include the installation of ten additional tanks (Photo 1). Nine would be for oily wastewater, and one would be for petroleum contact water (PCW). The facility intends to bring oily wastewater back to its facility for processing instead of taking it to a third party for processing.

Photo 1 - area for tank expansion
