Re: Cliff Berry, Inc
EPA/DEP ID: FLR 000 119 784
Duval County – Hazardous Waste

Florida Department of
Environmental Protection
Hazardous Waste Inspection Report

Facility Name: Cliff Berry Inc - Jacksonville Facility
On-Site Inspection Start Date: 04/09/2013 **On-Site Inspection End Date:** 04/09/2013
ME ID#: 42441 **EPA ID#:** FLR000119784
Facility Street Address: 1518 Talleyrand Ave, Jacksonville, Florida 32206-5436
Contact Mailing Address: PO Box 13079, Fort Lauderdale, Florida 33316-0100
County Name: Duval **Contact Phone:** (954) 763-3390

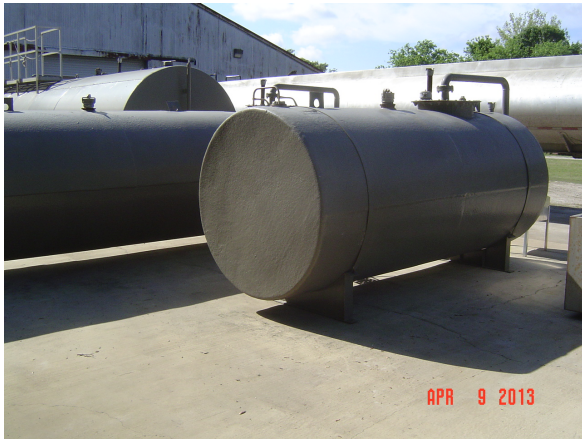
Photo 1 - used oil tanks

The facility has three double-walled used oil storage tanks including one 15,000-gallon tank with two compartments of 10,000 and 5,000-gallon capacities, one 2,000-gallon tank, and one 4,000-gallon tank (Photos 1-2). The tanks were properly labeled and appeared to be in good condition. Next to the tanks is an area for storing used oil generated from the loading and off-loading of used oil into the tanks. The facility places buckets underneath the hose fittings during off-loading, and any used oil that drips into these buckets is captured and added to a 55-gallon used oil drum. This drum was properly labeled and in secondary containment. There was also one drum of oily rags from the off-loading operations. These drums were properly labeled (Photo 3).
