FLORIDA DEPARTMENT OF ENVIRONMENTAL PROTECTION

Re: Moran Environmental Recovery
EPA/DEP ID: FLD 092 718 576
Duval County – Hazardous Waste

**Florida Department of
Environmental Protection
Hazardous Waste Inspection Report**

Facility Name: Moran Environmental Recovery LLC
On-Site Inspection Start Date: 10/16/2013 **On-Site Inspection End Date:** 10/16/2013
ME ID#: 44626 **EPA ID#:** FLD092718576
Facility Street Address: 251 Levy Rd, Atlantic Beach, Florida 32233-2613
Contact Mailing Address: 251 Levy Rd, Atlantic Beach, Florida 32233-2613
County Name: Duval **Contact Phone:** (781) 815-1100

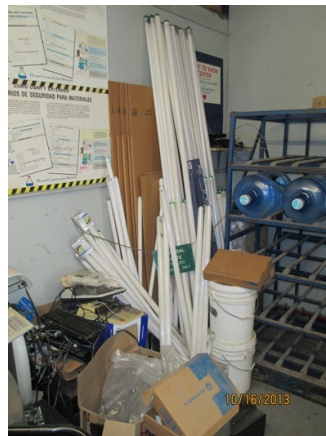
Photo 2

The facility collects E-waste and universal waste lamps in the corner of the maintenance shop. At the time of the inspection, the facility had several dozen lamps that were not in containers (Photo 2). The facility should store spent universal waste lamps in containers that are closed, secure, and labeled "universal waste lamps" [40 CFR 273.13(d) and 273.14(e)].

Explanation: The facility did not store its spent universal waste lamps in closed and secure containers.

Explanation: The facility did not store its spent universal waste lamps in containers that were properly labeled.

Corrective Action: The facility sent documentation to the Department on 12.10.13, returning to compliance.

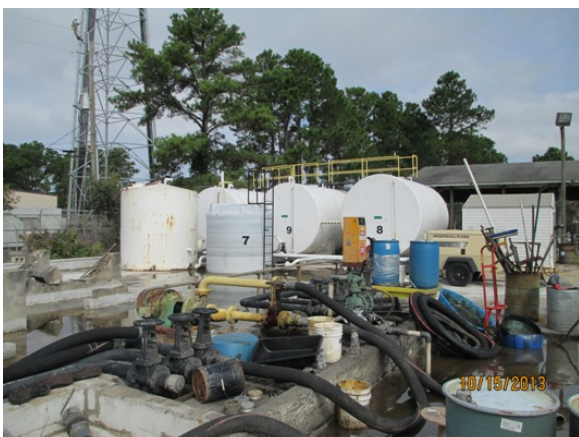
A large concrete pad located in the rear of the facility is used to park full tanker trucks and to wash them out. If MER picks up a load of oily water from a customer, and is not immediately able to transport it to Water Recovery LLC (WRI) for processing, the truck is parked on the pad and then taken to WRI the next morning. The facility also washes out the insides of their skids/tanker trucks onto the pad. This wastewater is allowed to drain into a sump, and it's either pumped directly into another tanker truck to be hauled to WRI, or it is pumped into a wastewater tank located on the pad (Photo 3).

Some parts of the pad contained cracks that appeared to have been resealed. This is an area of concern. Due to the potential for oily water to sit on this pad and potentially migrate through the cracks into the soil beneath the pad, the facility should inspect this pad on a regular basis and follow best management practices to reseat the pad and routinely check for new cracks as needed.

Photo 3 - pad sump and WW tank in rear
