**Re: Jacksonville Transflo Terminal  
EPA/DEP ID: FLD 984 253 526  
Duval County - Hazardous Waste**

Florida Department of  
Environmental Protection  
Hazardous Waste Inspection Report

**Facility Name:** Jacksonville Transflo Terminal

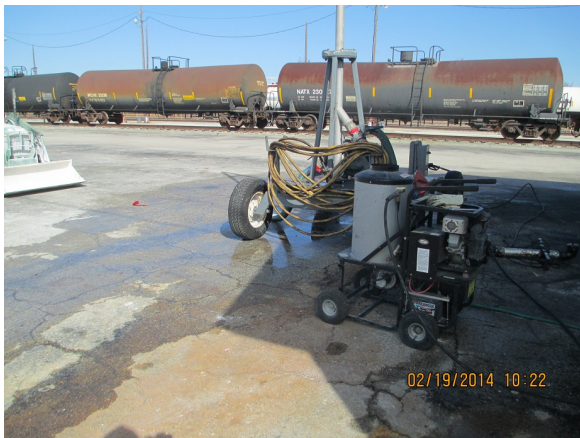
Photo 1

At the time of the inspection, an employee was using a pressure washer to clean the hose of one of the pumpers that transfers products to and from the rail cars (Photo 1). According to Mr. Maschman, the facility has a standard of operation (SOP) that should be followed when performing this type of cleaning, including setting up a tarp and several absorbent pads to collect wastewater and contaminants during washing. However, the employee was not following the facility's SOP, and industrial wastewater that may have contained used oil and/or other contaminants was draining into the facility's storm water drainage system (Photo 2). This is an Area of Concern that has been referred to the Department's Waste Water Section for further review.

Subsequent to the inspection, the facility provided documentation of further training for all employees regarding equipment washing and the facility's SOP.
