**Florida Department of
Environmental Protection
Hazardous Waste Inspection Report**

Facility Name: Florida Transformer Inc

On-Site Inspection Start Date: 12/12/2013

Routine Inspection for LQG (>1000 kg/month) facility

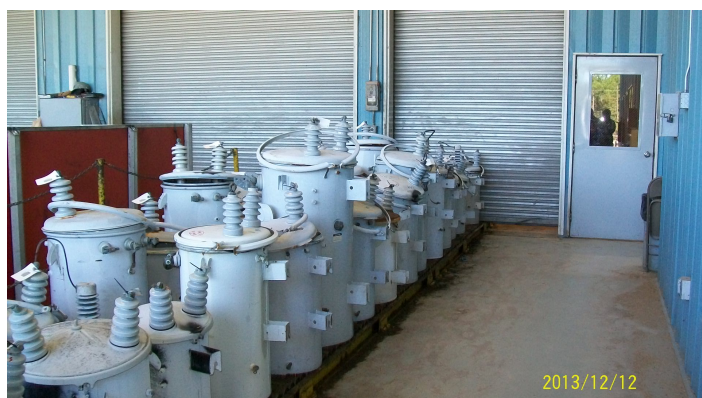
Intake Processing

The facility receives transformers from Alabama, Mississippi, Georgia, Tennessee, Florida, North Carolina, South Carolina, and Maryland. The facility uses contracted drivers to transport all out-of-state pickups. FTI only has one employed driver that conducts all in-state transformer transporting. The transformers are unloaded onto a conveyor system.

Any transformers that are shipped for disposal must be accompanied by oil analysis test documents before being received by facility. The transformers that are not designated for disposal have oil samples taken once they arrive at the facility. Each transformer has its own barcode attached to it once it enters the facility. This barcode follows the transformer throughout its processing. The transformers with PCB-contaminated oils receive a red and orange tag and the transformers with non-PCB oils receive a white tag. FTI uses in-house software to scan the transformer barcodes before weighing and emptying the them of their oil. The empty transformers are then scanned again and weighed. The empty weight is used to calculate the amount of oil removed.

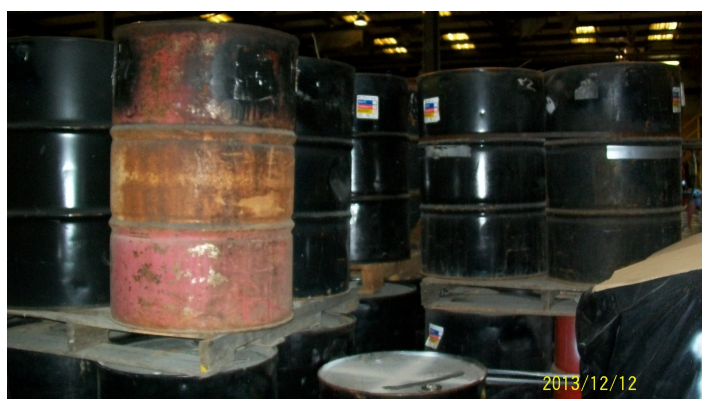
180-Day Storage

The hazardous waste storage area is located in the northeast corner of the intake processing area. At the time of this inspection, thirty-four 55-gallon drums of used mineral spirits (24 drums for recycle) and processing sludge (10 drums) were in storage. Mineral spirit waste is generated from the rinsing of the drums/transformers that contained PCB contaminated used oil and the sludge is generated from the operation of the facility used oil processing machine (Red Dragon). The mineral spirits stored in this area are distilled and then reused in the cleaning process. The mineral spirits are re-used 2-3 times before being transported for disposal by a registered transporter. The still bottoms from the mineral spirits recycling are containerized and shipped out as hazardous waste by Chem Waste. The PCB-storage area is located south of the hazardous waste storage area in the building. All containers were labeled with their contents ("Used Mineral Spirits" or "Sludge") but not

with the words "Hazardous Waste", and no storage start dates were assigned to some of the drums.

Type:	Violation
Rule:	262.34(a)(3), 262.34(a)(4), 262.34(c)(1), 262.34(c)(1)(i), 262.34(c)(1)(ii), 262.34(c)(2), 262.34(d)
Explanation:	FTI has generated in excess of 1000 kilograms of hazardous waste per month since the activation of its Red Dragon Used Oil processor. The waste by-product that is generated is a characteristically hazardous for corrosivity due to the pH range of 12-14 and hazardous for toxicity due to benzene. The facility's lab wastes generated from testing of oil samples for PCB content are hazardous for corrosivity (pH 0-2.0). FTI's paint related wastes are hazardous due to xylene, toluene, acetone, and barium content. The containers from the waste streams were not labeled with the words "Hazardous Waste" or the "accumulation start date" while in storage.
Corrective Action:	The facility needs to ensure that it notifies the Department of its change in generator status from small quantity generator to large quantity generator. The facility must also ensure that all hazardous waste is properly disposed of within the required 90-day time period. The facility also needs to ensure that all containers in storage are correctly labeled with the words "Hazardous Waste" and the "accumulation start date".

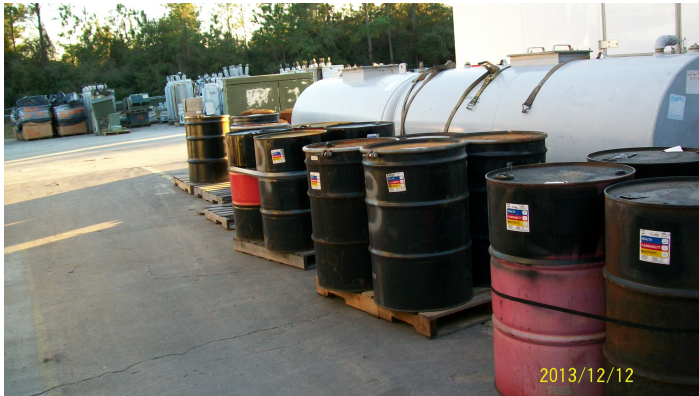
Tank Farm/Red Dragon HW Drums

The Tank Farm and Red Dragon used oil processing area is located to the south of the Intake Processing building. There are a total of 13 storage tanks located in the facility tank farm. Four of the thirteen tanks contain RCRA regulated used oils. Tank-T holds used oils that have a PCB content of 2-49 ppm. Tanks B and F contain used oils that have less than 2 ppm PCBs. Tank-C contains non-PCB used oils. All of these tanks have a capacity of 8,400-gallons. Tanks PO-1 and PO-2 are for storing processed used oils and have a capacity of 8,225-gallons and 15,000-gallons respectively. Oil in Tank PO-1 is for onsite repair purposes and oil in Tank PO-2 is for vendor purposes. Tanks T, B, F, C, and PO-1 are in a concrete secondary containment unit. Tank PO-2 is a double-walled, above-ground storage tank. FTI's Red Dragon Used Oil Processor is located to the south of the Tank Farm. The waste generated from the operation of the Red Dragon are sludges contaminated with toluene and benzene. Inspectors observed 21 drums of hazardous waste being stored outside of the Red Dragon used oil processor. 19 drums contained hazardous waste sludge, one drum contained paint-related debris, and the last drum contained contaminated media blast. The drums were not labeled with the words "Hazardous Waste", or storage date.

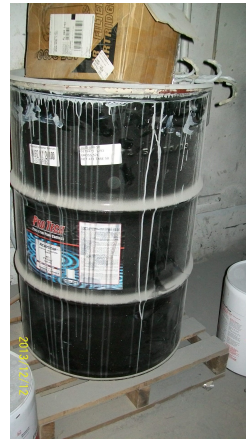
Paint Booth HW Drum

FTI has three paint booths located onsite. Two booths are internal to the building and one is external. A visual inspection of the middle paint booth was conducted. The facility paints all transformers that are being repaired/refurbished. The wastes generated in this area are paint booth filters, waste solvent and waste paint. The filters and liquids are satellite accumulated in two 55-gallon drums. At the time of the inspection, these drums were not properly labeled or closed. The facility procedure is to label the containers after the drum is full, to top off any drum with water with the filters inside and then move the drums to the 90-day storage area.
