**Florida Department of
Environmental Protection
Hazardous Waste Inspection Report**

Facility Name: Safety - Kleen Systems Inc

On-Site Inspection Start Date: 06/01/2015

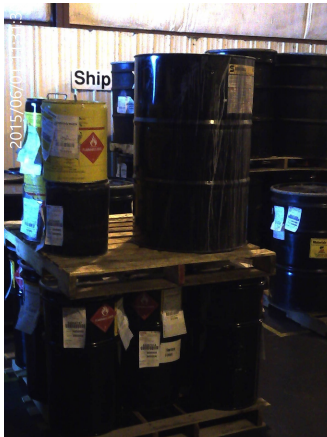
This area contained 26 containers of hazardous waste awaiting shipment. The oldest date observed was April 11, 2015. All containers were labeled dated and in good condition. Approximately 23 boxes of universal waste lamps were present in closed, labeled, and dated boxes. Oldest universal waste date observed was May 19, 2015.

HW Storage Area

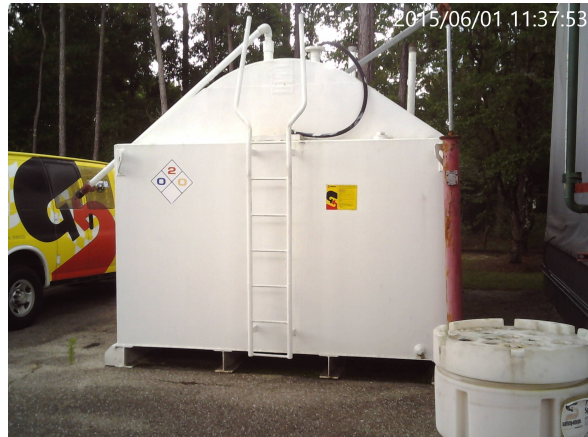
The covered and enclosed tank storage area contains a 150° solvent, used oil tank and permitted hazardous waste storage tank. Outside this area are a 150° solvent tank and a used antifreeze tank. All tanks and the load/unload pipe manifold area appeared to be in good condition. The hazardous waste solvent tank contents are transported by Safety Kleen Systems, Inc. (TXR000050930) to destination facility Safety Kleen Systems, Inc (SCD077995488) as waste combustible liquids (D001, D018, D039 & D040) approximately once a month.

Used antifreeze tank

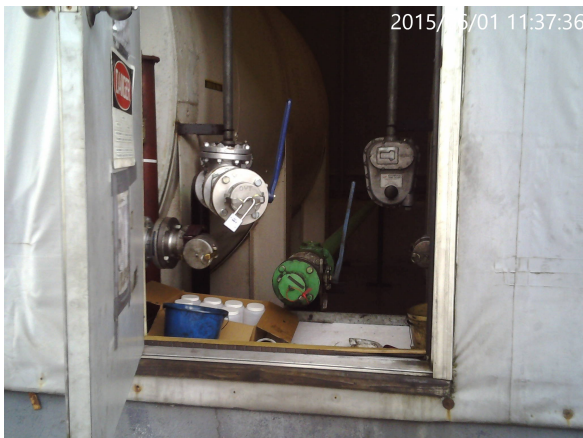
Tank loading and unloading piping

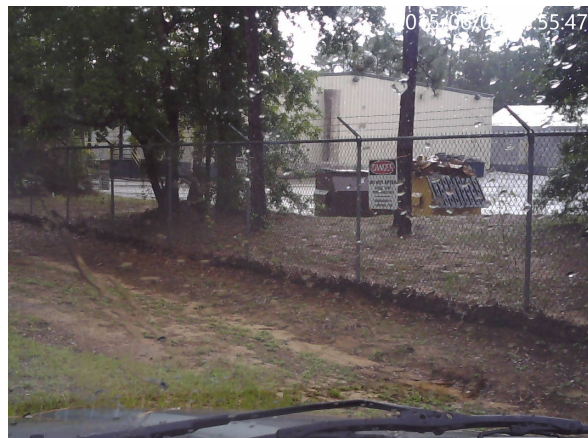
The outside storage/laydown area, driveways, vehicle parking lot, solid waste dumpsters and the perimeter fence/lawn areas were inspected with no violations noted. Signs are attached to the perimeter fencing and in good condition. At the time of inspection the used oil wastewater tank was being removed and replaced with an empty tank. Secondary containment for this tanker was closed and in good condition.

Facility grounds and signage
