**Florida Department of
Environmental Protection
Hazardous Waste Inspection Report**

Facility Name: Ring Power Corp

On-Site Inspection Start Date: 11/06/2014

Routine Inspection for CESQG (<100 kg/month) facility

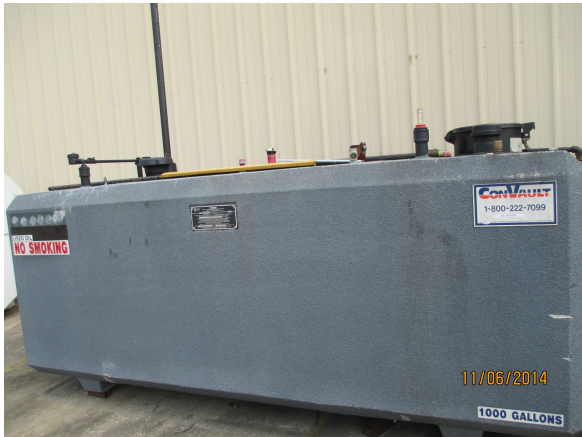
General maintenance on a variety of vehicles is performed in this area. Used oil, used oil filters, and spent antifreeze are generated from the facility's operations. Used oil is drained into portable dollies and then pumped into a 1,000 gallon double-walled tank located outside (Photo 1). All of these used oil dollies and the used oil tank were properly labeled. The facility has one 55-gallon drum to collect used oil filters. This drum was properly labeled. When used oil filter drums are full they are taken to the drum storage area located on the wash rack.

Photo 1 - used oil tank

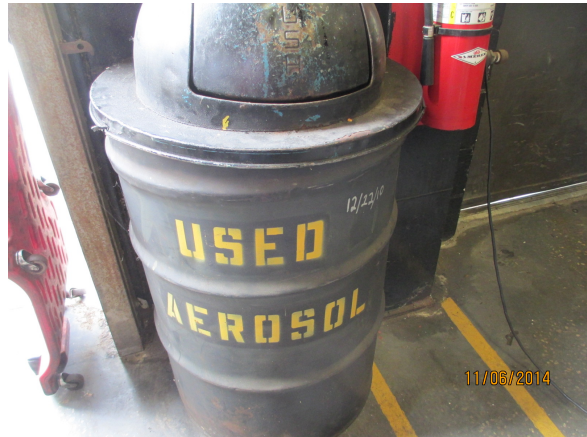
Photo 2

There was one 55-gallon drum for the collection of waste aerosols (Photo 2). Mr. Morris stated that aerosol cans are collected in this drum once they are empty. Mr. Morris also stated that the waste aerosol cans are punctured in the old used oil filter crusher because some of the cans are not completely empty. The residue is collected in the used oil filter drum. Since the waste aerosol can liquid is a D001 hazardous waste, this is not ensuring proper disposal of hazardous waste [40 CFR 261.5(g)(3)] (Photo 3).

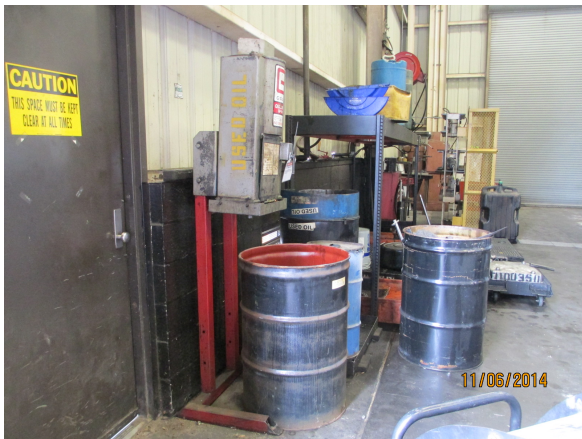
Type: Violation
Rule: 261.5(g)(3)
Explanation: The facility was puncturing aerosol cans and capturing the waste in its used oil drum. The D001 hazardous aerosol waste was not being properly disposed of.
Corrective Action: The facility sent documentation to the DEP on 11.11.14, returning to compliance. No further action is necessary.

Photo 3 - used oil filter puncture system used for aerosols

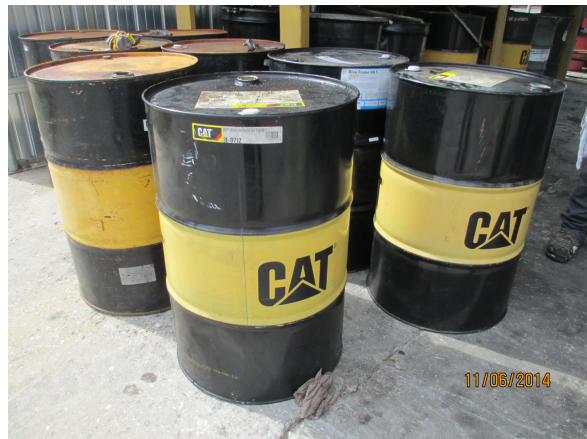
Equipment is washed down in this area with a closed-loop wash system. Sludge and dirt generated from this wash rack is disposed of as a non-hazardous waste. The facility also uses this area for storage of used oil drums that have been transported back to the facility after field technicians have serviced generators. At the time of the inspection, there were three 55-gallon drums of used oil and some empty drums (Photos 4). These used oil drums were not labeled [40 CFR 279.22(c)(1)] and were not within adequate secondary containment because they were stored at the edge of the concrete berm [Rule 62-710.401(6), FAC].

Type: Violation
Rule: 62-710.401(6)
Explanation: The facility was storing three 55-gallon drums on the edge of its containment berm.
Corrective Action: The facility sent documentation to the DEP on 11.11.14, returning to compliance. No further action is required.

Photo 4 - used oil drums on the edge of berm
