**Florida Department of
Environmental Protection
Hazardous Waste Inspection Report**

Facility Name: Marine Industrial Services Inc

On-Site Inspection Start Date: 02/23/2016

Routine Inspection for Used Oil Transporter facility

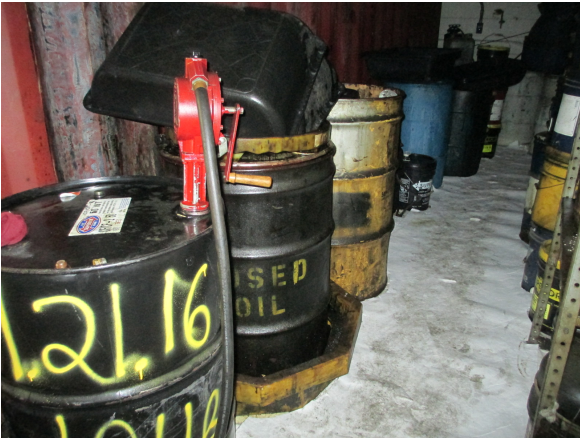
There was one 55-gallon drum for used oil filters and one drum for used oil generated from the facility's maintenance operations. All of these drums were properly labeled. While the drums were located inside the shop, the building was not completely sealed in a way that would contain used oil. The facility's used oil drum should have secondary containment [62-710.401(6), FAC]. Per a May 5, 2016, e-mail, the facility's used oil container is within secondary containment. The facility also had several 5-gallon buckets used to accumulate used oil from the shop. At the time of the inspection, all of these containers were empty. The facility is reminded that all used oil containers, including drip pans, buckets, and other transfer containers, should be labeled with the words "Used Oil" when they contain used oil.

Type:	Violation
Rule:	62-710.401(6)
Explanation:	One 55-gallon drum of used oil did not have adequate secondary containment.
Corrective Action:	No further action is required. In a May 5, 2016, e-mail, the facility provided documentation that it's used oil container is within secondary containment.

Used oil with inadequate secondary containment
