Re: Safety-Kleen Systems, Inc.
EPA/DEP ID: FLD 980 847 214
Clay County – Hazardous Waste

**Florida Department of
Environmental Protection
Hazardous Waste Inspection Report**

Facility Name: Safety-Kleen Systems Inc

On-Site Inspection Start Date: 06/07/2016

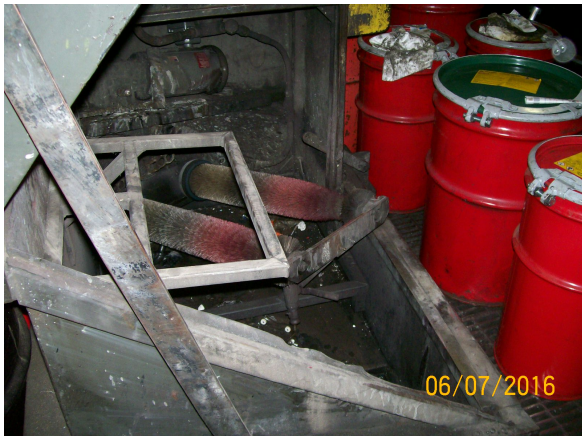
Drums containing hazardous waste or non-hazardous waste spent petroleum distillates are poured into one of two automatic drum washers (Photo 1). The liquid is directed to a permitted 15,000-gallon aboveground storage tank. The spent solvent is manifested as D001/D018/D039/D040 hazardous waste approximately every two weeks for reclamation at Safety-Kleen in Lexington, South Carolina (SCD 077 995 488). Sludge is removed from the hazardous waste tanks, as needed, and characterized approximately every three years. Solids and wipes from drum washing are placed into a closed and labeled 55-gallon satellite drum (Photo 2). This satellite drum is used to accumulate "branch waste." Branch waste is a mixed solid and liquid waste stream used for wipes, absorbents, PPE, sludge, and similar items generated by Safety-Kleen in the course of managing, packaging, and bulking hazardous waste. This waste stream is disposed of as D001/D004/D005/D006/D007/D008/D009/D010/D011/D018/D019/D021/D022/D023/D024/D025/D026/D027/D028/D029/D030/D032/D033/D034/D035/D036/D037/D038/D039/D040/D041/D042/D043/F002/F003/F005 hazardous waste.

Photo 1. Drum washer

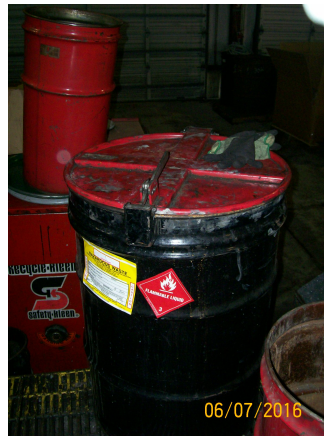
Across from the loading dock was one closed and labeled satellite container for branch waste. Nearby, there was a closed and labeled satellite container for spent aerosols accumulating in a separate area.

Photo 2. Satellite drum for "Branch Waste"

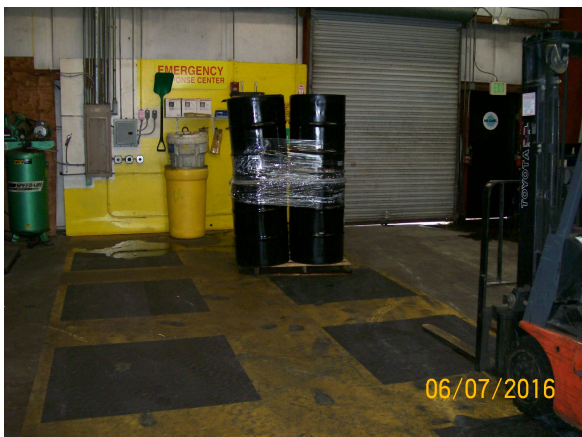
The Receiving Dock includes one 10-day Transfer Area and it is described above. Across from the Warehouse Container Storage Area is a second 10-day Transfer Area (Photo 3) at the loading dock. Both 10-day Transfer Areas are marked by yellow paint and signage. Both had appropriate safety equipment, decontamination equipment, and spill kits. At the time of the inspection, no hazardous waste was being stored in the second 10-day Transfer Area across from the Warehouse Container Storage Area.

Photo 3. 10-day transfer area

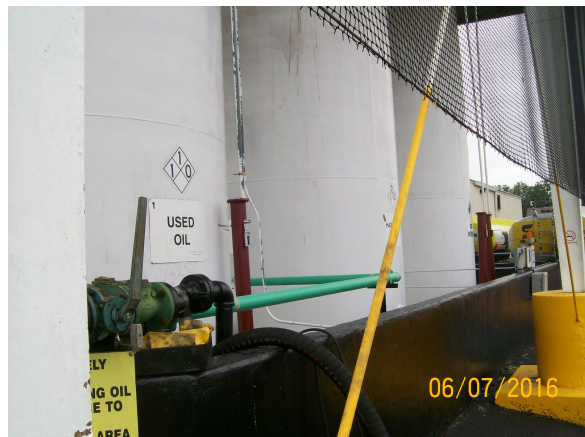
The Tank Farm contains three above-ground storage tanks; one permitted 15,000-gallon hazardous waste storage tank, one 15,000-gallon used antifreeze tank, and one empty 15,000-gallon tank labeled for used oil (Photo 4). The hazardous waste tank is used to store D001/D018/D039/D040 spent parts washer solvent/mineral spirits and it was labeled, "Hazardous Waste." The tank system, including associated ancillary equipment and secondary containment, appeared to be in good condition.

Photo 4. Tank farm w/ permitted hazardous waste tank
