Re: Flagler Construction Equipment
EPA/DEP ID: FLR 000 213 686
Columbia County – Hazardous Waste

**Florida Department of
Environmental Protection
Hazardous Waste Inspection Report**

Facility Name: Flagler Construction Equipment

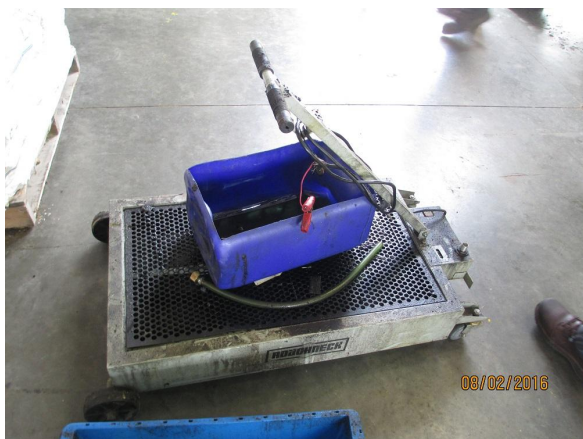
Photo 1

Used oil, used oil filters, and spent antifreeze are generated in the shop bays. Used oil and spent antifreeze is accumulated separately in one 10-gallon mobile container or two plastic containers. Used oil filters are drained on the 10-gallon mobile container (Photo 1). All three accumulating containers were not labeled with the words "Used Oil" (Photo 2) [40 CFR 279.22(c)(1)]. The facility labeled the containers during the inspection.

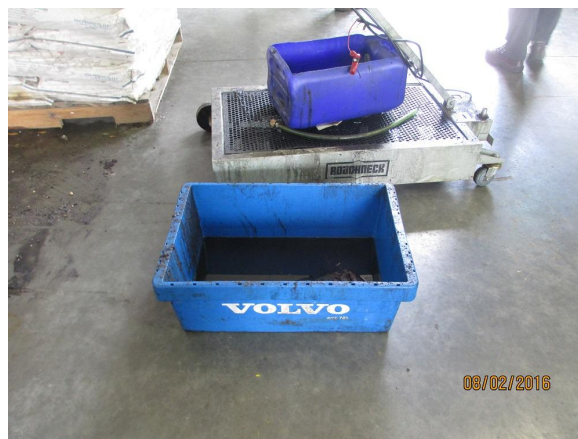
Photo 2

Explanation: Three used oil containers were not labeled with the words "Used Oil."

Corrective Action: No further action is required. The facility is in compliance per a August 19, 2016 email.

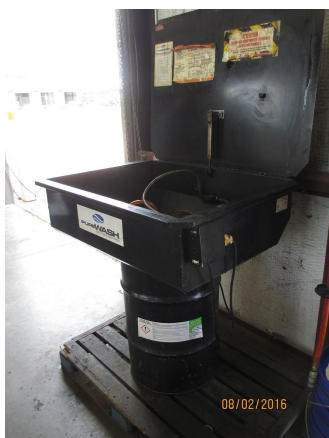
Photo 3

The service bays share one 30-gallon (pureWASH systems) parts washer that is serviced by Heritage Crystal Clean on a continued use program, every eight weeks (Photo 3).

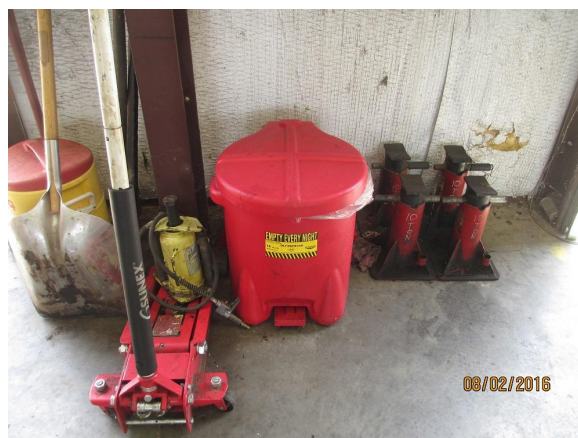
Photo 4

Shop rags from the service areas are accumulated in one 5-gallon container that was closed, but not labeled "Excluded Solvent Contaminated Wipes" (Photo 4). The facility labeled the container during the inspection.

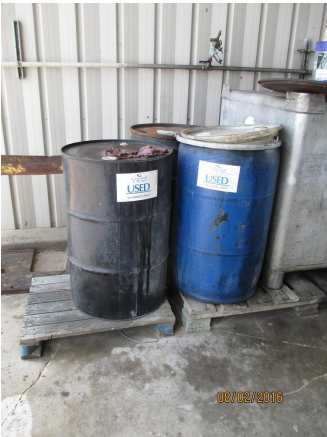
Photo 5

Inside the Vehicle Wash Bay were two 55-gallon drums of used oil filters, one 55-gallon drum of spent antifreeze, and a single-walled 250-gallon metal tote of used oil (Photo 5). All containers were properly labeled, however the metal tote was not double-walled or located within in secondary containment (Photo 6) [Rule 62-710.401(6), FAC].

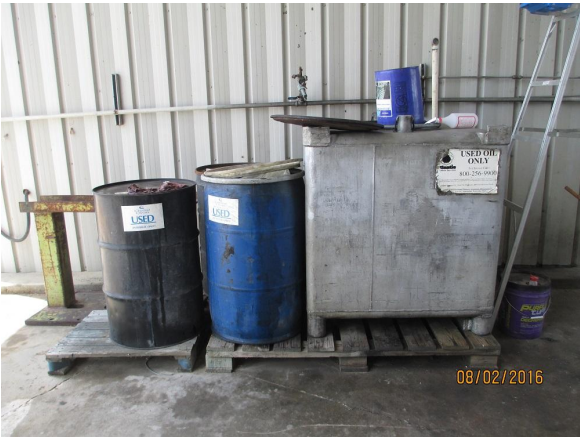
Photo 6

Explanation: One 250-gallon used oil metal tote was not double walled.

Corrective Action: No further action is required. The facility is in compliance per a August 19, 2016 email.

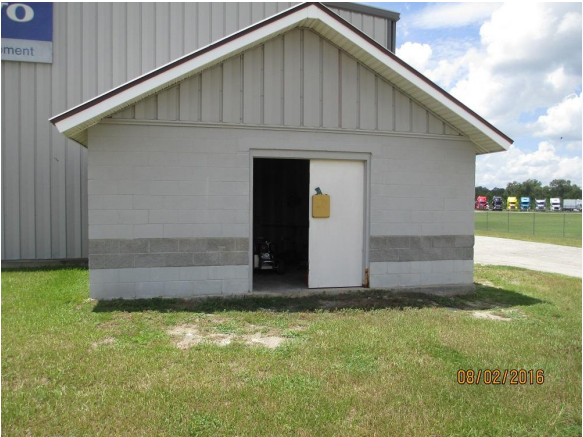
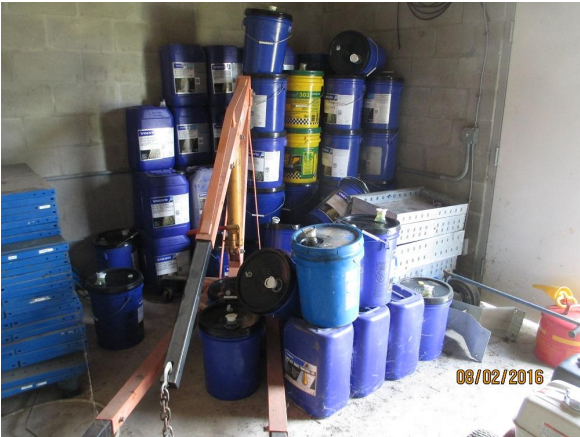
The Storage Building is used to store empty 5-gallon containers for recycling and servicing equipment (Photos 7 and 8).

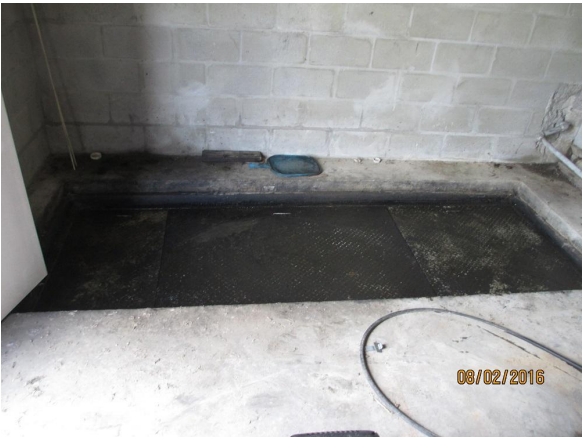
Photo 9

On the left side of the room is the 500-gallon wash bay accumulation tank (Photo 9). Non-hazardous oily wastewater generated from the vehicle wash bay is accumulated inside the tank and is pumped out by Heritage Crystal Clean monthly.
